PIC Program Update!

(Pollution, Identification, and Correction)

Neighborhood Meeting • June 2023

Clallam County Watersheds • PIC Program

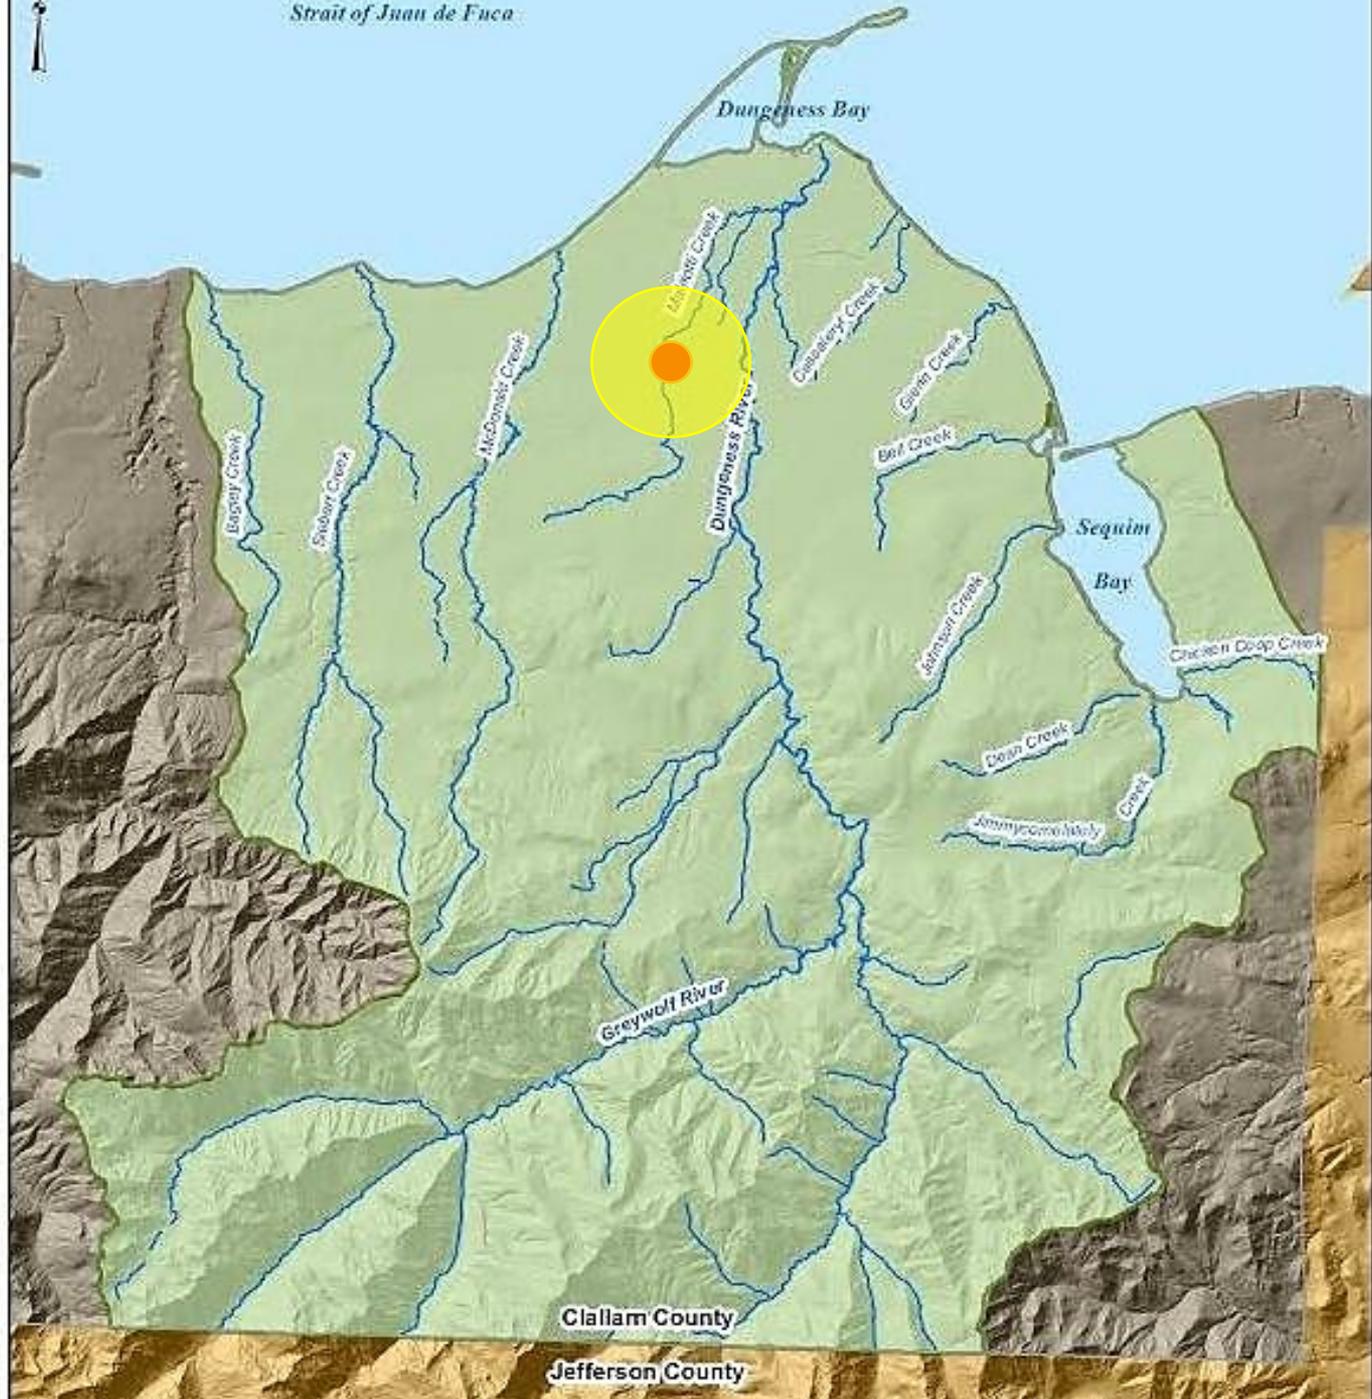
— Main Streams Clallam County Clean Water District

Sources: Clallam County - streams, Clean Water District, boundaries - 2014

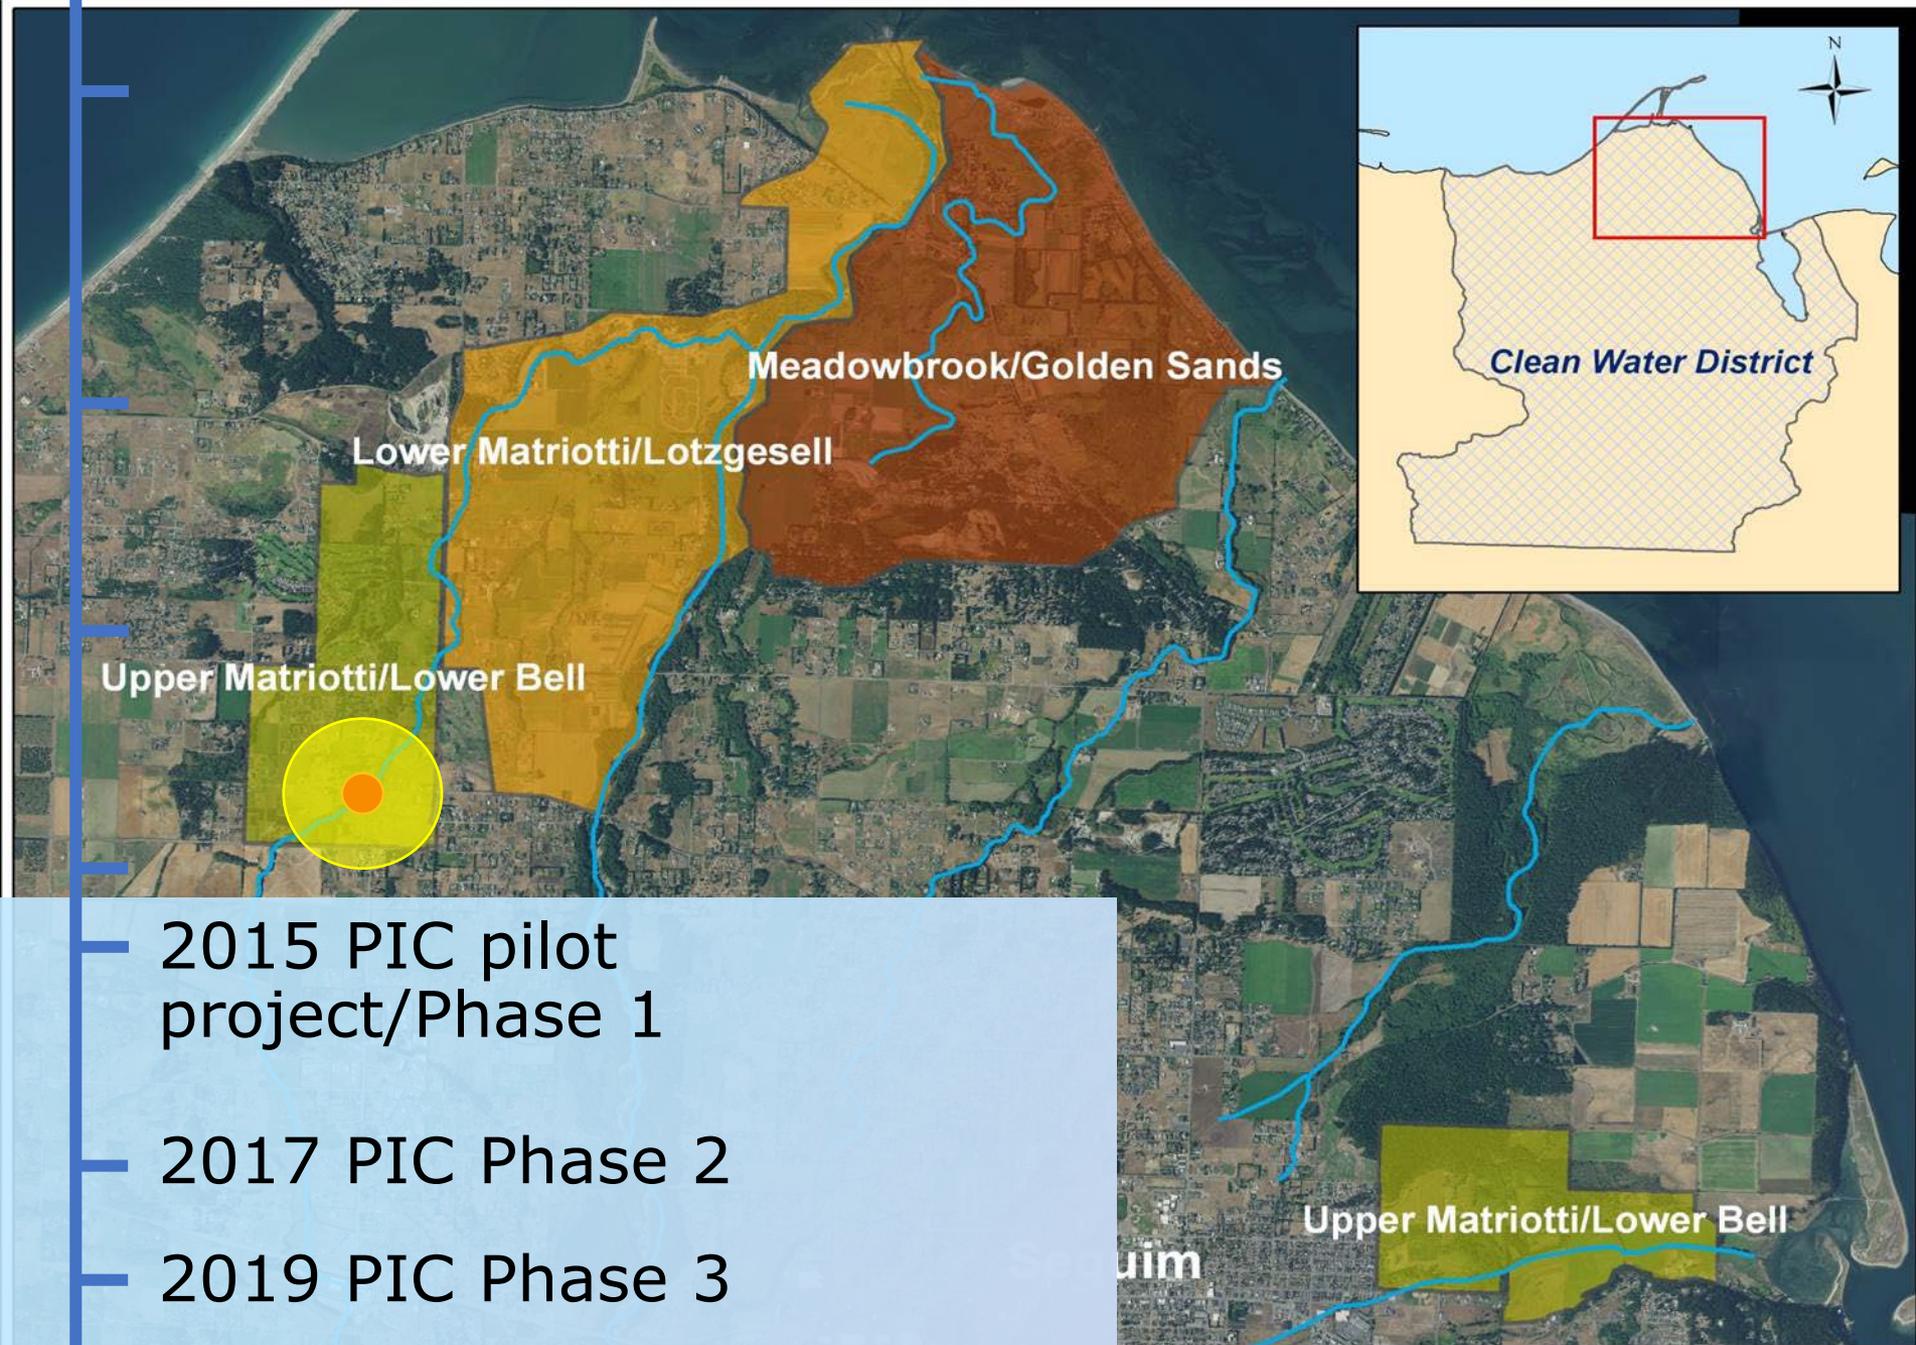
— 2015 PIC pilot project/Phase 1

— 2017 PIC Phase 2

— 2019 PIC Phase 3

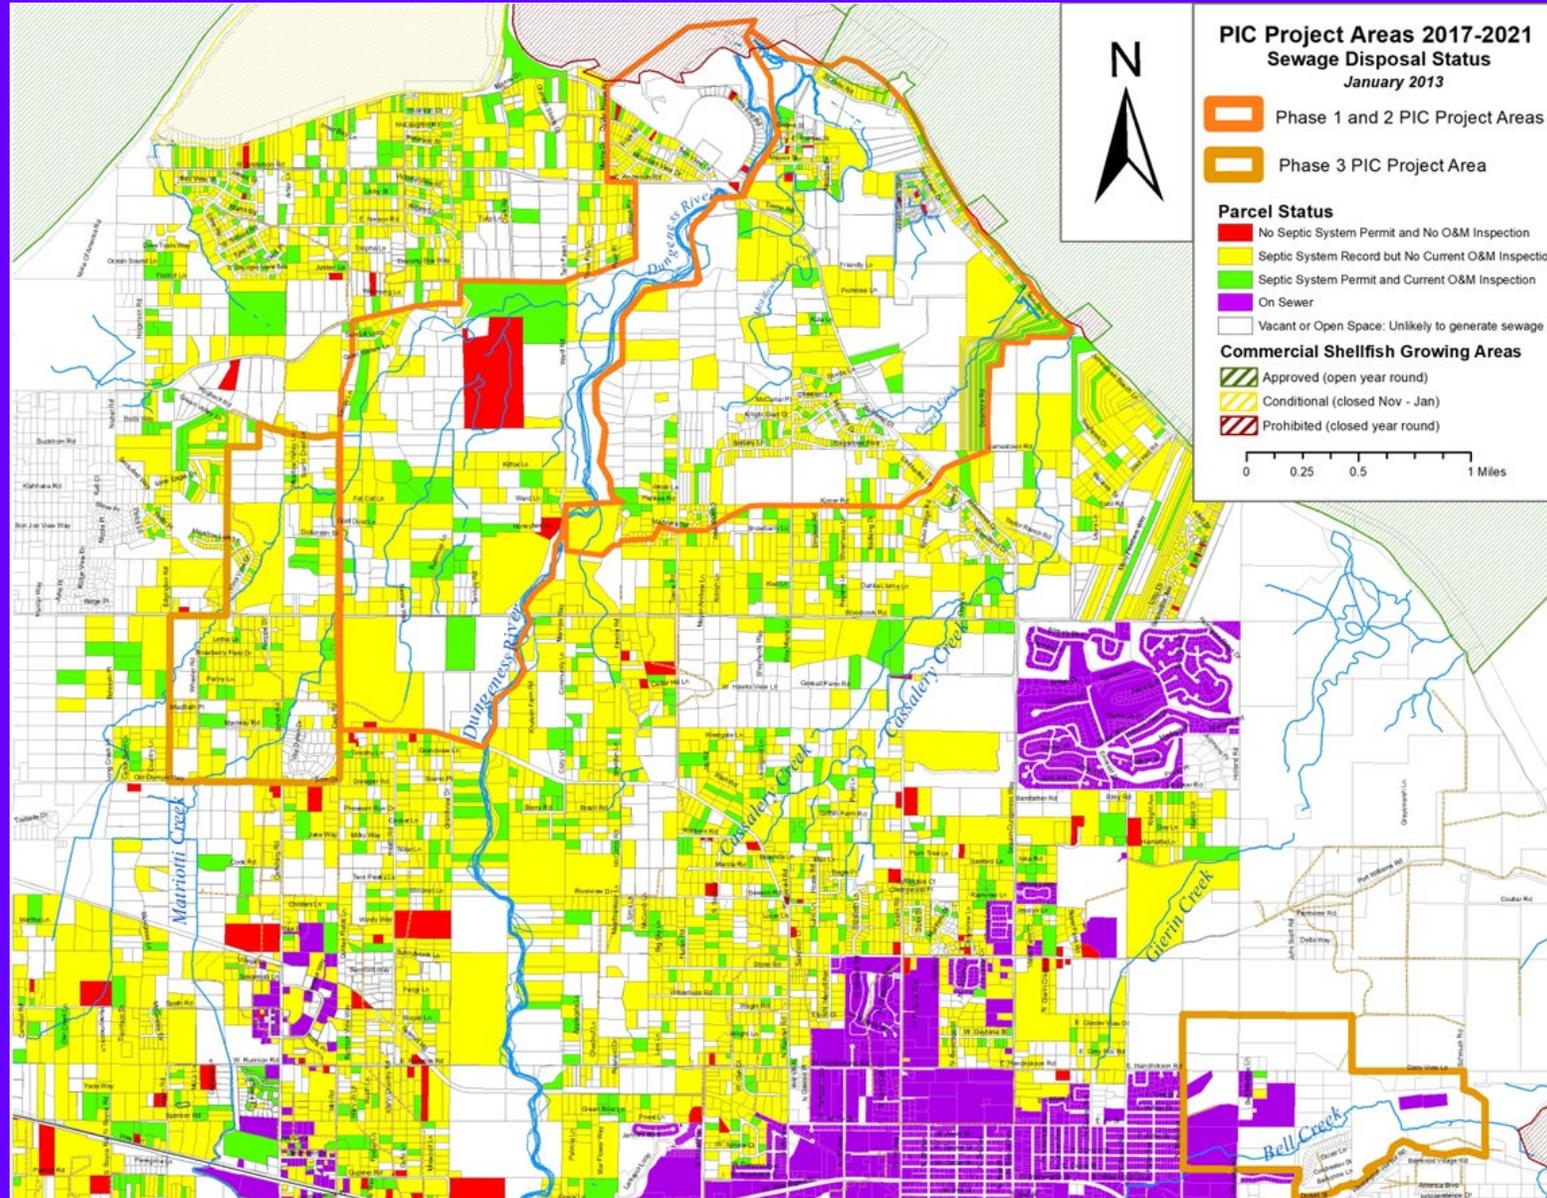
January 2013 Inspection Status

Red to Green Maps

Red = No septic permit/no inspection

Yellow = Septic system exists/no current inspection

Green = septic permit/ current inspection

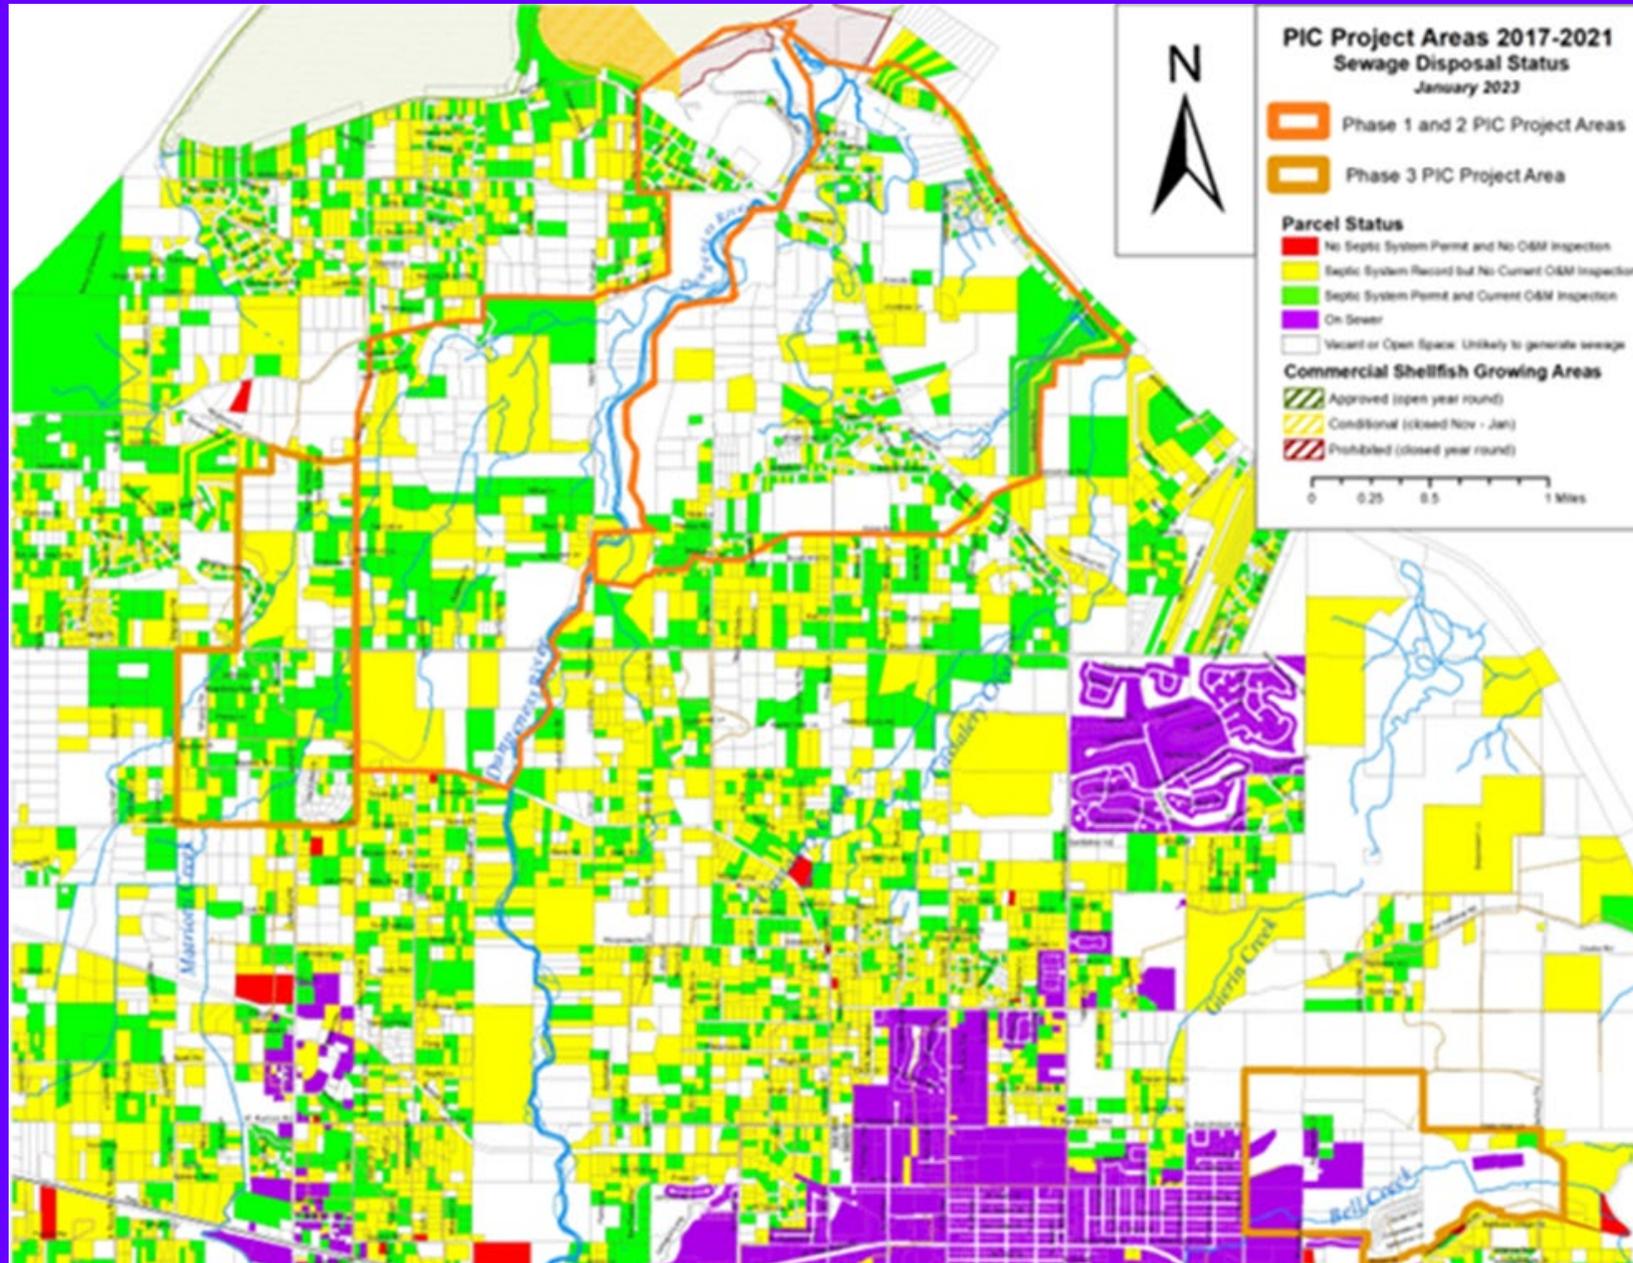
January 2023 Inspection Status

589 of PIC properties are current on their required inspections as of January 2023

64% of OSS in the PIC areas are current on inspections as compared to 38% in the MRA and 32% in the county.
