Dungeness Reservoir Progress Update to Clallam County Board of Commissioners

August 14, 2023

Comprehensive Project Overview

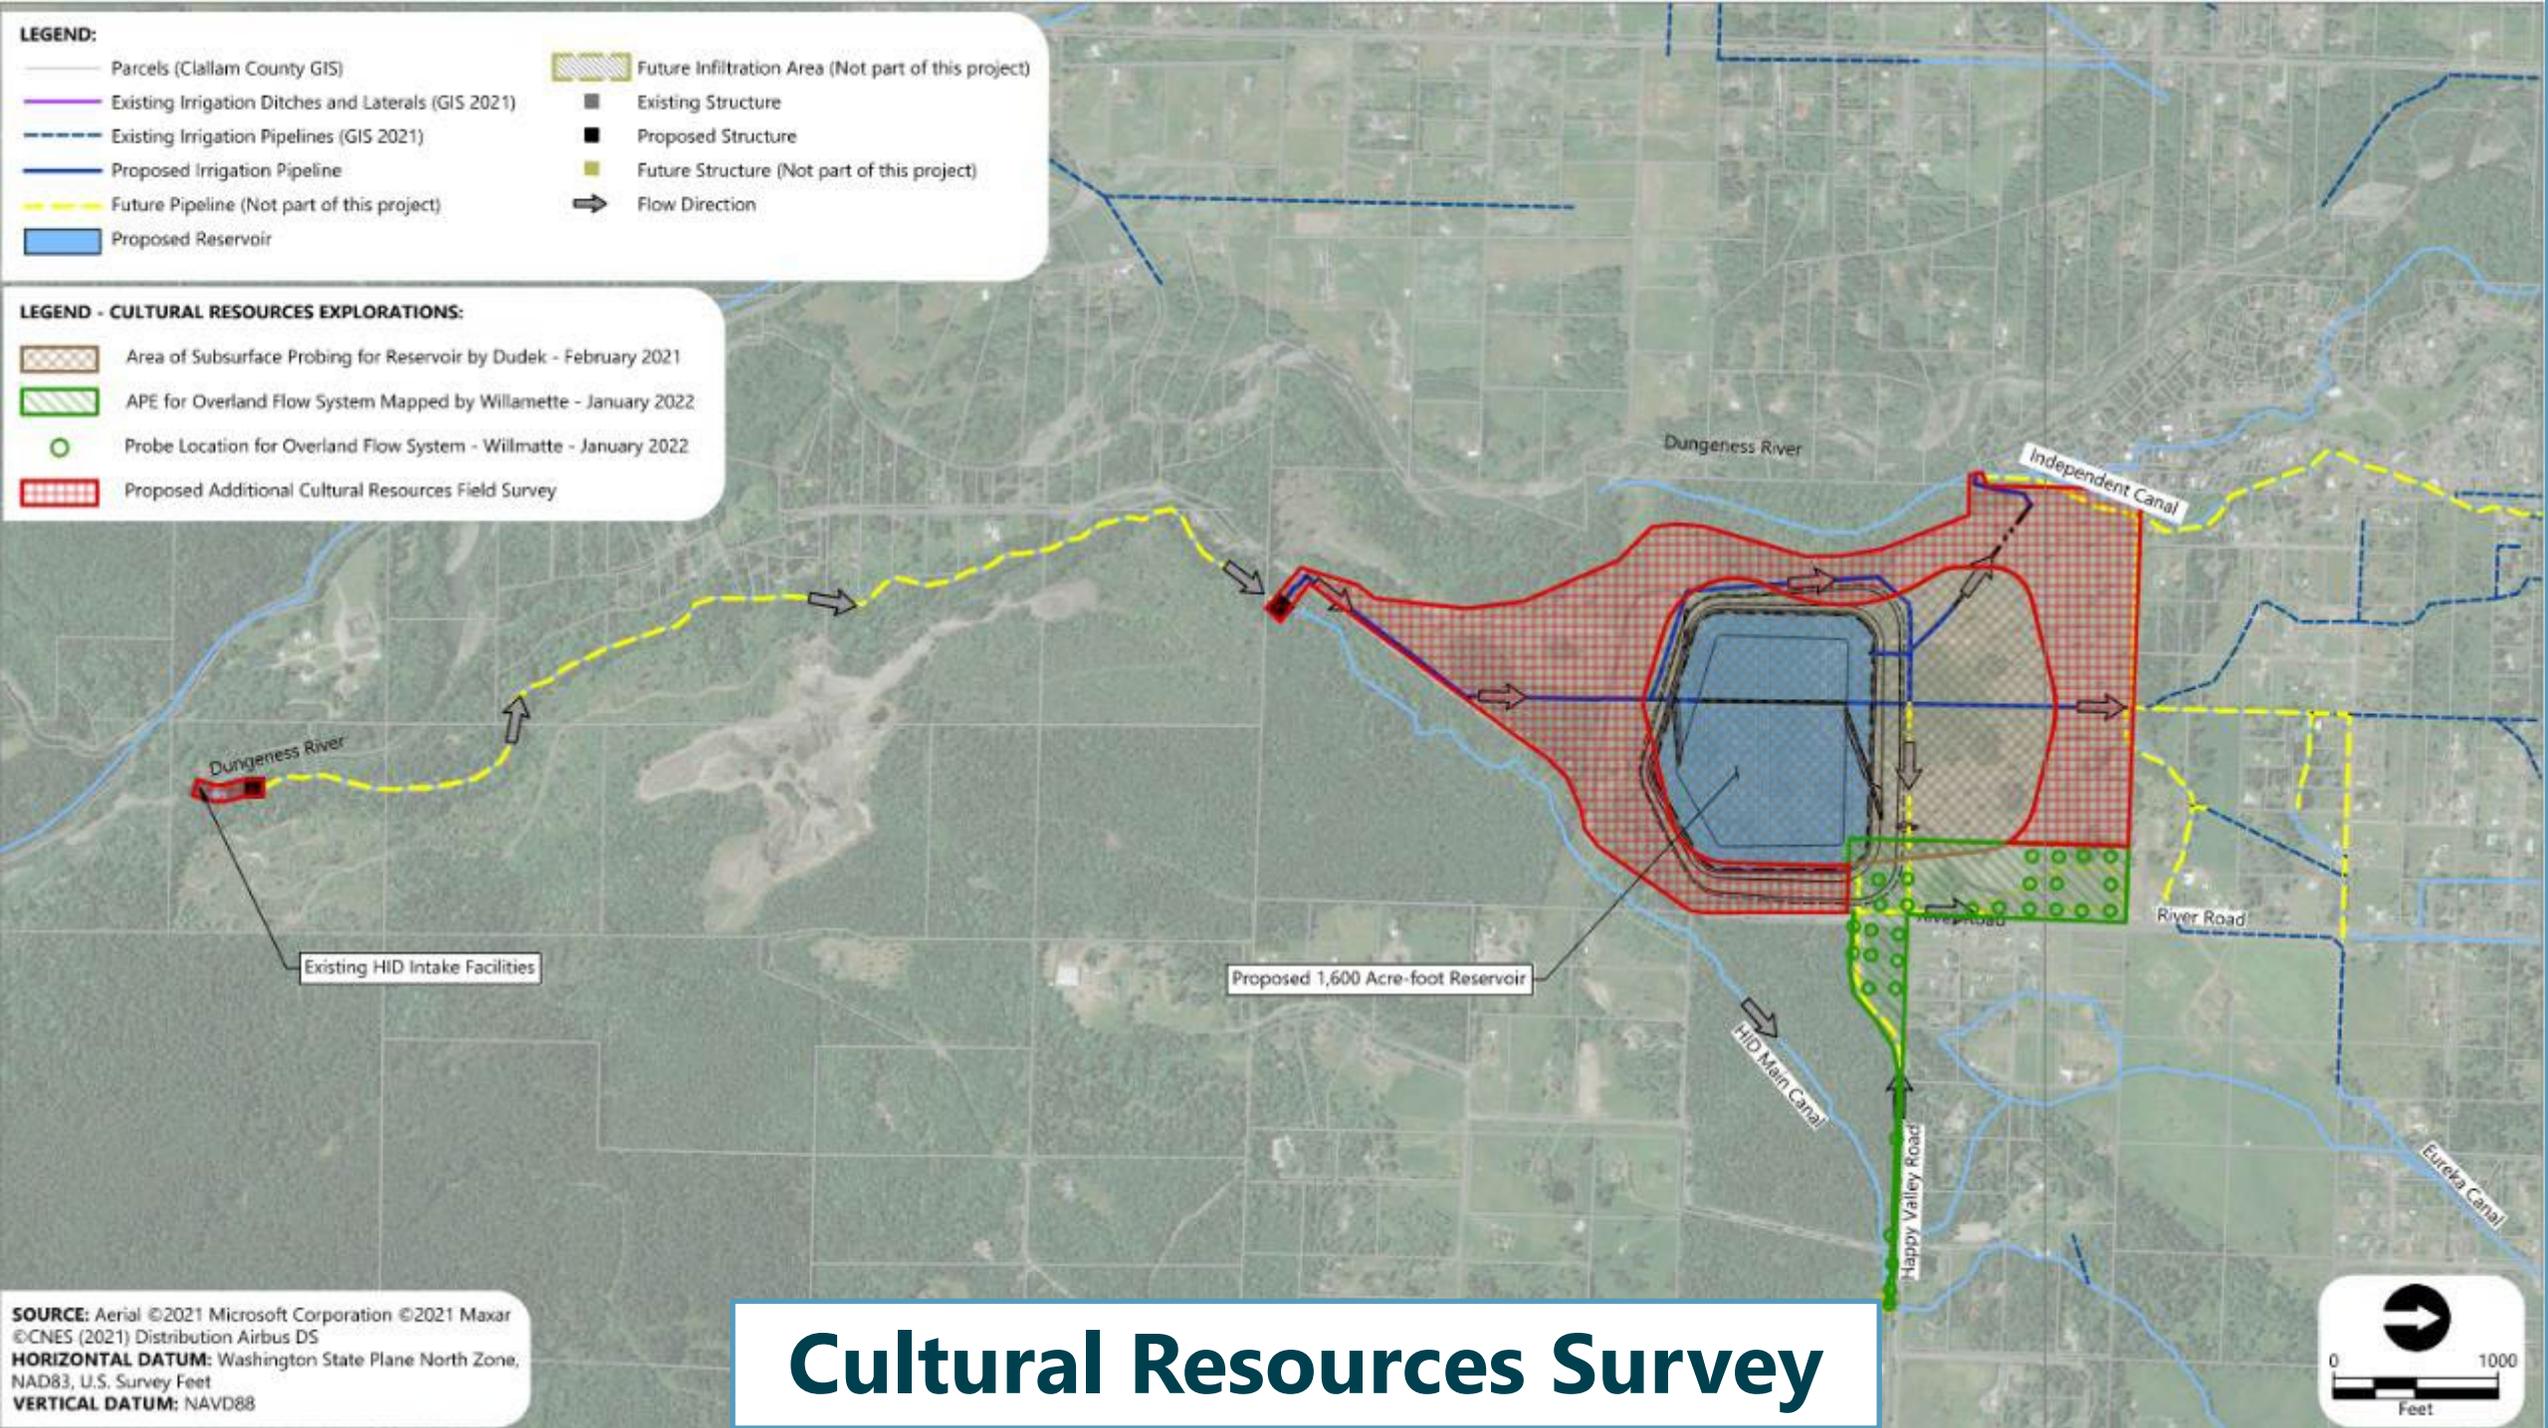
Cultural Resources Survey

- Supplemental topographic survey
- Cultural resources
- Utility location in River Road with City of Sequim
- Geotechnical
 - Geophysical survey
 - Borings on HID Canal near intake facilities and at location of flow control structure
 - Seismic reconnaissance

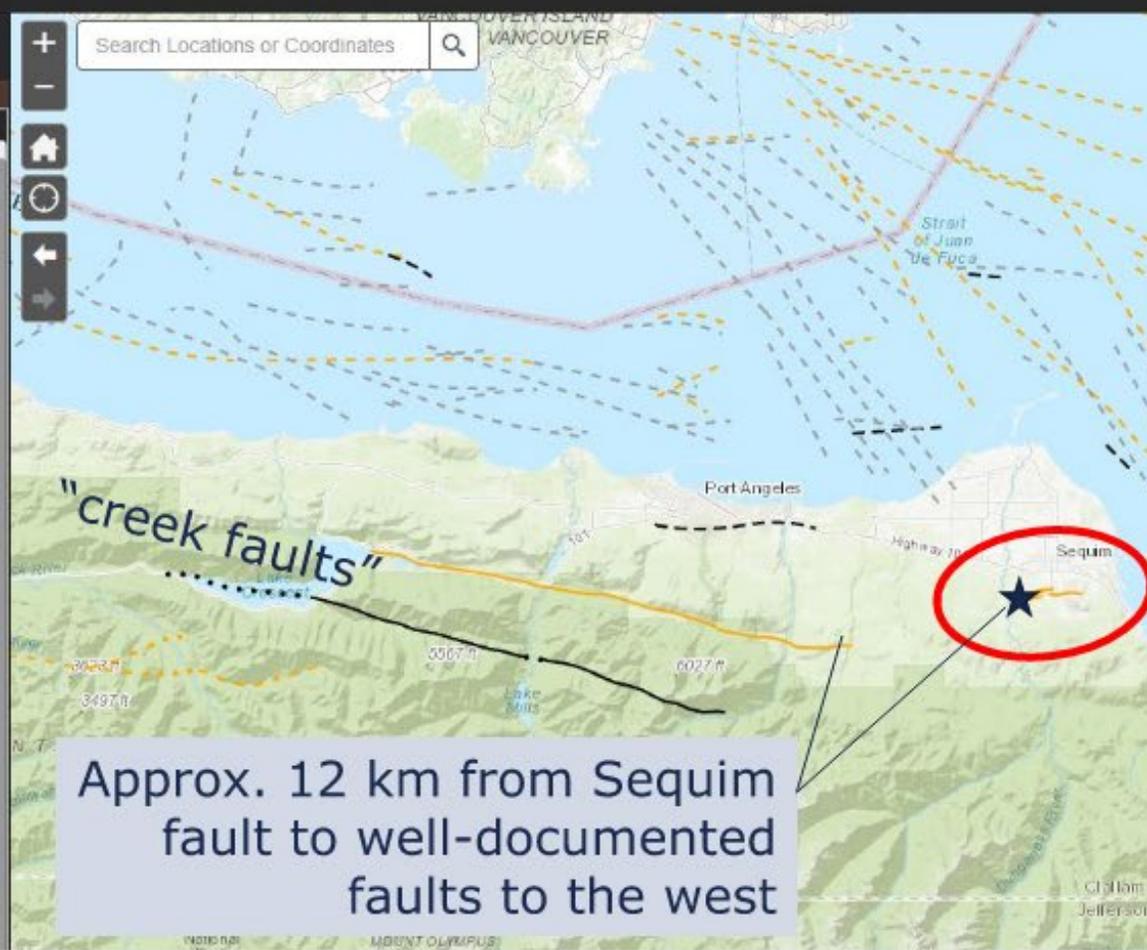
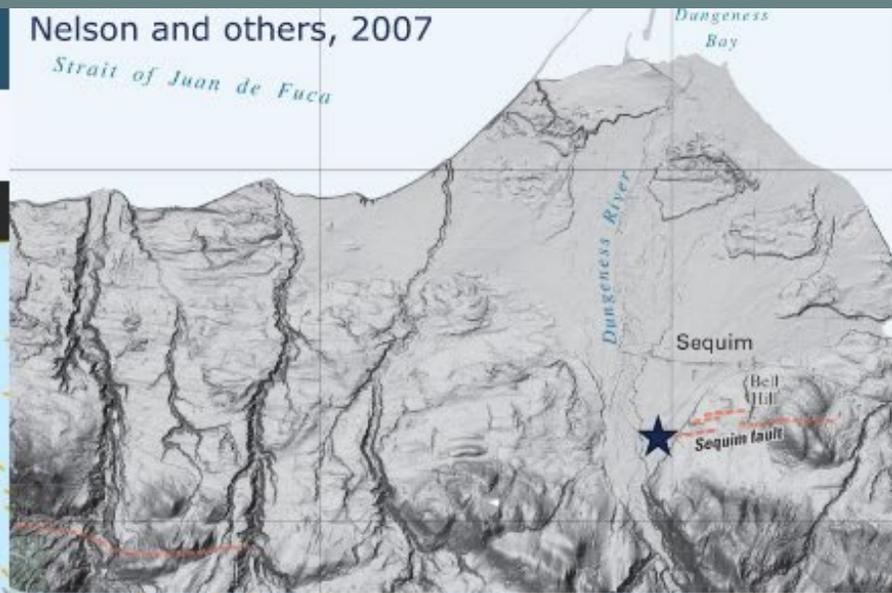
Seismic Review – Prior to Preliminary Design

- 2007 USGS Study
 - Fault line mapped at site, referred to as “Sequim Fault”
 - Study did not provide explanation or basis for mapping
- 2020 PanGEO Report
 - County contracted with PanGEO to complete feasibility review
 - Review of available geologic information
 - Site review with geologists from USGS
 - Initial geologic map and LiDAR topographic data review
 - Found no explanation of mapping of “Sequim Fault”
 - Found “no identifiable evidence of faulting in the project area”
 - Recommended review of excavations for any “soil anomalies”

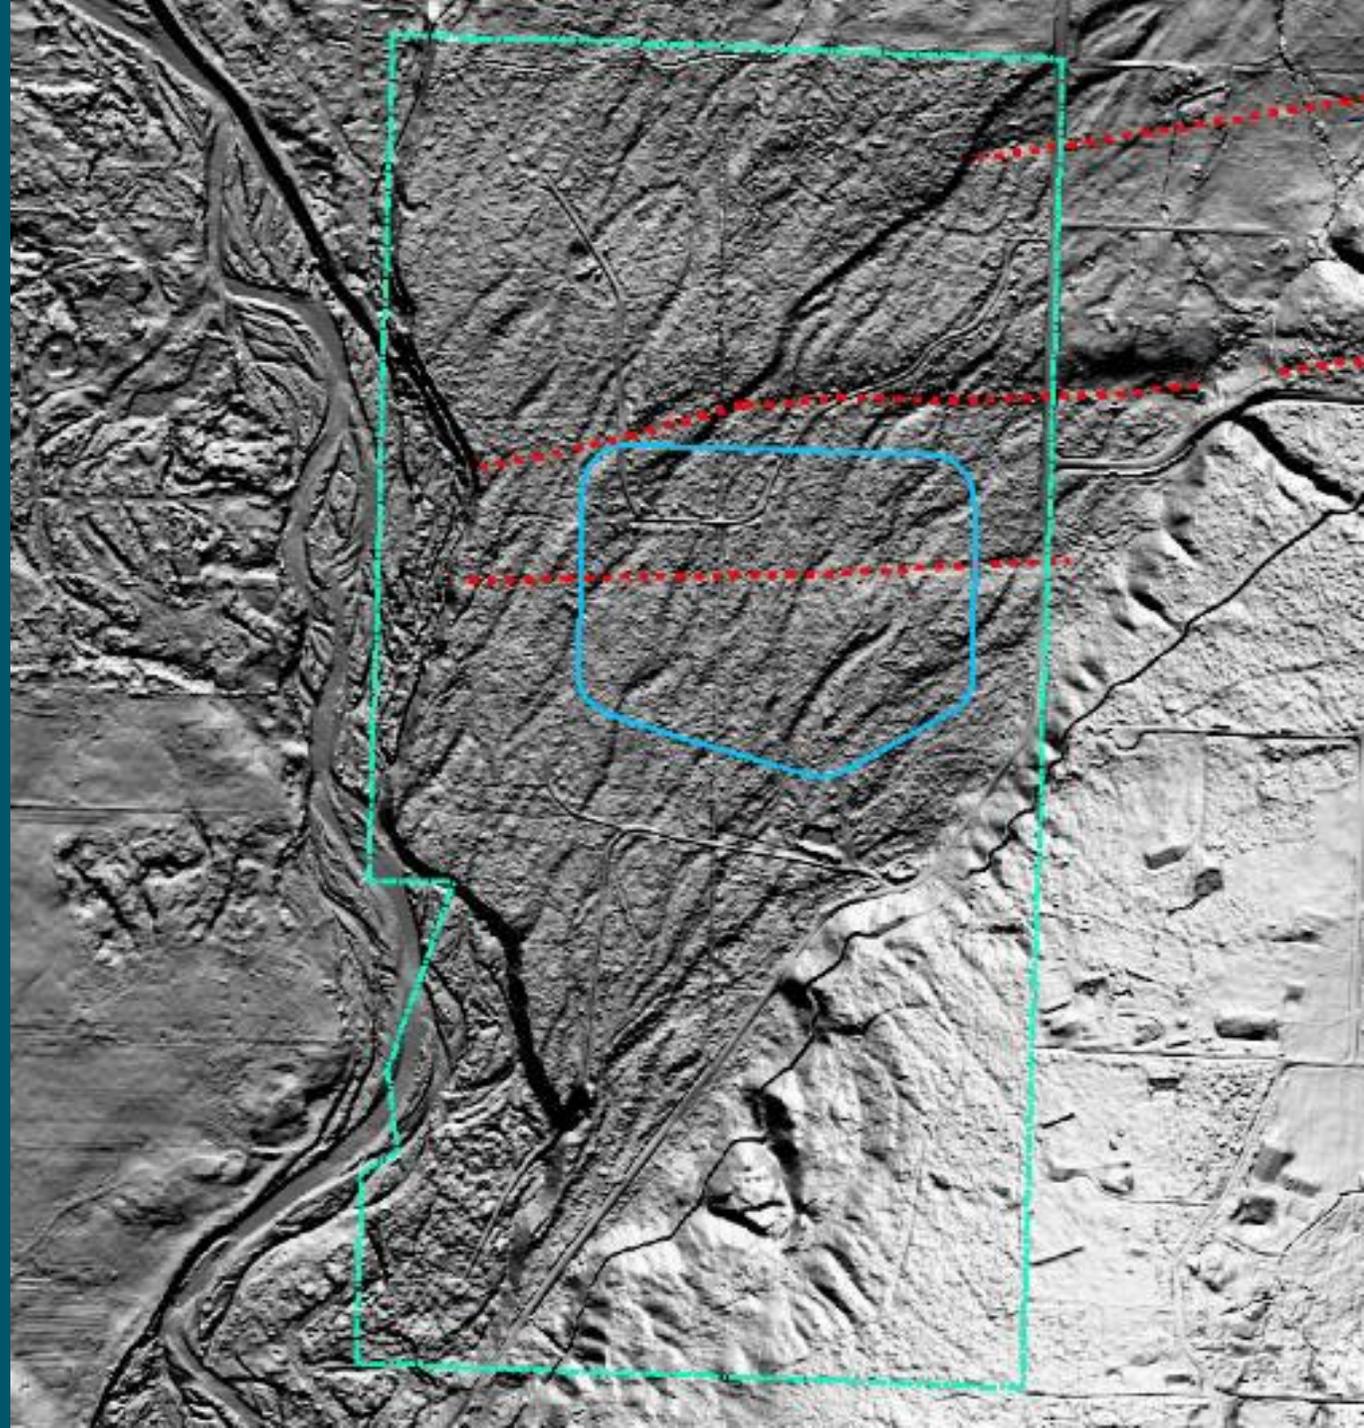
2023 Review by Shannon & Wilson

- Desktop review, including analysis and interpretation of LiDAR topographic data for potential surface deformation
- Site review
- Identified subtle linear topographic features (lineaments) that suggest presence of faults

- Develop a phased plan for investigating and characterizing the fault zone identified by Shannon & Wilson
- Review plan with Ecology's Dam Safety Office
- Complete initial phase of investigation, as allowed by Land Lease or Property Acquisition with DNR (or investigate at off-site locations)
- Based on information gathered, determine whether additional investigation is needed
- Based on information gathered, verify which design configurations are viable and select a preferred configuration
- Proceed with additional geotechnical investigations (as needed), permitting, and detailed design
- Continue to identify and secure funding to support design, permitting and construction

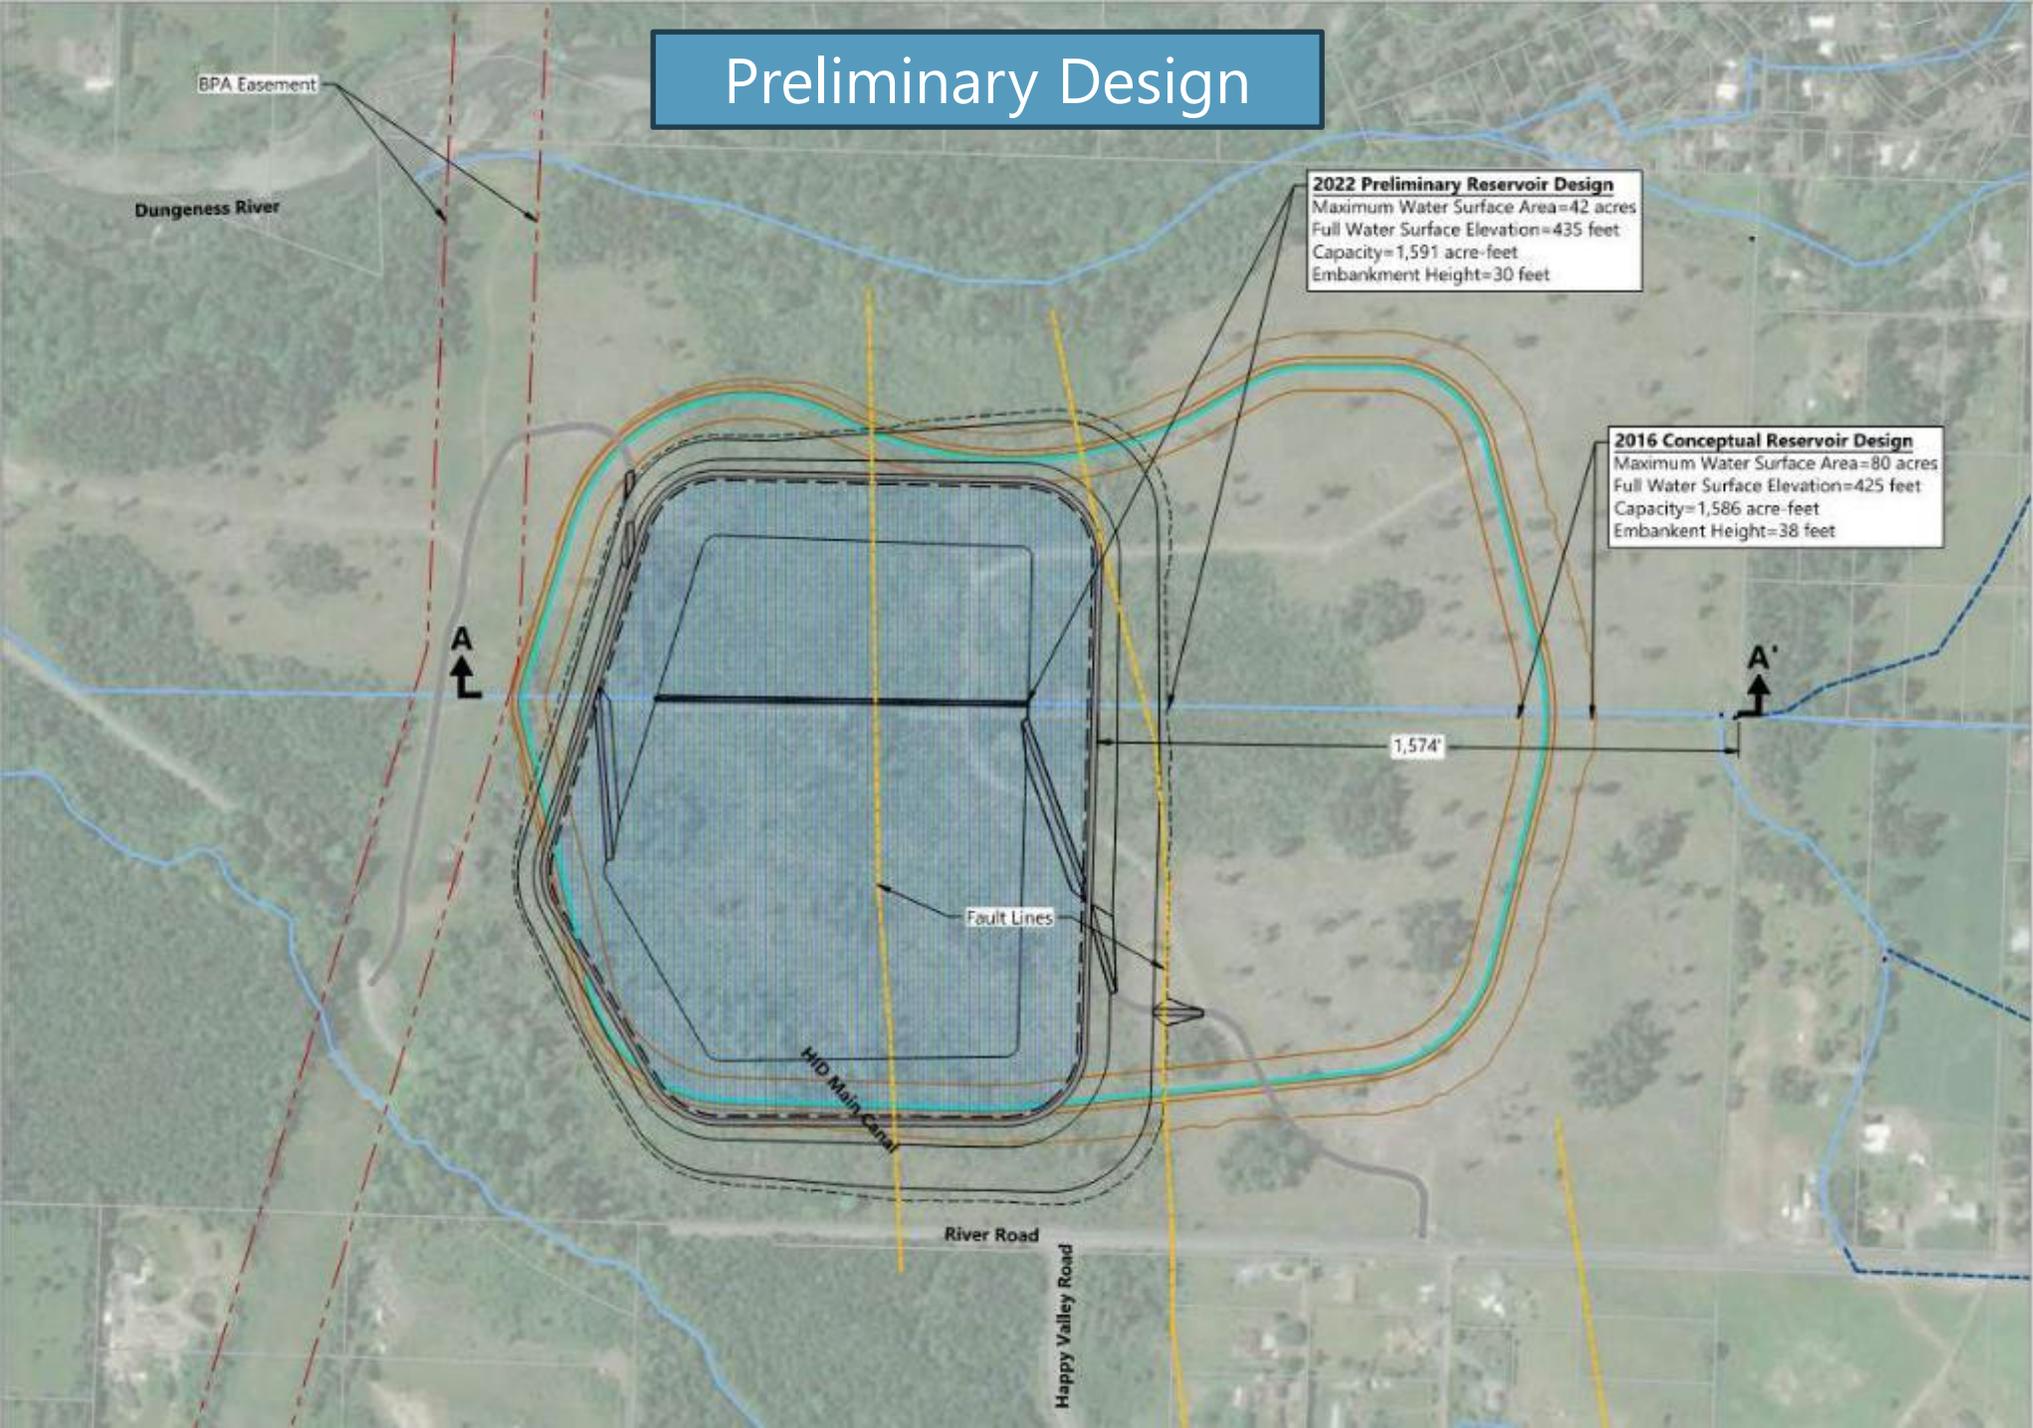
Preliminary Design

2022 Preliminary Reservoir Design
Maximum Water Surface Area=42 acres
Full Water Surface Elevation=435 feet
Capacity=1,591 acre-feet
Embankment Height=30 feet

2016 Conceptual Reservoir Design
Maximum Water Surface Area=80 acres
Full Water Surface Elevation=425 feet
Capacity=1,586 acre-feet
Embankment Height=38 feet

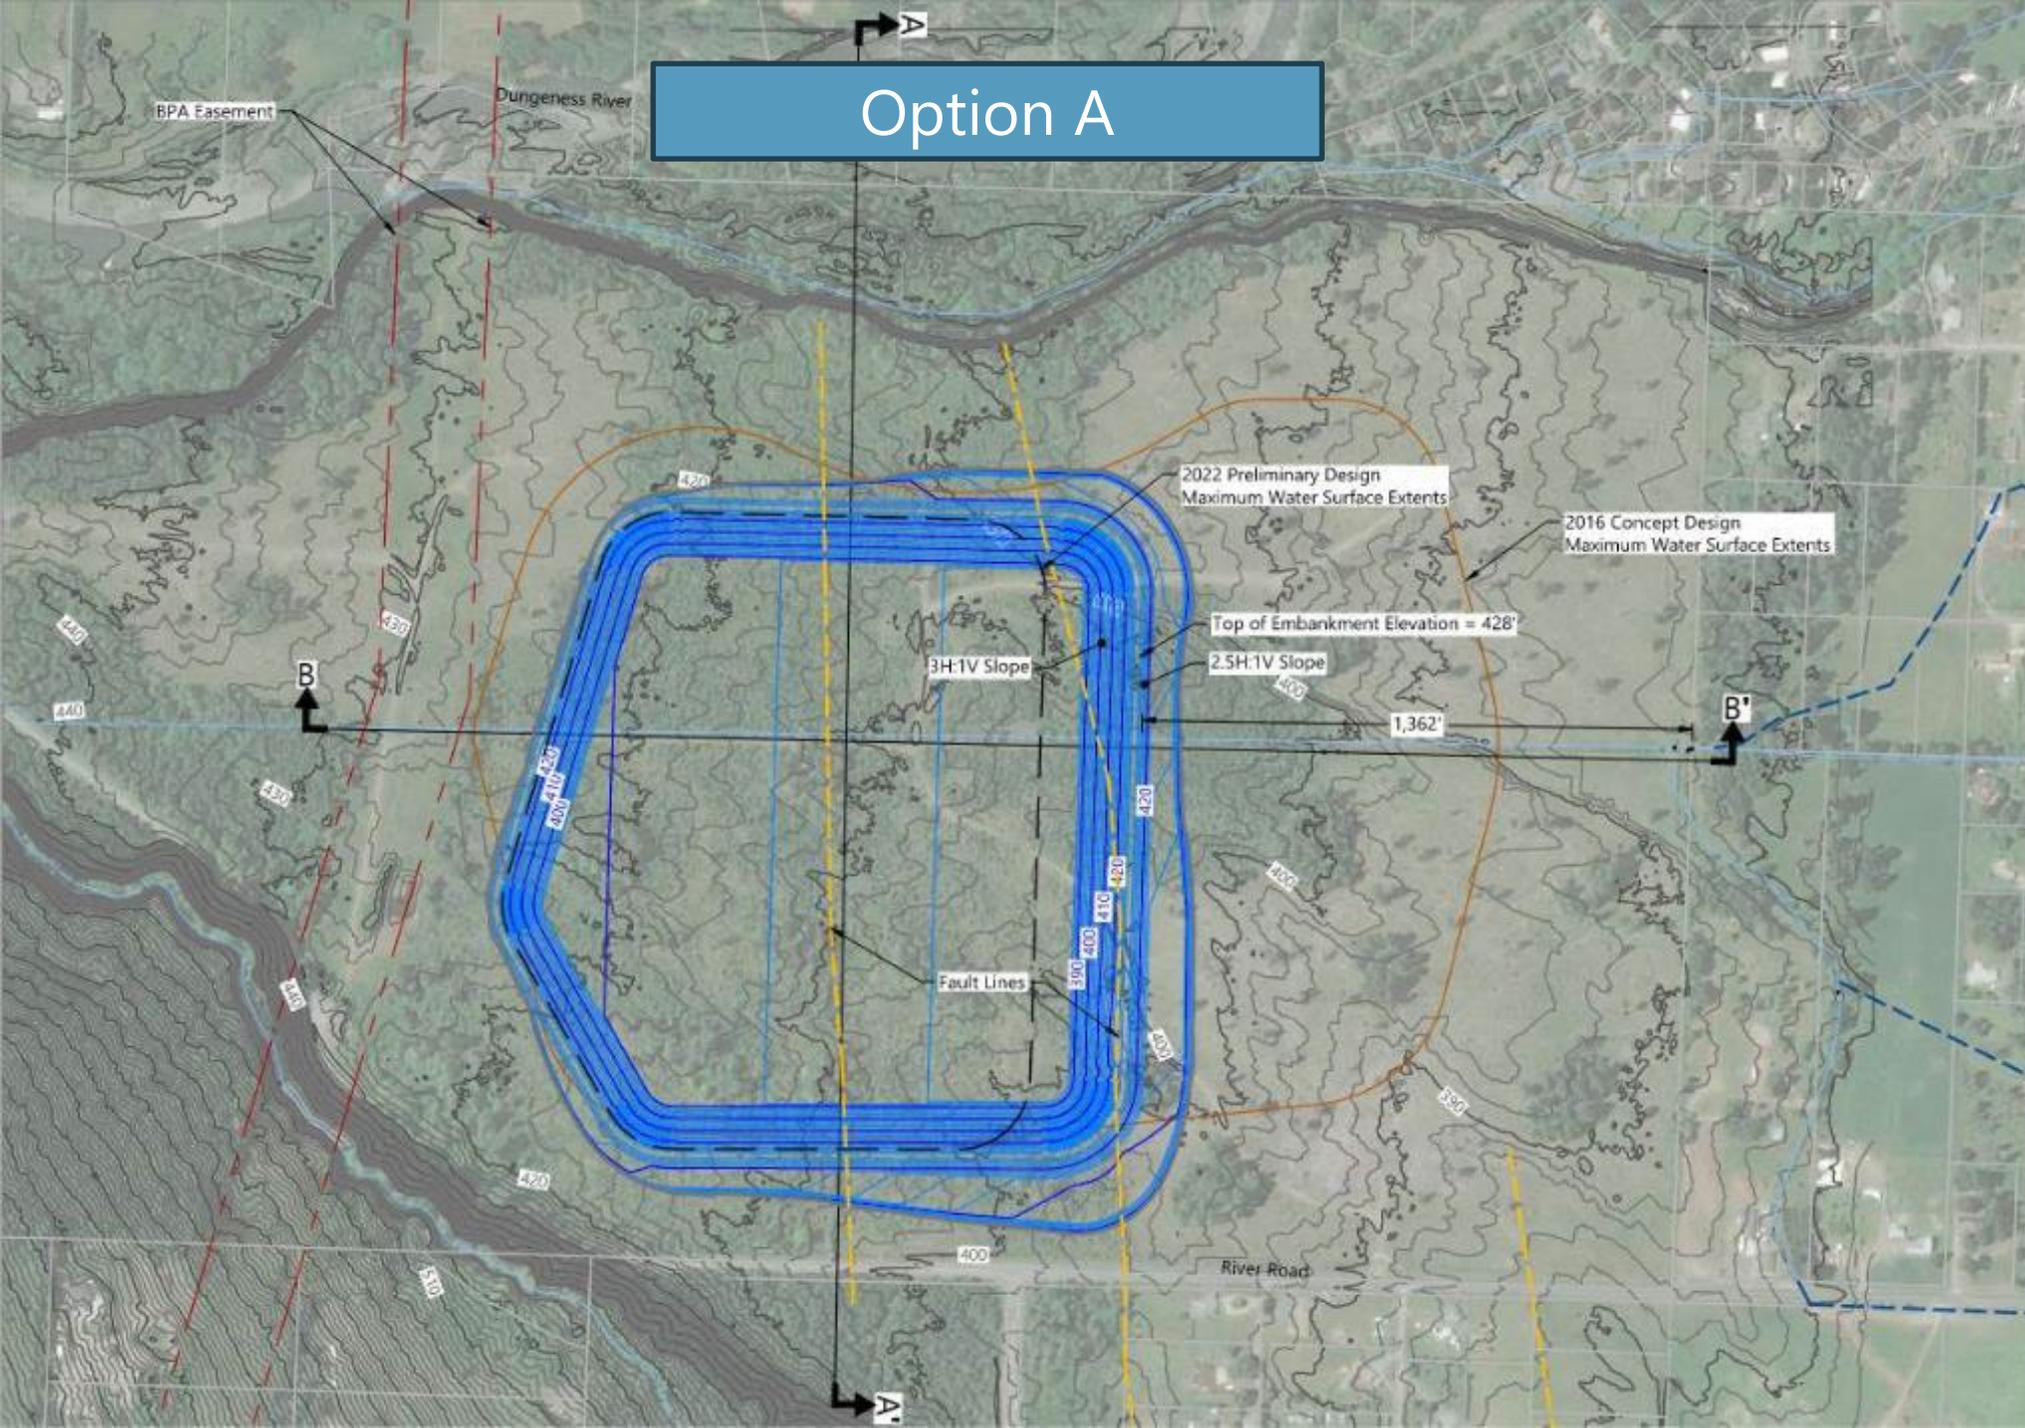
- Preliminary Design
- Options A - C
 - Designed to be responsive to public comment about height of embankment and volume of water stored above-ground
- Option D
 - Completed after seismic reconnaissance to look at potential for shifting reservoir south to avoid overlap with fault zone mapped by Shannon & Wilson
 - Also designed to be responsive to public comment about height of embankment and volume of water stored above-ground
 - Configured to minimize impact on BPA easement

Design Variable	Preliminary Design	Option A	Option B	Option C	Option D
Maximum WSEL	435 feet	425 feet	422 feet	415 feet	435 feet
Storage Capacity	1,591 Acre-feet	1,595 Acre-feet	1,544 Acre-feet	1,591 Acre-feet	1,420 Acre-feet
Height of N Embankment	30 feet±	22 feet±	20 feet±	14 feet±	23 feet±
Maximum Depth of Water Above Ex Ground	27 feet±	19 feet±	17 feet±	11 feet±	20 feet±
Total Excavation	1,243,501 CY	1,590,557 CY	1,681,850 CY	2,603,569 CY	1,745,452 CY
Distance from N Property Boundary	1,574 feet	1,362 feet	1,320 feet	1,115 feet	2,285 feet
Total Fill Required	642,529 CY	364,723 CY	280,226 CY	274,989 CY	363,563 CY
Cost of Key Elements	\$38.8 million	\$41.2 million	\$42.4 million	\$44.5 million	\$43.6 million
