REACH MR-6: Green Point

REACH SUMMARY

REACH REACH MR-6: Green Point

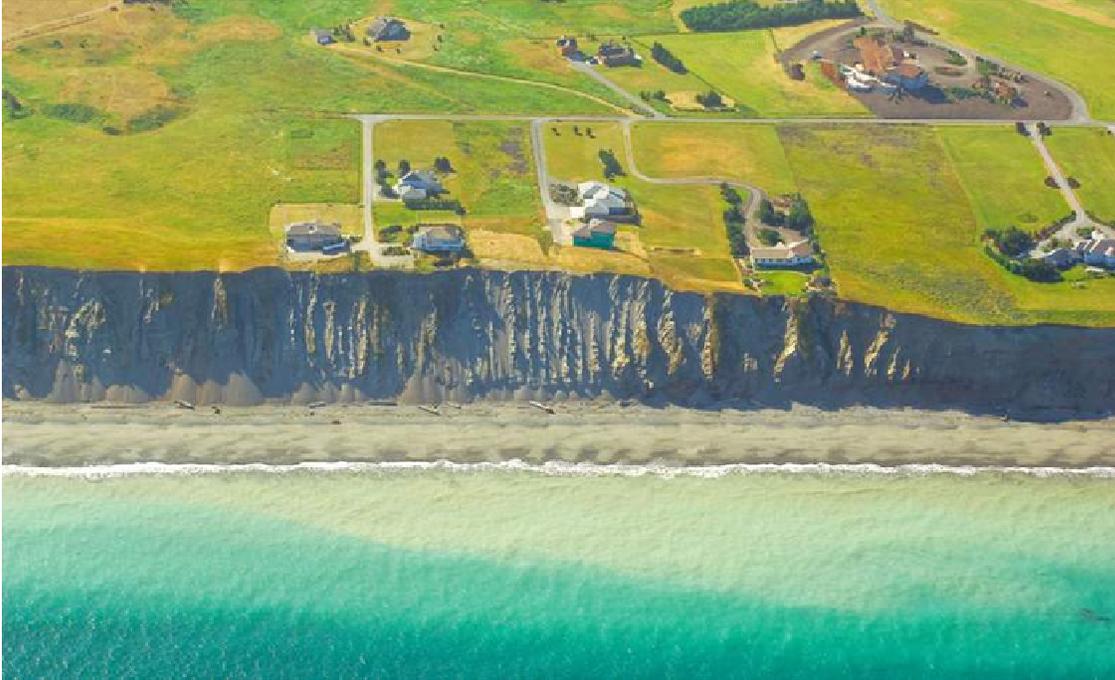
1
2 **Figure 4-3. Segment of exceptional feeder bluff west of Dungeness Spit lacking native riparian forest cover**
3 **(Photo: Ecology Coastal Atlas)**
4

24 The predominant shoretype in the reach is bluff backed beach, with smaller portions of barrier
25 beach and barrier estuary. Over 70% of this reach is mapped as feeder bluff or feeder bluff
26 exceptional (Figure 4-3). From Lees Creek, net shore-drift is eastward along the feeder bluffs,
27 transporting sand, gravel, and cobble that maintains Dungeness Spit. These feeder bluffs are
28 subject to the high wind and wave energy. There is very minimal armoring within this drift cell,
29 which allows unimpeded drift and natural beach building processes to occur to occur along
30 Dungeness Spit. The area just west of Green Point is a landslide hazard area. Recent landslides
31 have been mapped along the feeder bluffs within the reach, and many homes along the edge of
32 the bluffs could be at risk. A second drift cell flows west from Lees Creek towards Port Angeles.
33 The shoreline within this drift cell is heavily modified. There are no overwater structures

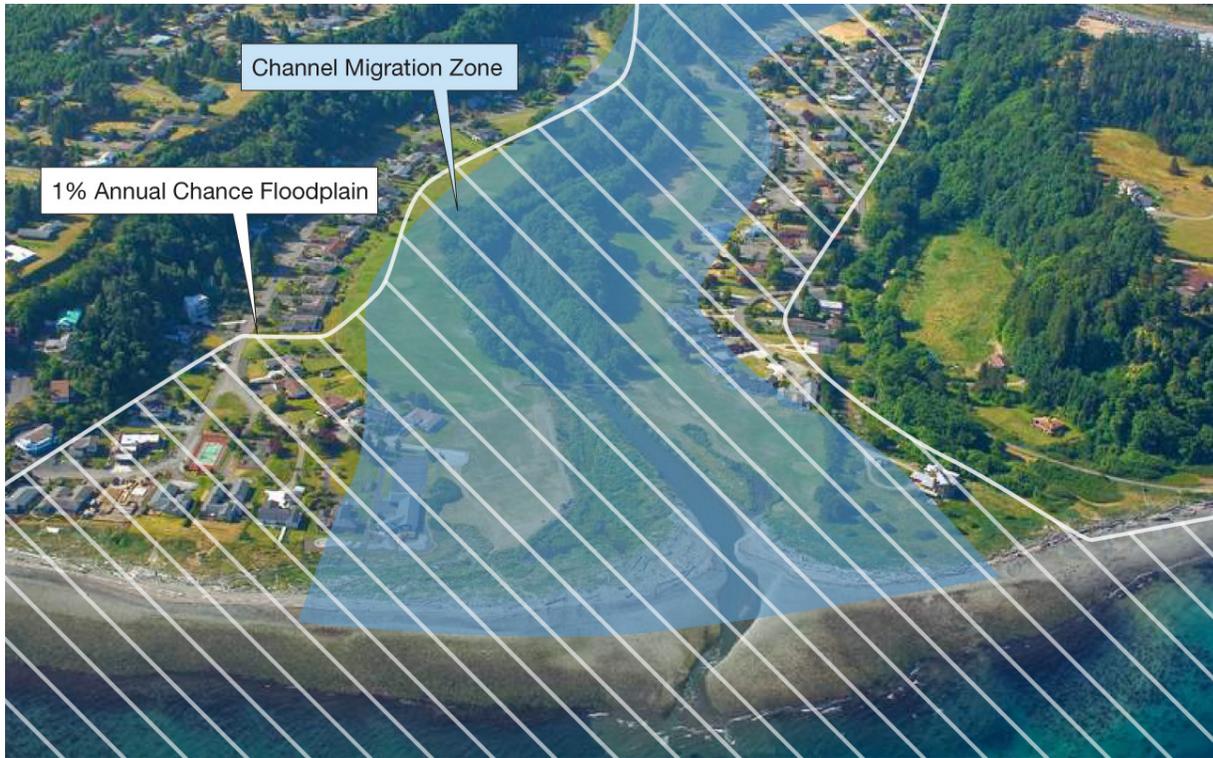
2 **Figure 4-4. Development at the mouth of Morse Creek with the mapped floodplain and channel migration**
 3 **zone. (Photo: Ecology Coastal Atlas)**

5 The mouths of Morse and McDonald Creek are in tsunami hazard areas and mapped FEMA 100-
6 year floodplains (coastal and stream). There is limited development adjacent to the McDonald
7 Creek mouth; however, dense residential development is located near the Morse Creek mouth,
8 and many of these homes are within the floodplain and/or channel migration zone of the creek
9 (Figure 4-4). The mouth of Siebert Creek has been the focus of a coordinated program by the
10 North Olympic Land Trust and other organizations to acquire conservation easements.

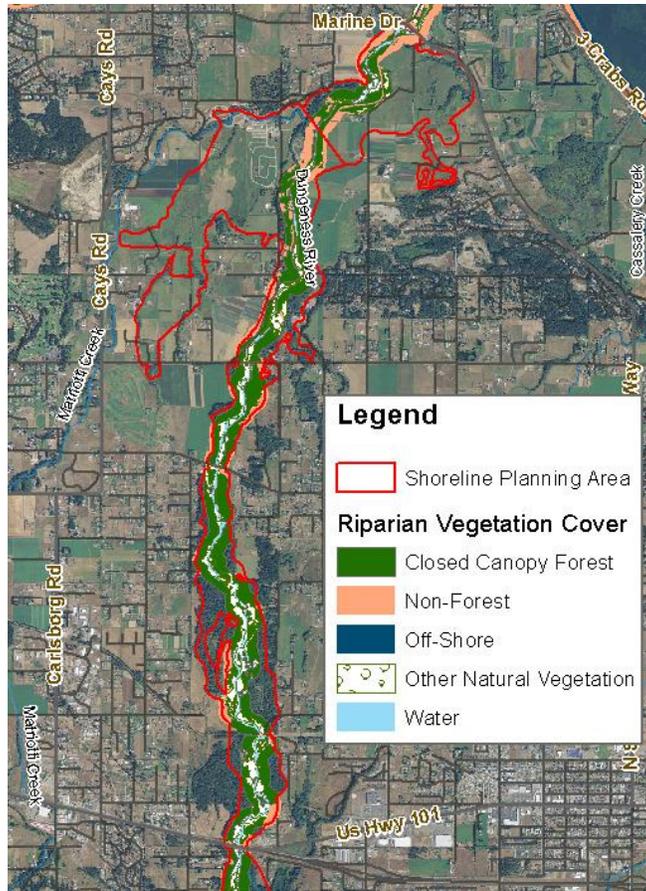
Figure 6-1. Riparian vegetation cover along the lower Dungeness River.

15 Upstream from RM 10.8 (confluence with Canyon Creek), the watershed and riparian corridor of
16 the Dungeness River and its tributaries consists almost entirely of forest habitat. Forest cover
17 dramatically decreases downstream, as the river flows through residential developments and
18 agricultural lands. Downstream from RM 10.8, the width of the forested riparian corridor varies
19 from 0 to approximately 500 feet (Figure 6-1).

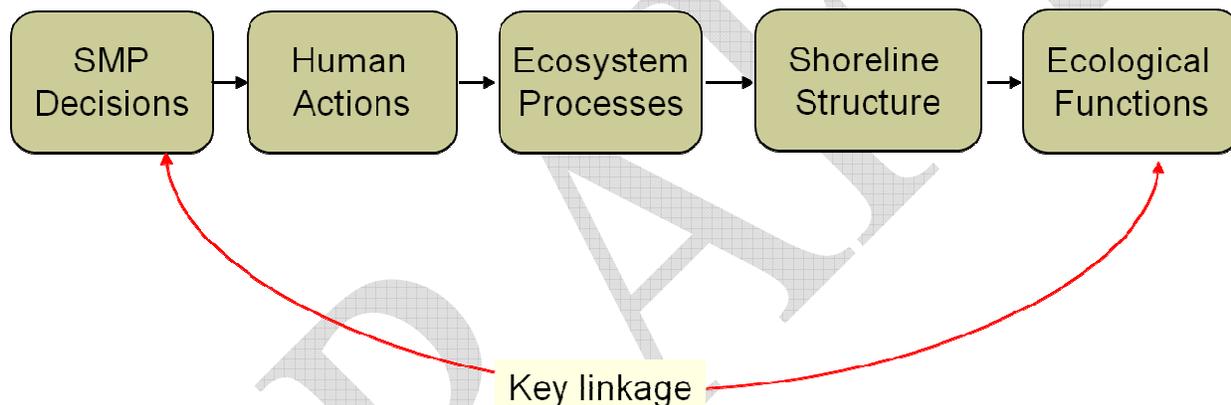
Figure 3-5. Relationship between human actions and shoreline ecological functions in the context of shoreline master programs

Ecological functions are dependent on the structure of the shoreline, which is shaped by ecosystem processes (such as erosion and deposition of sediment), which are affected to greater or lesser degrees by the actions people take on the shoreline. This basic model applies to a wide range of actions—many different ecological functions are linked to human actions and therefore to SMP decision. In this way, SMP decisions can lead to increases or decreases in ecological functions over time (Figure 3-5).

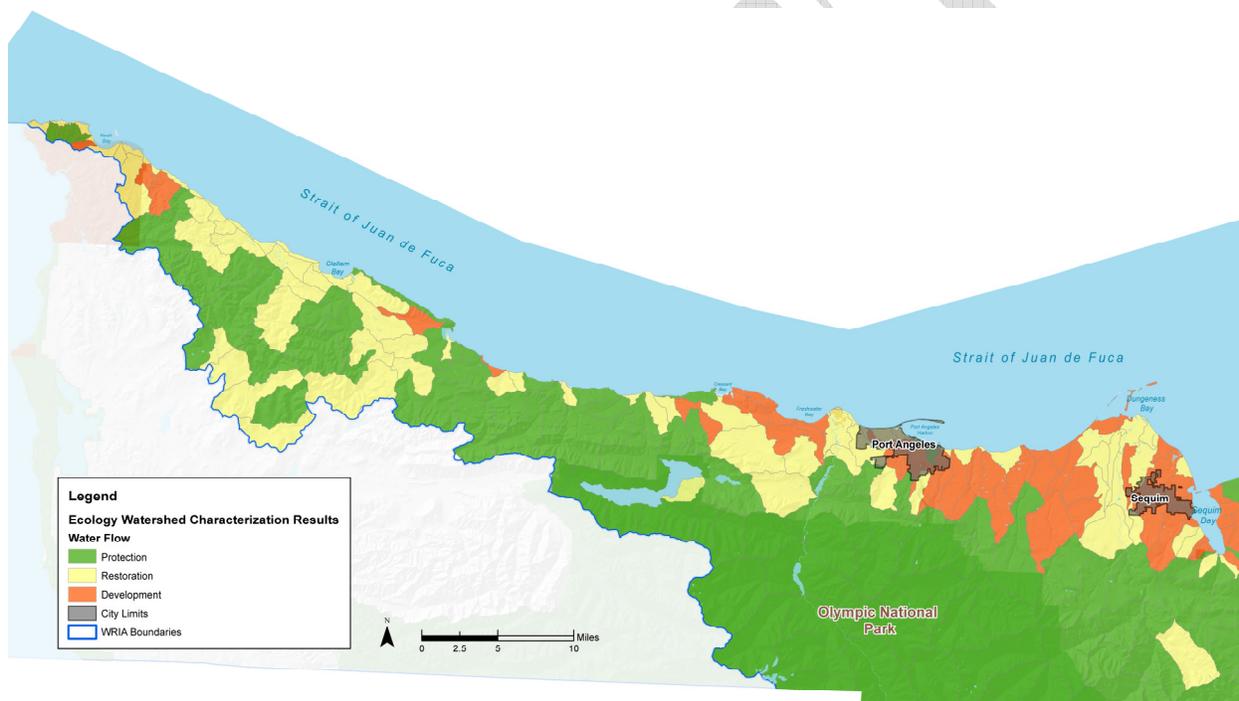
12 **Figure 5-6. Ecology’s relative ranking of the water flow processes for each sub basin draining to the Strait of**

- 1 The results provide a relative ranking of sub basins into one of three categories (Figure 5-6):
- 2 • Protection – these sub basins are highly important in terms of infiltration, recharge, water
- 3 storage and other natural water flow processes and have minimal alteration. Protection of
- 4 the existing conditions is a high priority.
- 5 • Restoration – these sub basins areas are also very important to natural hydrology, but
- 6 have experienced alteration. Restoration in these areas could help to increase ecological
- 7 process and functions.
- 8 • Development – these sub basins are less important—on a relative scale—for hydrology
- 9 processes and they have been moderately to highly altered. Development in these areas
- 10 would generally have less impact on hydrology than in either of the other two categories.
