6. FRESHWATER REACH SUMMARY

6.1 *Little Quilcene River (Maps 1a to 6a in Appendix A)*

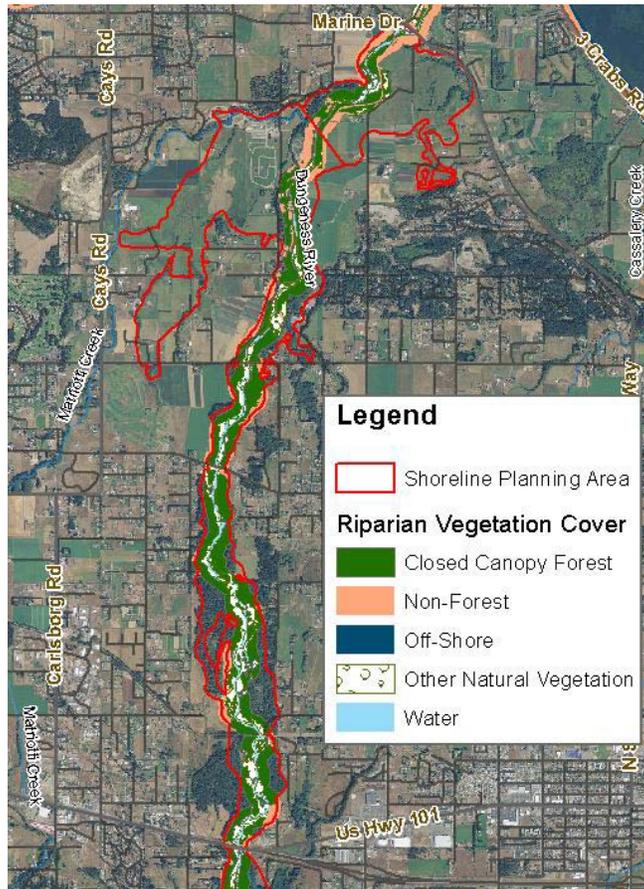
Figure 6-1. Riparian vegetation cover along the lower Dungeness River.

Upstream from RM 10.8 (confluence with Canyon Creek), the watershed and riparian corridor of the Dungeness River and its tributaries consists almost entirely of forest habitat. Forest cover dramatically decreases downstream, as the river flows through residential developments and agricultural lands. Downstream from RM 10.8, the width of the forested riparian corridor varies from 0 to approximately 500 feet (Figure 6-1).

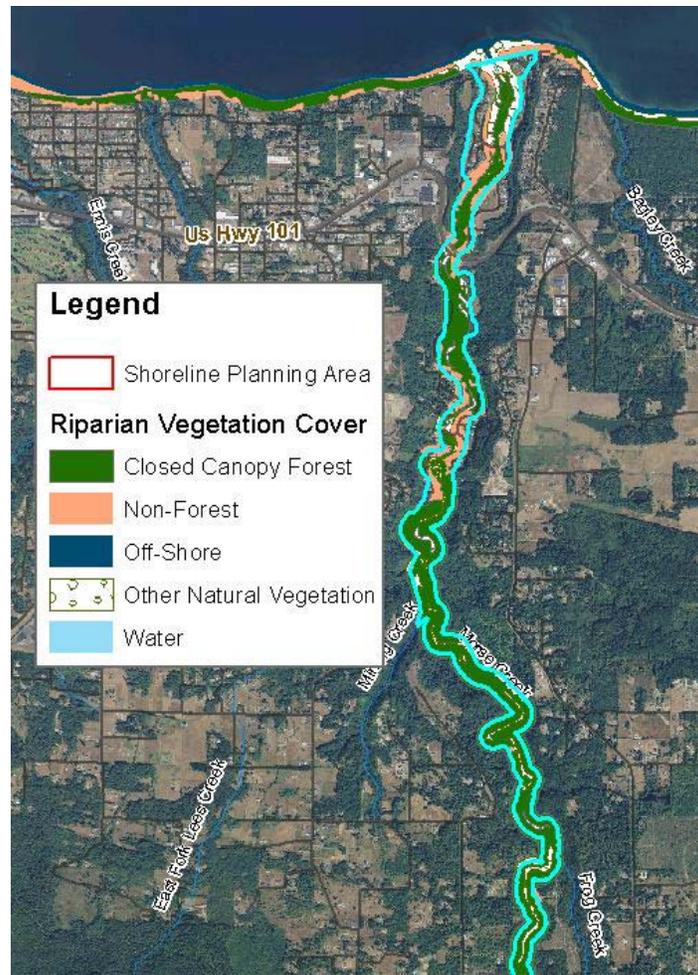
Figure 6-2. Riparian vegetation cover along the lower 4 miles of Morse Creek.

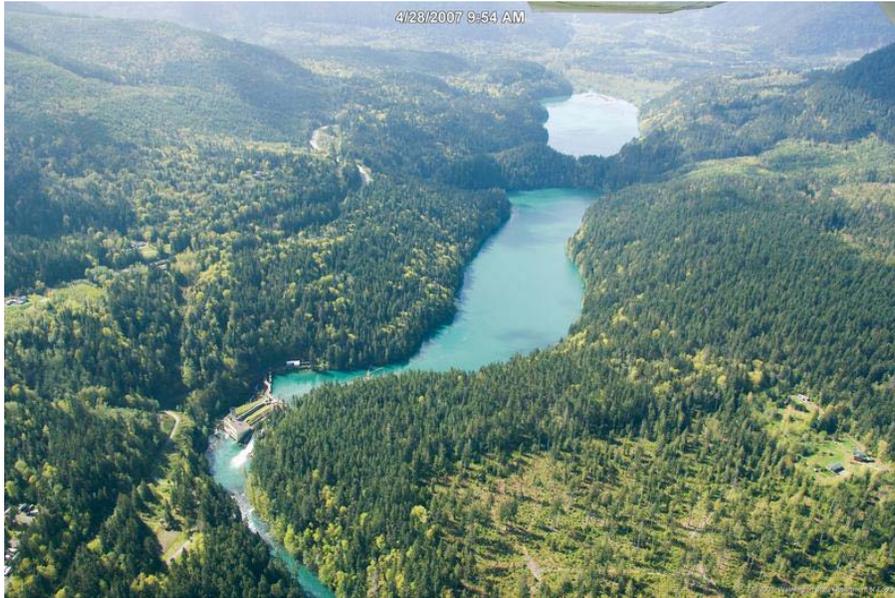
Figure 6-4. The Elwha River and Lake Aldwell (Ecology Photo)

Prior to construction of the dams (Figure 6-4), the Elwha system produced abundant stocks of several different salmonid species, including Chinook that weighed in excess of 100 pounds (Entrix, 2005). Today, anadromous fish use is limited to the reach downstream of the Elwha River Dam, which provides habitat for steelhead and Chinook, coho, and chum salmon species. The Lower Elwha Hatchery is the primary source of steelhead and salmon in the river. The sockeye run, and possibly the pink run, are now extinct in the Elwha. Salmonid use above the Elwha dam is limited to resident cutthroat, rainbow, and bull trout.

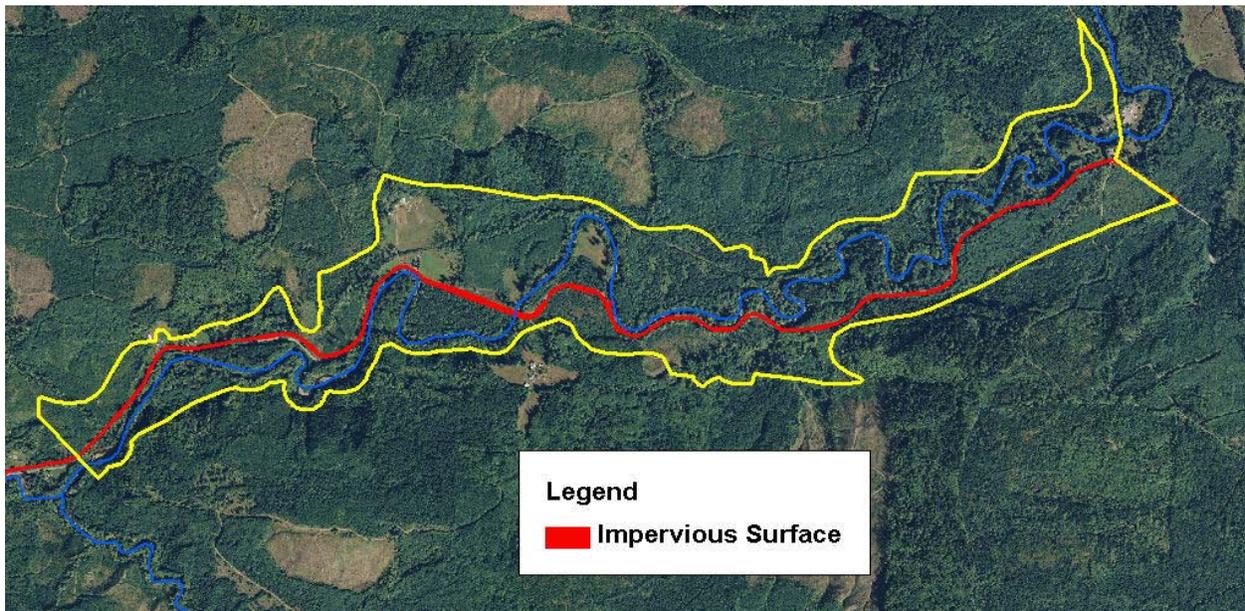
Figure 6-6. Impervious surface along the middle reach of the Pysht River
