4. MARINE REACH INVENTORY

This chapter describes the marine shoreline reaches that are within the jurisdiction of the County's SMP (in WRIAs 18, 19, and a portion of 17, excluding incorporated areas and the Makah Reservation) (see Figure 3-7 for the reach locations). Reaches are described in terms of their physical attributes, ecological condition, and human environment / land use characteristics. Maps are provided in Appendix A.

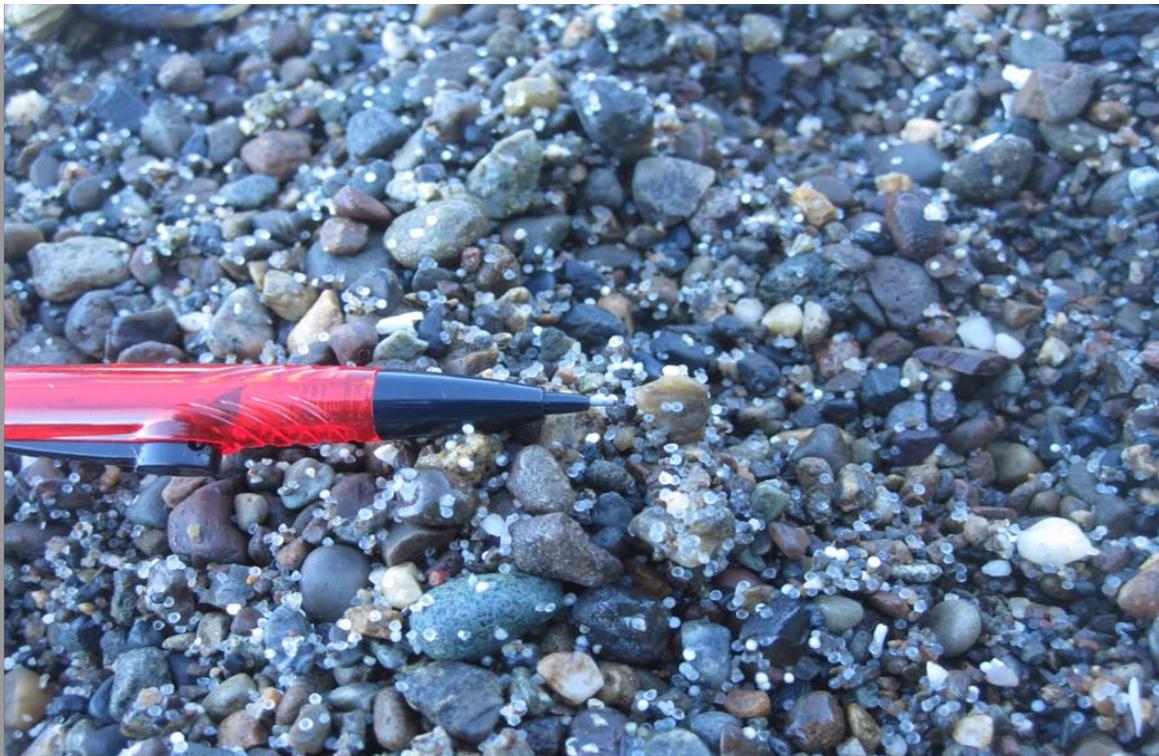
Figure 4-1. Forage fish eggs on gravelly beach substrate

Forage fish species such as surf smelt and sand lance spawn in the upper intertidal gravel and gravel-sand beaches of Discovery Bay and Sequim Bay (Figure 4-1). Eelgrass is mapped throughout a majority of the reach, and patches of kelp are mapped along the Strait. The marine shores in this area, and in particular the Discovery Bay and Sequim Bay shorelines, are prime habitat for juvenile salmonids, which use the shallow nearshore waters for migration and rearing. The Jamestown S'Klallam Tribe and Clallam County (2004) identified the nearshore areas between Sequim Bay on the east and Morse Creek on the west as being of particular importance

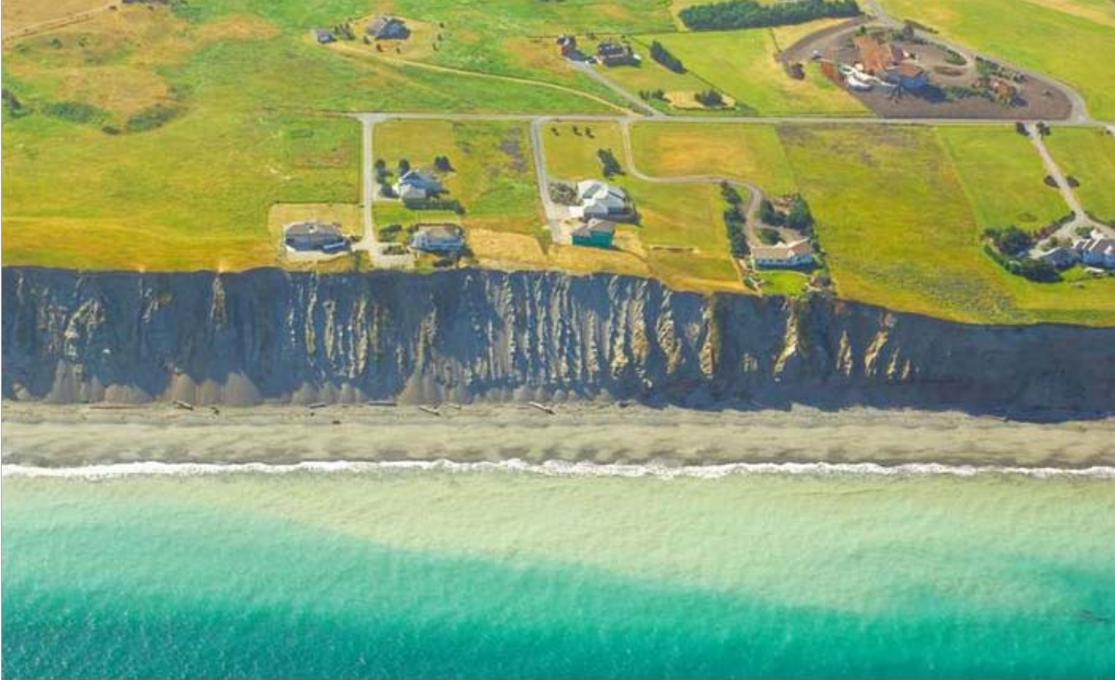
Figure 4-3. Segment of exceptional feeder bluff west of Dungeness Spit lacking native riparian forest cover. Note proximity of existing homes to edge of retreating bluffs (Photo: Ecology Coastal Atlas)

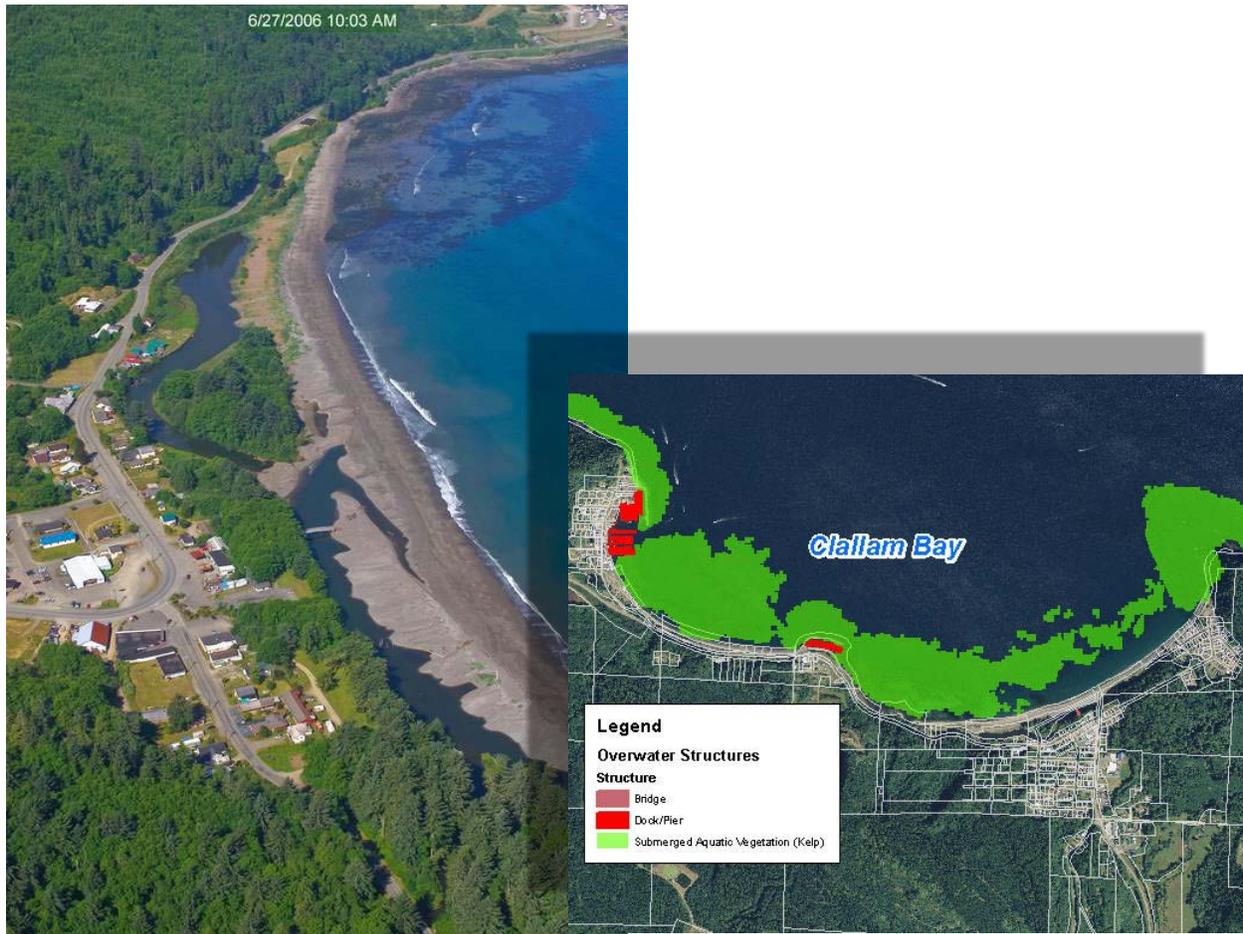
Figure 4-8. Clallam Bay shoreline showing overwater structures (shown in red) and kelp stands (shown in green on right photo) (Photo: Ecology Coastal Atlas)

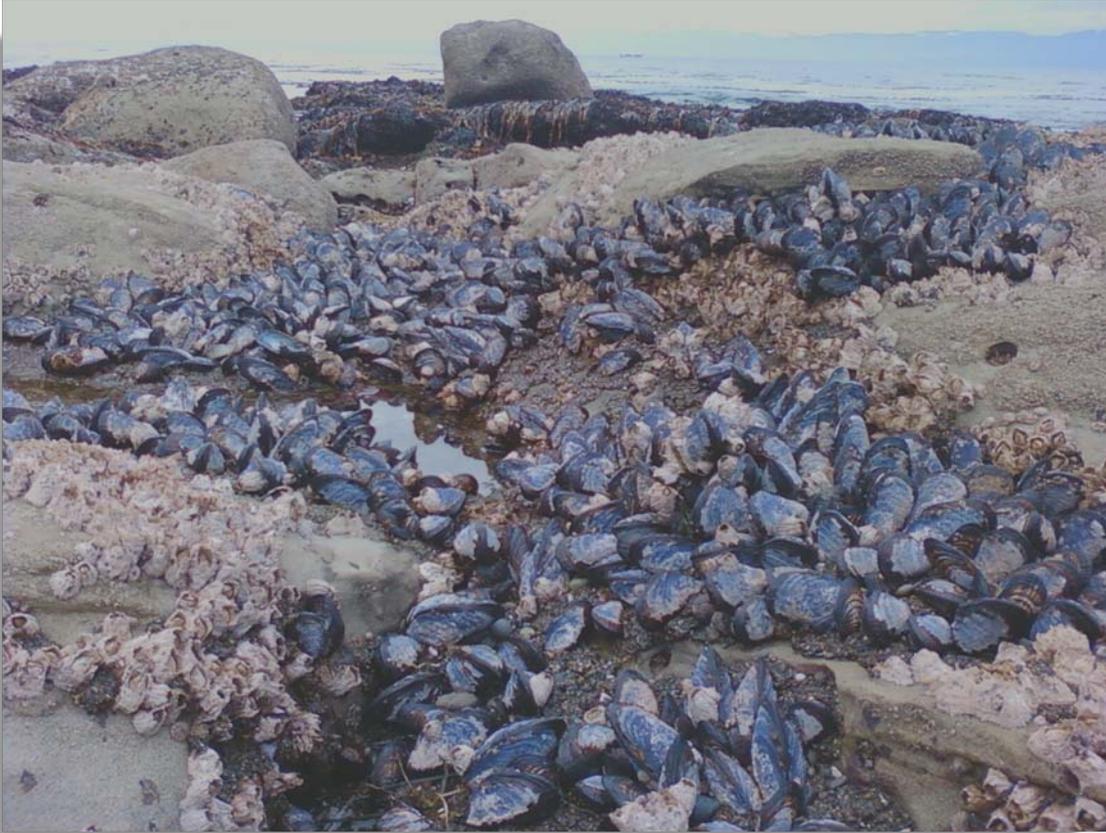
Figure 4-9. Mussels and other fauna on the rocky beach west of Sekiu Point

Rocky platform shores comprise over half of the shoreline within the reach, with bluff backed beach in the center of the reach. Two small pocket beaches are located in the western portion of the reach. Net shore-drift within the reach is entirely eastward. A small section of shoreline

armoring is located at the eastern end of the reach, near Sekiu. The remainder of the shoreline is unaltered (Figure 4-9).
