3. STRAIT OF JUAN DE FUCA ECOSYSTEM: MARINE SHORELINES

3.1 *Overview of Marine Shoreline Ecosystem Processes*

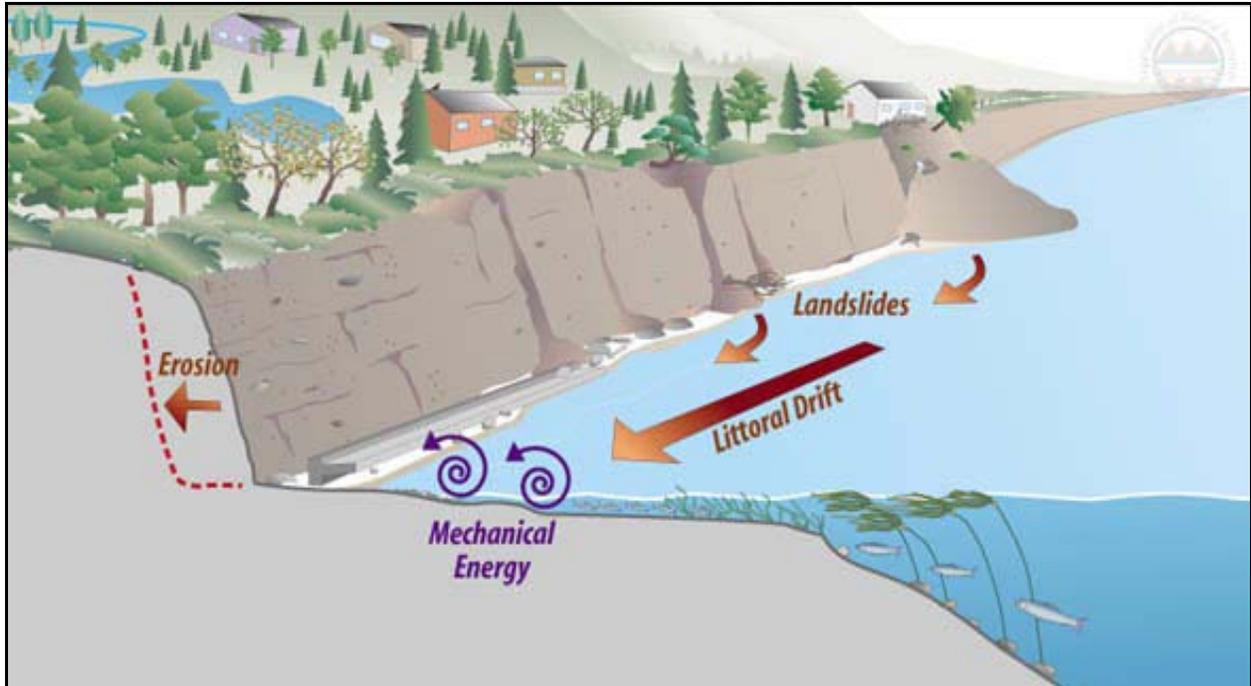
Figure 3-3. Bluff erosion, landslides and littoral drift (Source: King County)

Bluff sediments are distributed along the shore by a process called littoral drift. Surface waves typically approach the shore at an angle from the northwest creating longshore currents that transport the sediment down-drift. Net shore-drift refers to the long-term, net result of littoral drift (Figure 3-3).

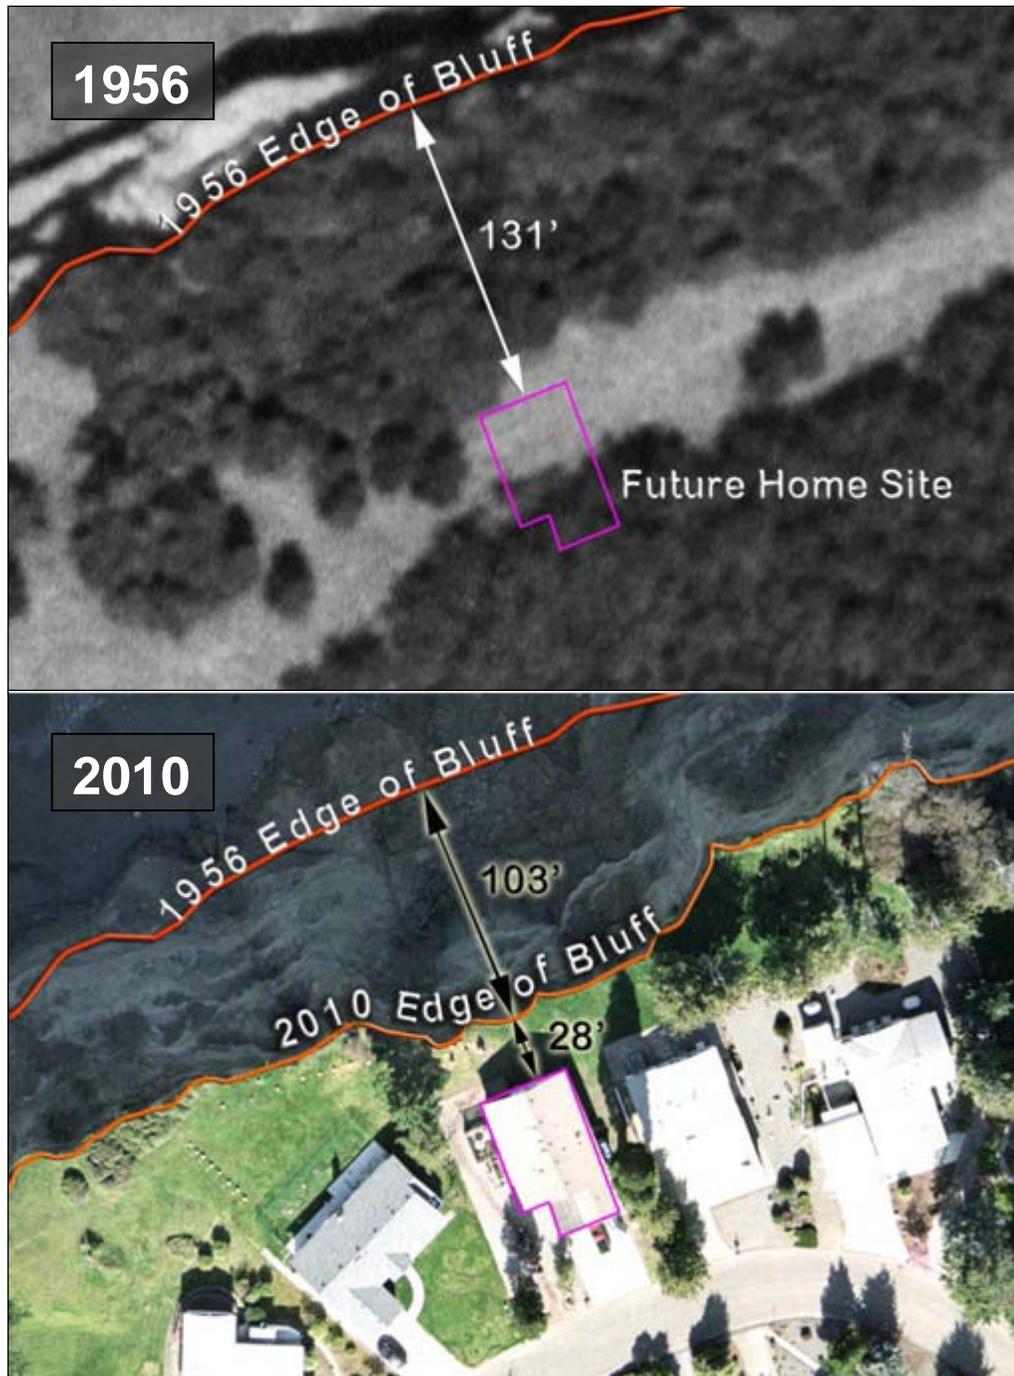
Figure 3-4. Bluff erosion threatening homes along Cypress Circle, west of Dungeness Spit (Source: Randy Johnson)

This process of net shore-drift transporting sediment from an erosional feature to a spit or barrier beach creates unique drift cells. Each drift cell acts as a system consisting of three components: a sediment source (called a feeder bluff); a transport zone where sediment is moved alongshore by wave action with minimal sediment input; and a deposition zone where wave energy is no longer sufficient to transport the sediment. For example, the rapidly eroding bluffs down-drift of Dungeness Spit provide the sediment that maintains the spit. While bluff erosion is a natural process that maintains beaches, it can be detrimental to structures (and their occupants) that are built too close to the bluff edge (Figure 3-4).

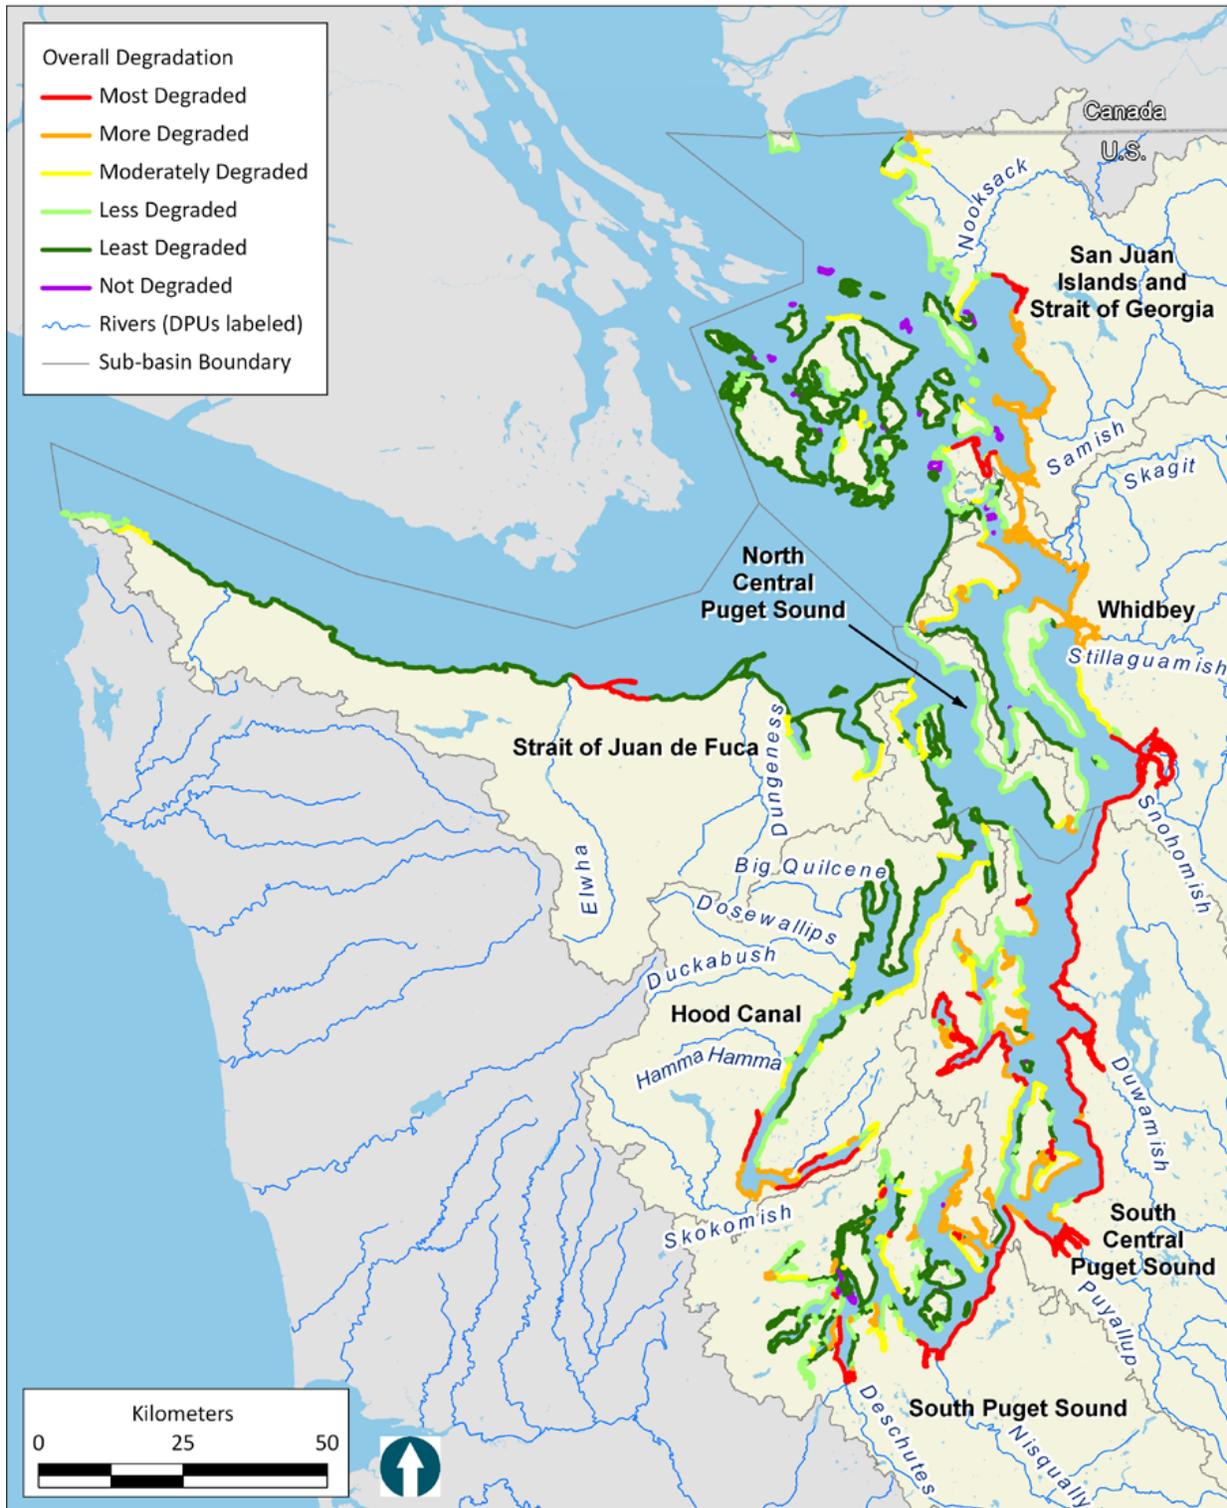
Figure 3-5. Relative degradation of Strait of Juan de Fuca nearshore reaches in terms of nearshore processes (Schlenger et al. 2010)

The level of degradation was rated on a relative scale from most degraded to not degraded. It is important to note that PSNERP did not evaluate biological conditions (such as vegetation or habitat availability) per se, but assessed the configuration of the shoreline compared to historic conditions and the presence of modifications or ecological stressors such as fill, armoring, marinas, dams and other features. Overall the reaches of the Strait were less degraded than most other areas of Puget Sound (Schlenger et al. 2010) (Figure 3-5). The low level of degradation

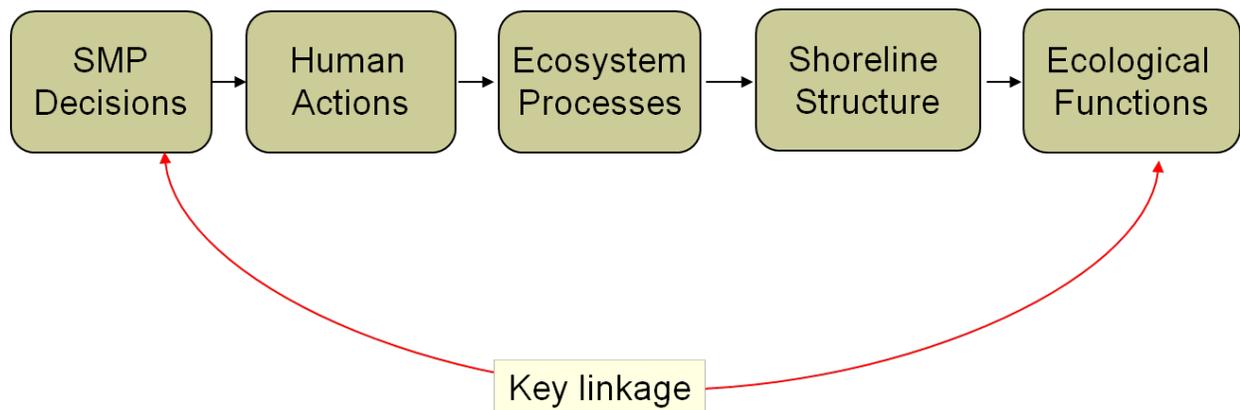
Figure 3-6. Relationship between human actions and shoreline ecological functions in the context of shoreline master programs

Ecological functions are dependent on the structure of the shoreline, which is shaped by ecosystem processes (such as erosion and deposition of sediment), which are affected to greater or lesser degrees by the actions people take on the shoreline. This basic model applies to a wide range of actions—many different ecological functions are linked to human actions and therefore to SMP decision. In this way, SMP decisions can lead to increases or decreases in ecological functions over time (Figure 3-6).

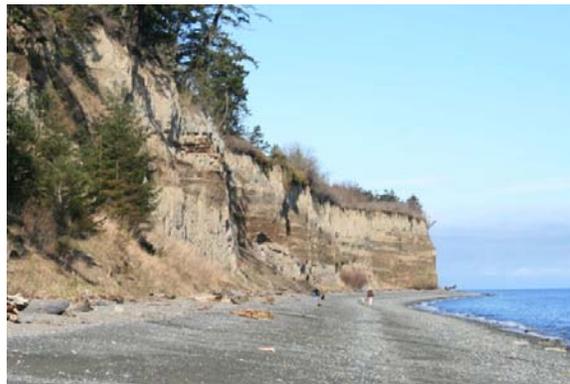
<p>South of Dungeness River (Reach 4)</p>

Shoretype	Criteria		Photo Example
	Presence of (priority in order):	Absence of:	
Feeder Bluff Exceptional (FBE)	<ol style="list-style-type: none"> 1. Bluff/ bank 2. Recent landslide scarps 3. Bluff toe erosion 4. Abundant sand/gravel in bluff 5. Colluvium/ slide debris 6. Primarily unvegetated or vegetated slumps 7. Trees across beach 8. Boulder/ cobble lag 9. Steep bluff (relative 	<ol style="list-style-type: none"> 1. Shoreline bulkhead/ fill 2. Backshore 3. Old/ rotten logs 4. Coniferous bluff vegetation 5. Bulkhead

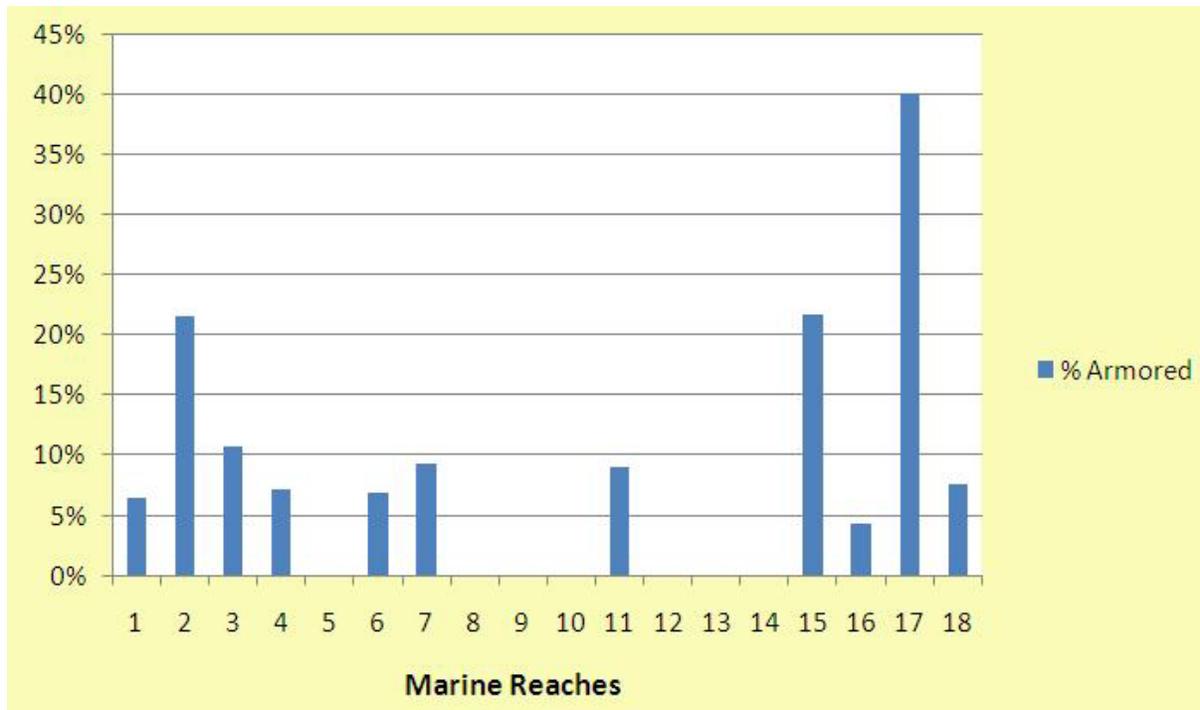
Figure 3-9. Percent of each reach with hard armoring along the Strait of Juan de Fuca in Clallam County (data from point PSNERP 2009, Battelle 2008)

A majority of the landslide- and erosion-prone land is high bluff and not conducive to traditional forms of shoreline stabilization (such as concrete bulkheads). Bulkheads are sometimes used to reduce bluff toe erosion but that approach has not been widely used in Clallam County, as bluff toe armoring is generally ineffective in the high-energy Strait of Juan de Fuca shoreline environment. Overall, only about 8% of the marine shoreline in unincorporated Clallam County is armored (Figure 3-9, see Map 6 in Appendix A). Currently, very little of the armoring occurs in areas that are mapped as feeder bluffs (Table 3-9), with the exception of some feeder bluff shorelines in Sequim Bay and the Gibson Spit vicinity. The few reaches that are more heavily armored tend to be low bank accretion shores or bays such as Sequim Bay and Clallam Bay. In those places, the armoring is typically intended to prevent waves from overtopping, reduce flooding, minimize storm damage, retain fill, support marina development and/or protect pier abutments, outfalls and transportation/utility infrastructure.

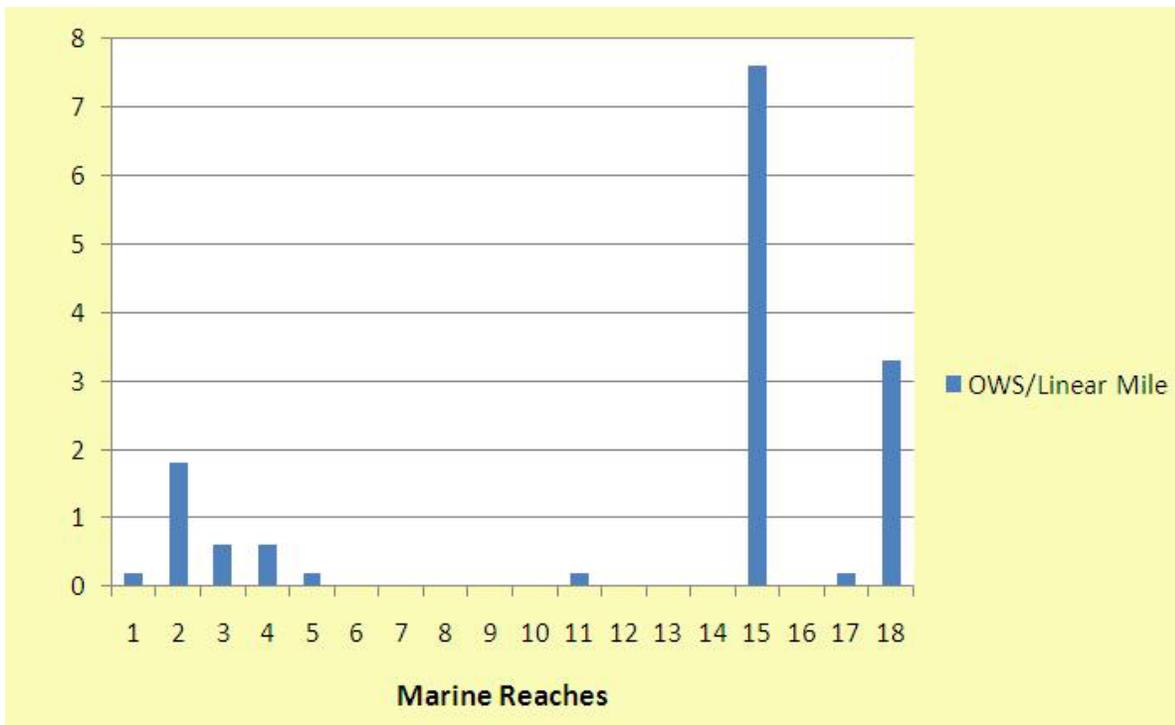
Figure 3-10. Number of overwater structures per mile of reach along the Strait of Juan de Fuca in Clallam County (data from PSNERP 2009)

There are relatively few overwater structures along the Strait and most occur in bays and other sheltered areas (Figure 3-10, see Map 6 in Appendix A). Because the majority of these structures are not in sediment transport zones, they generally do not have a major effect on net shore-drift (Table 3-11). On the other hand, these structures create shade that can limit or reduce the suitability of aquatic areas for eelgrass and kelp. Minimizing the number and extent of overwater structures in transport zones and in areas that support submerged aquatic vegetation will help ensure no net loss of ecological functions.

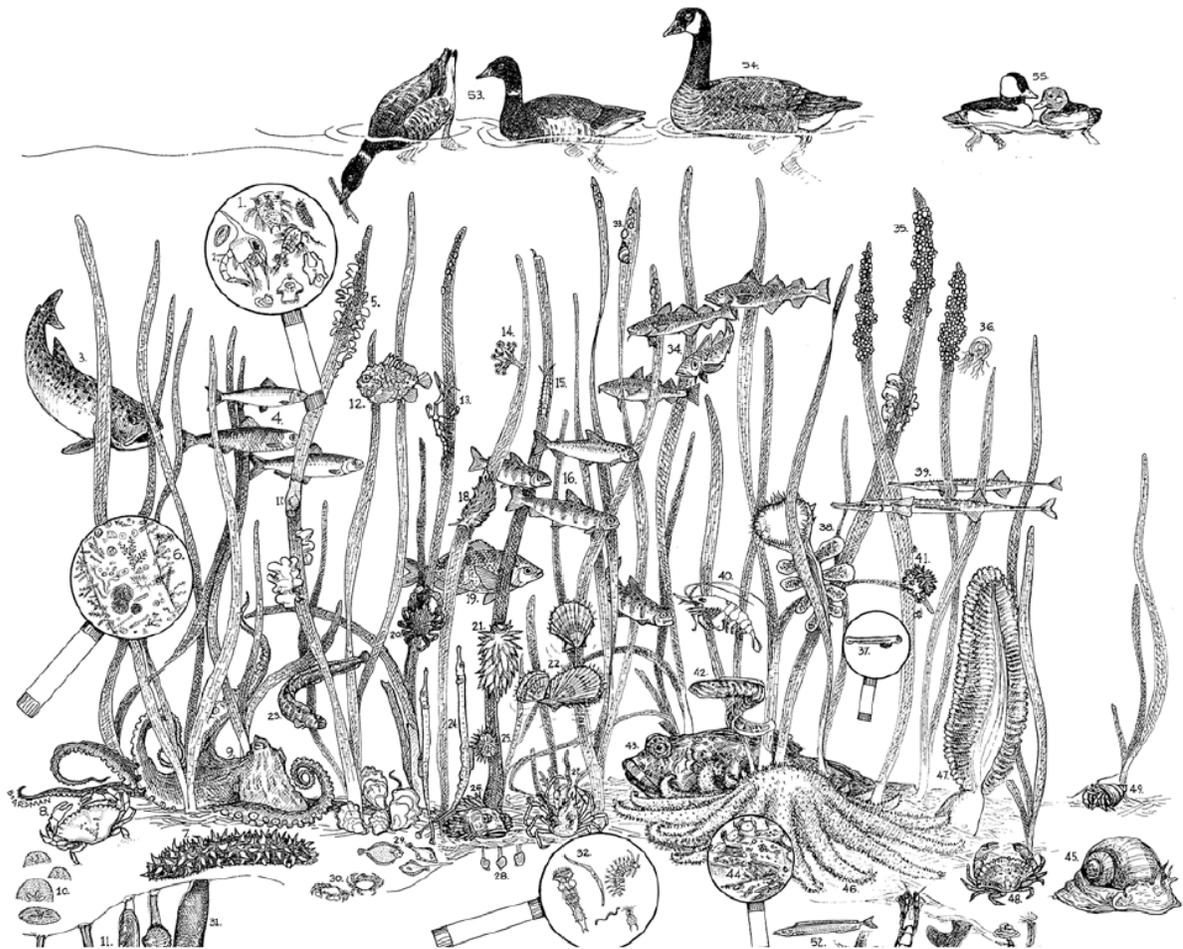
The Eelgrass Meadow — A World of Microhabitats

Figure 3-12. Illustration of the importance of eelgrass meadows as microhabitat for numerous species (from Port Townsend Marine Science Center; used with permission)
