4. MARINE REACH INVENTORY

4.1 *Reach 1: Diamond Point (Maps 1a to 6a in Appendix A)*

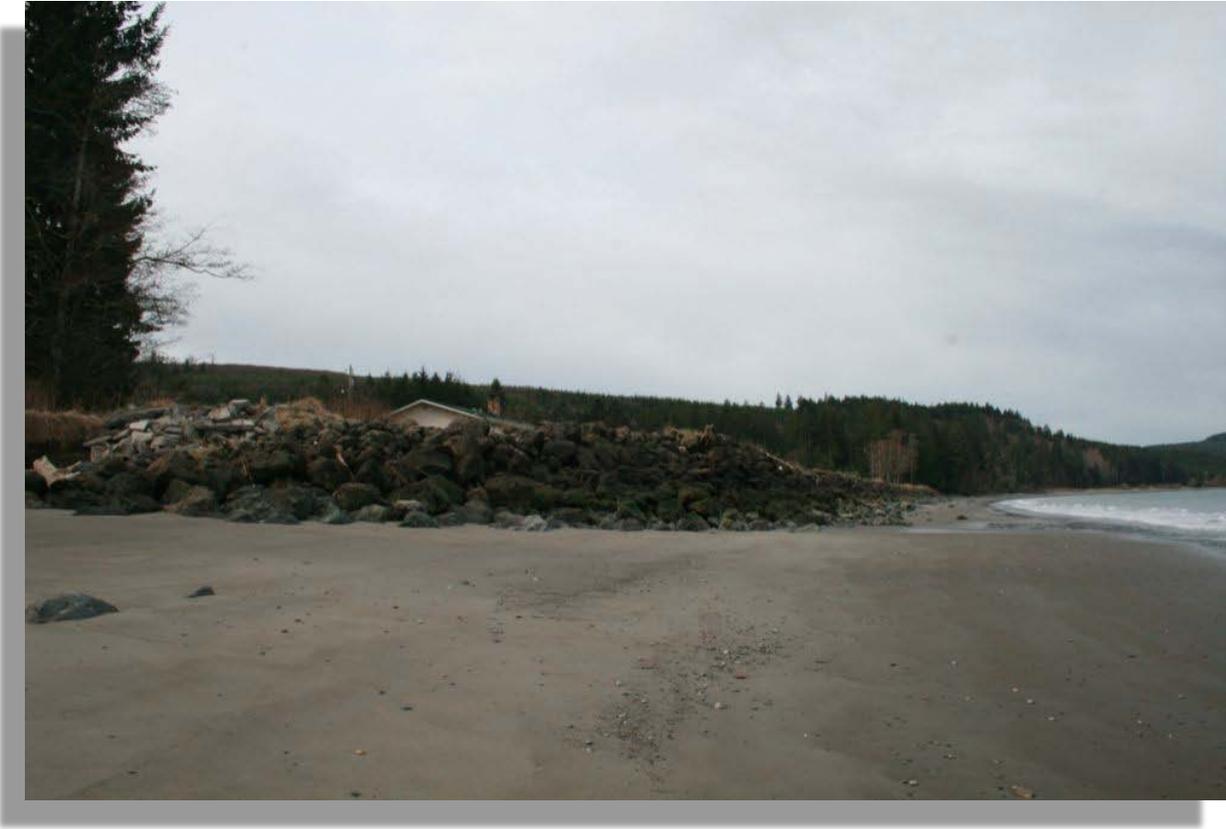
Figure 4-10. Riprap or “hard” shoreline armor and homes on the beach near the Hoko River (Photo by A. MacLennan)

Shoreland landowners whose homes are close to the shore along low beach areas may seek to construct bulkheads or other shoreline armoring structures to protect their property from wind and wave action (Figure 4-10). In addition, given the location of the underdeveloped properties, shoreline armoring may be necessary if future structures are built. An increase in shoreline armoring could negatively impact natural sediment transport and beach maintenance processes.

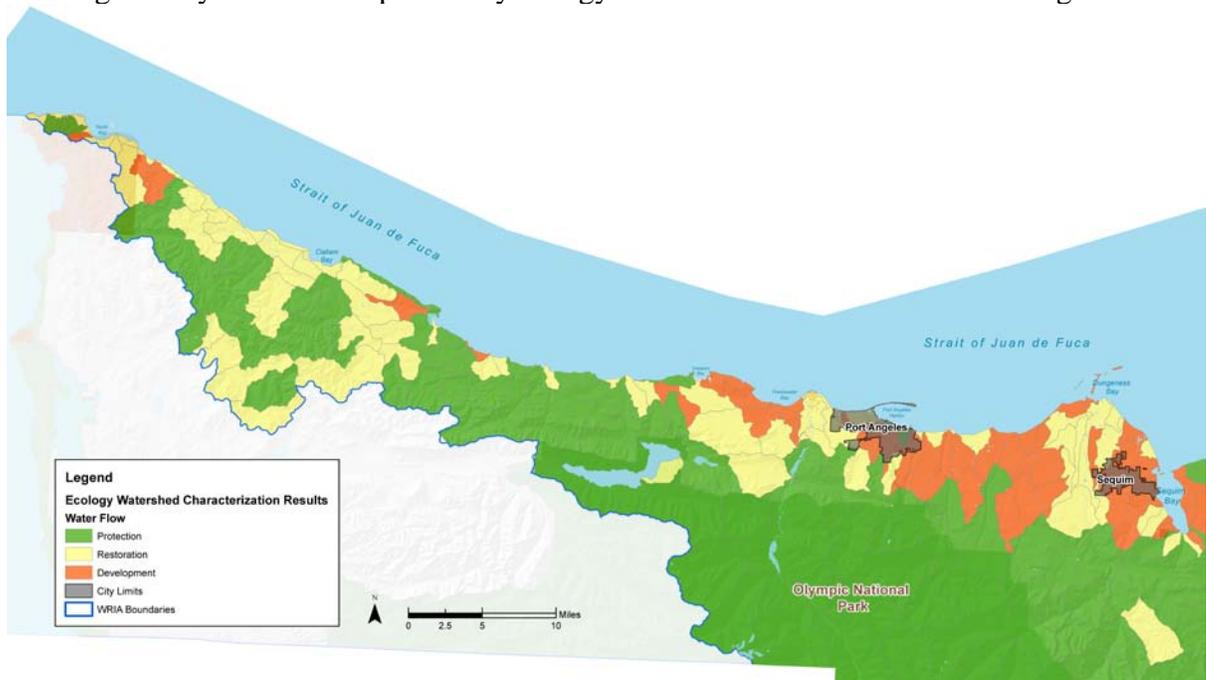
Figure 5-7. • Ecology’s relative ranking of the water flow processes for each sub basin draining to the Strait of Juan de Fuca

- Protection – these sub basins are highly important in terms of infiltration, recharge, water storage and other natural water flow processes and have minimal alteration. Protection of the existing conditions is a high priority.
- Restoration – these sub basins areas are also very important to natural hydrology, but have experienced alteration. Restoration in these areas could help to increase ecological process and functions.
- Development – these sub basins are less important—on a relative scale—for hydrology processes and they have been moderately to highly altered. Development in these areas would generally have less impact on hydrology than in either of the other two categories.

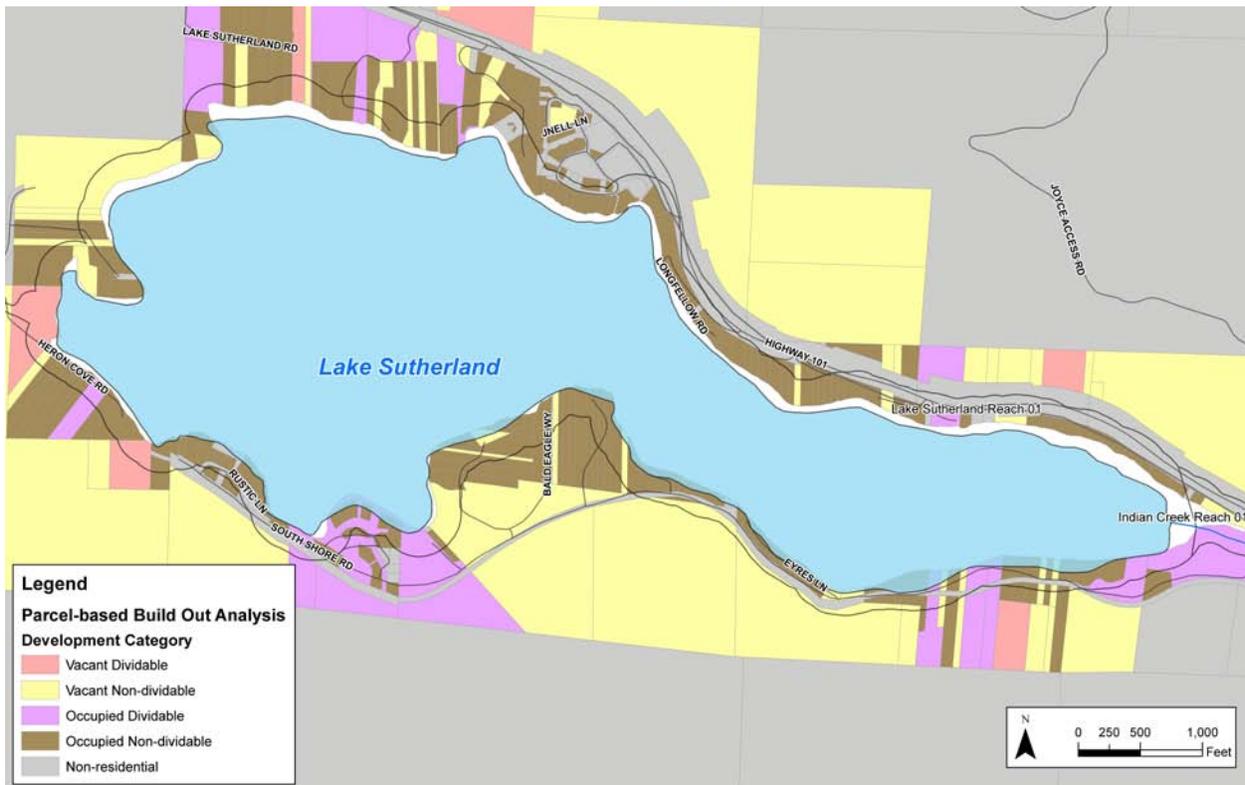
Figure 6-5. Existing and potential future development patters at Lake Sutherland. Brown and yellow parcels are not subdividable.
