Reach Sheet Data Descriptions and Sources

Marine Reach Sheet Explainer

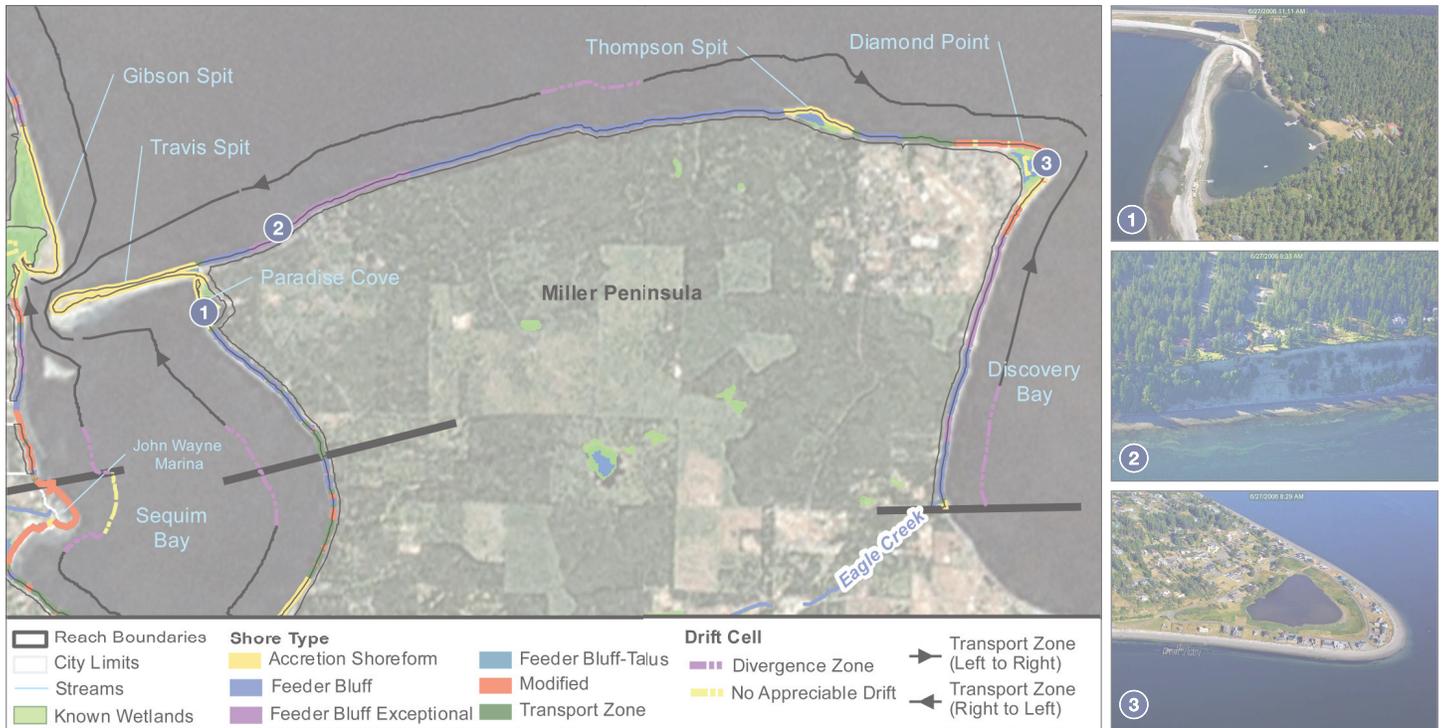
REACH MAP

The reach maps show the physical features of each “reach” or inventory segment—there are 18 segments on the marine shore overall, excluding incorporated areas and the Makah Reservation. Geologic shore type and drift cell components are depicted to help illustrate the location of feeder bluffs, sediment transport zones, accretion shores and modified shores. The maps also show the direction of net shore-drift, divergent zones and areas of no appreciable drift. Shoreline oblique photos taken by Ecology in 2006 are provided to help orient the reader to key localities. The aerial photo base map is from 2009.

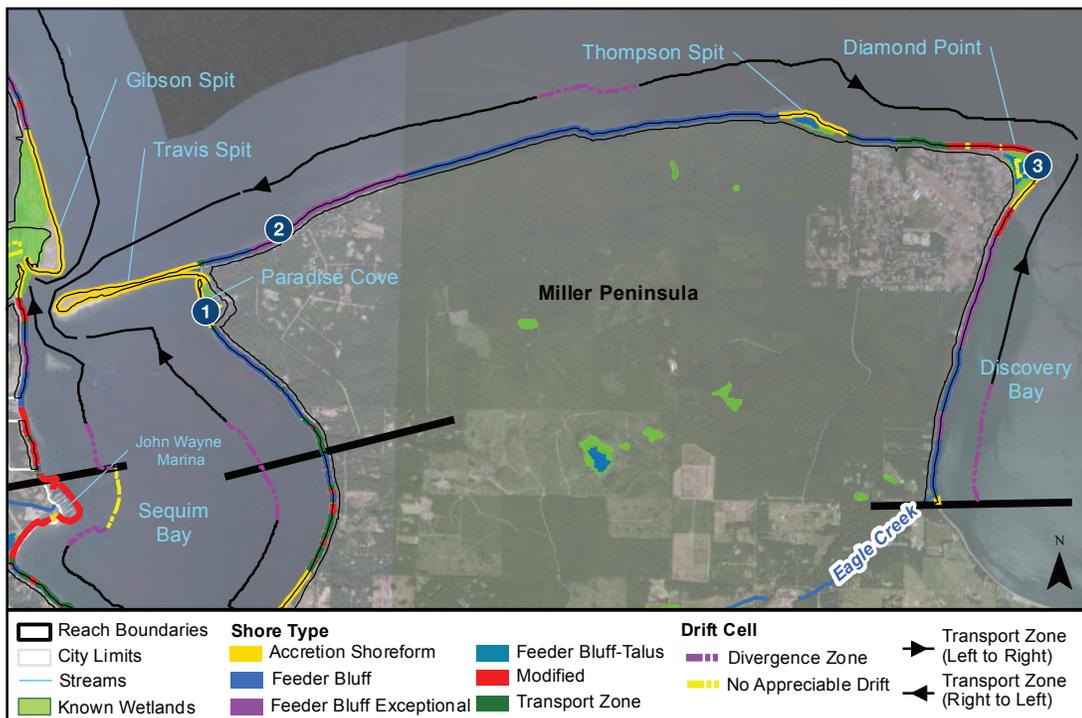
The “Diamond Point” reach extends along Miller Peninsula, from the Clallam/Jefferson county line to the northwest corner of Sequim Bay. The reach borders Discovery Bay to the east, the Strait of Juan de Fuca to the north, and Sequim Bay to the west, and includes Diamond Point, Thompson Spit, Travis Spit, and Paradise Cove. Over half of the reach consists of feeder bluffs, which are erosion hazard areas. Minimal shoreline armoring and overwater structures are present in the reach, and half of the shoreline area is forested.

Dense residential development is present at Diamond Point, portions of which lie within mapped tsunami and flood hazard areas. Some low-density residential development is located along the feeder bluffs in the Travis Spit vicinity and bordering Discovery Bay. Approximately one-third of the shoreland area is in public ownership, managed by WSP (Miller Peninsula State Park [undeveloped]) and DNR.

Under current zoning regulations, approximately one-third of the reach area has potential for new residential development. The developable land is generally located in the eastern and western portions of the reach. Existing parcel boundaries at the southwestern portion of the reach (Discovery Bay feeder bluffs) have narrow shoreline frontages, which could lead to dense shoreline development in this area. Parcels in the Travis Spit vicinity are generally larger.

Most bluff areas are unstable (58%) with recent slides into Discovery Bay and the Strait of Juan de Fuca (10%). Some recent slides are near existing homes. Diamond Point, Thompson Spit, and Travis Spit are in a tsunami hazard zone (39%) and FEMA coastal 100-year floodplain (51%).

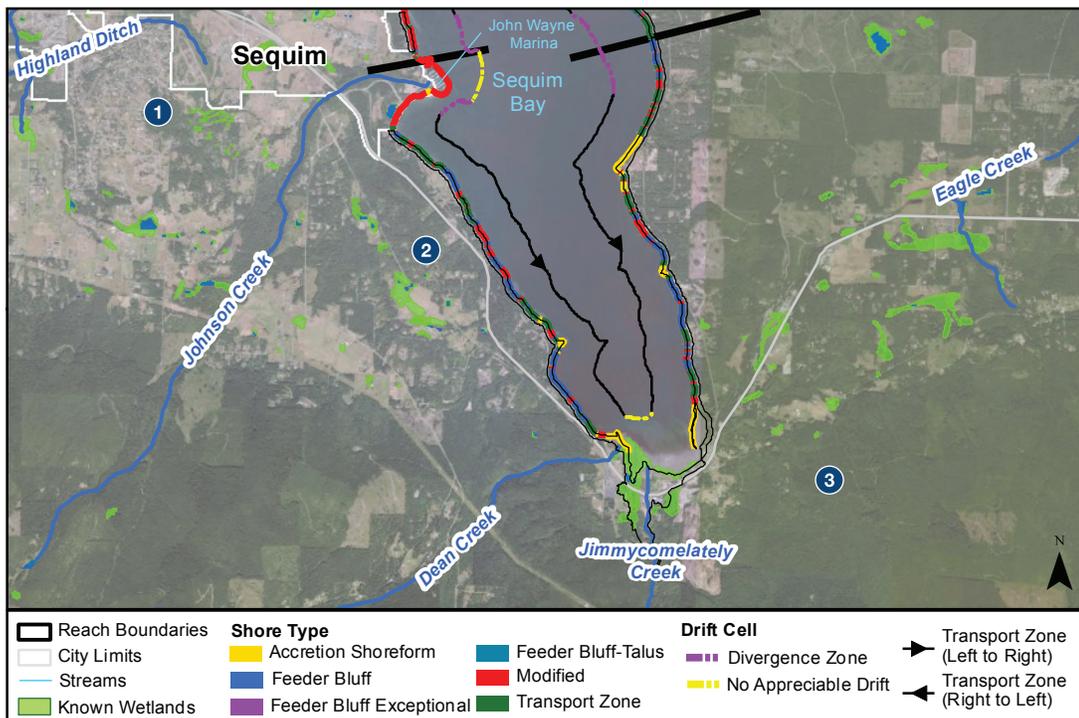
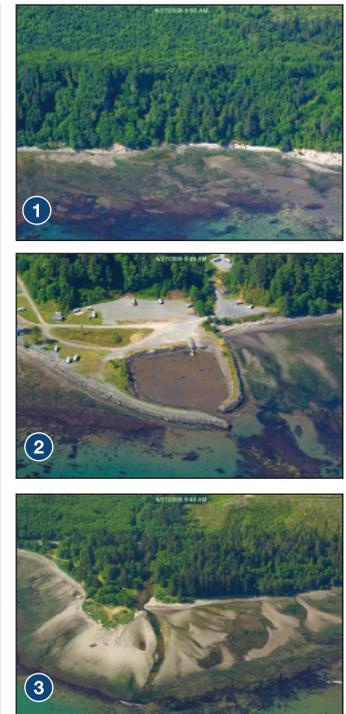
The "Sequim Bay" reach consists of the bay shoreline, from south of Travis Spit to just south of the John Wayne Marina. The reach excludes shoreline within City of Sequim jurisdiction. Approximately one-third of the shoreline consists of feeder bluffs. However, because of the relatively sheltered position of the bay, the presence of significant erosion hazard areas is minimal. Approximately 20% of the shoreline is armored, and several overwater structures (docks and piers) are mapped throughout the reach. The Bay shoreline contains dense concentrations of submerged aquatic vegetation and significant forage fish spawning habitat, which provides important habitat for marine species, including juvenile salmonids.

The dominant land use within the reach is moderate- to low-density residential development. A commercial area is located at the Bay head. Sequim Bay State Park, a popular recreational shellfish area, is located in the western portion of the reach. Approximately half of the shoreline contains forest cover and other natural vegetation, while the other half has been altered by development.

Under current zoning regulations, approximately half of the reach area has potential for new residential development. Existing parcel boundaries vary in size, but many of the lots have narrow water frontages (approx. 75'), which could lead to dense shoreline development in these areas. With increased development, more over water structures could potentially be constructed over eelgrass and/or valuable forage fish spawning habitat.

Several bluff areas are unstable (11%), but no recent slides are mapped. Most of Sequim Bay is in a tsunami hazard zone (43.6%) and FEMA coastal and stream (Jimmycomelately Creek) 100-year floodplains (45%).

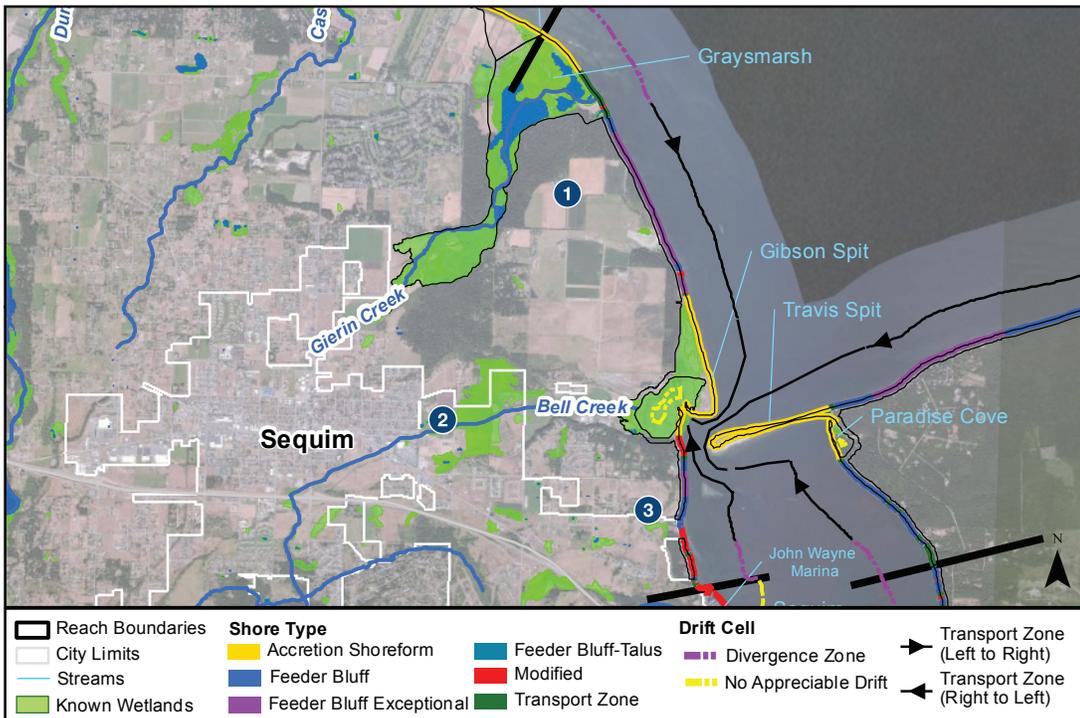
Moderate- to high-density development is present along Sequim Bay (which is within tsunami and coastal floodplain areas), but most of the shorelands in the reach are managed for timber or agriculture. All of the shoreland area and most of the shoreline is in private ownership.

Under current zoning regulations, over three-quarters of the shoreland zone has potential for new residential development. The undeveloped land is generally located north of Gibson Spit. Most of the undeveloped land cannot be subdivided into small (<5 acre) lots; therefore, there is low likely of future, dense shoreline development in the reach.

Several short bluff segments are unstable (5%) with no recent slides. Graysmarsh (Gierin Creek estuary), Gibson Spit, Bell Creek estuary and the northwest portion of Sequim Bay are in a tsunami hazard zone (61%) and FEMA coastal and stream (Gierin Creek) 100-year floodplains (59%).

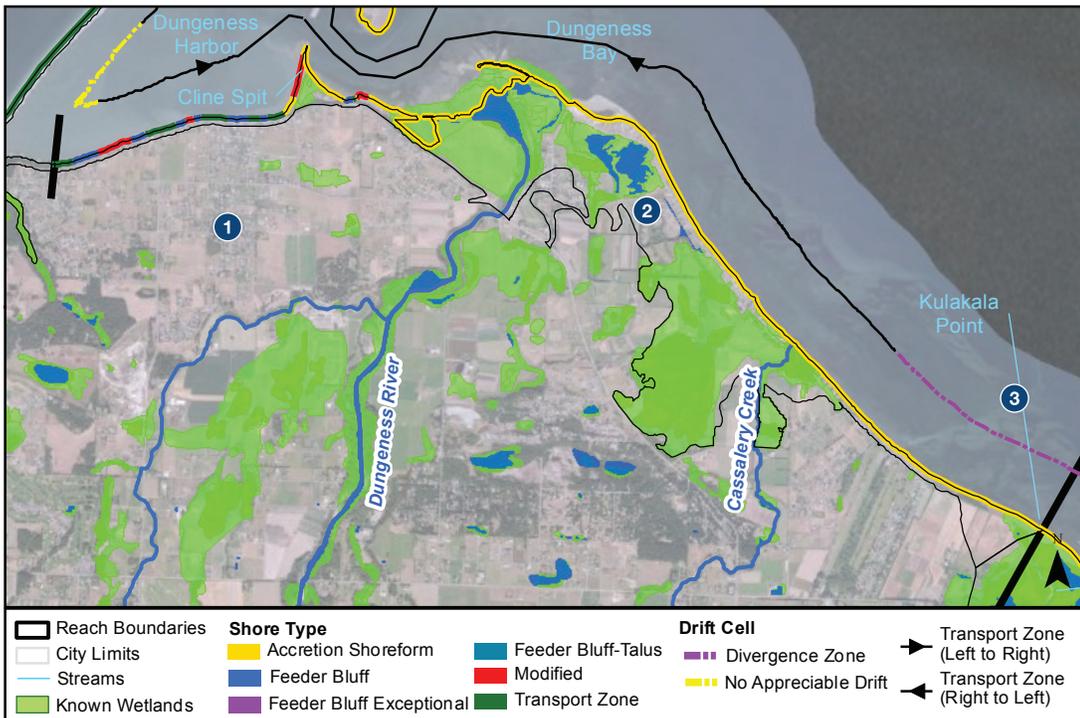
The "Kulakala Point" reach contains Strait of Juan de Fuca shoreline, extending from north of Graysmarsh (Gierin Creek mouth) to just east of the landward end of Dungeness Spit, and includes the Dungeness River delta, Cline Spit, and the south shorelines of Dungeness Bay and Dungeness Harbor. Much of the reach is within mapped tsunami and flood hazard zones. The Dungeness Harbor shoreline contains dense concentrations of submerged aquatic vegetation and significant forage fish spawning habitat, which provides important habitat for marine species, including juvenile salmonids.

High-density residential development is located along the low bank shores in the 3 Crabs Road vicinity, and several residences are protected by shoreline armoring. Land near the Dungeness River mouth is generally used for agriculture, but some residential development is present. Residential development is present along the feeder bluffs at the south shore of Dungeness Harbor. Approximately half of the shorelands contains forest cover and natural shrub/herbaceous vegetation, and the half has been impacted by development.

Under current zoning regulations, over half of the reach area has potential for new residential development, although the presence of wetlands in the Dungeness delta likely precludes intensive development in this area. Potential future development would likely be infill of existing subdivided parcels. In the event of sea level rise and increased storm activity, many landowners along 3 Crabs Road may feel the need to build bulkheads to protect property. There is also potential for an increase in overwater structures (docks) along the south shore of Dungeness Harbor.

Several bluff areas are unstable (3%) with a small slide incident along Dungeness Harbor, near existing homes. Dungeness Harbor, Cline Spit, the Dungeness River floodplain, and Kulakala Point are in a tsunami hazard zone (96%) and FEMA coastal 100-year floodplain (82%).

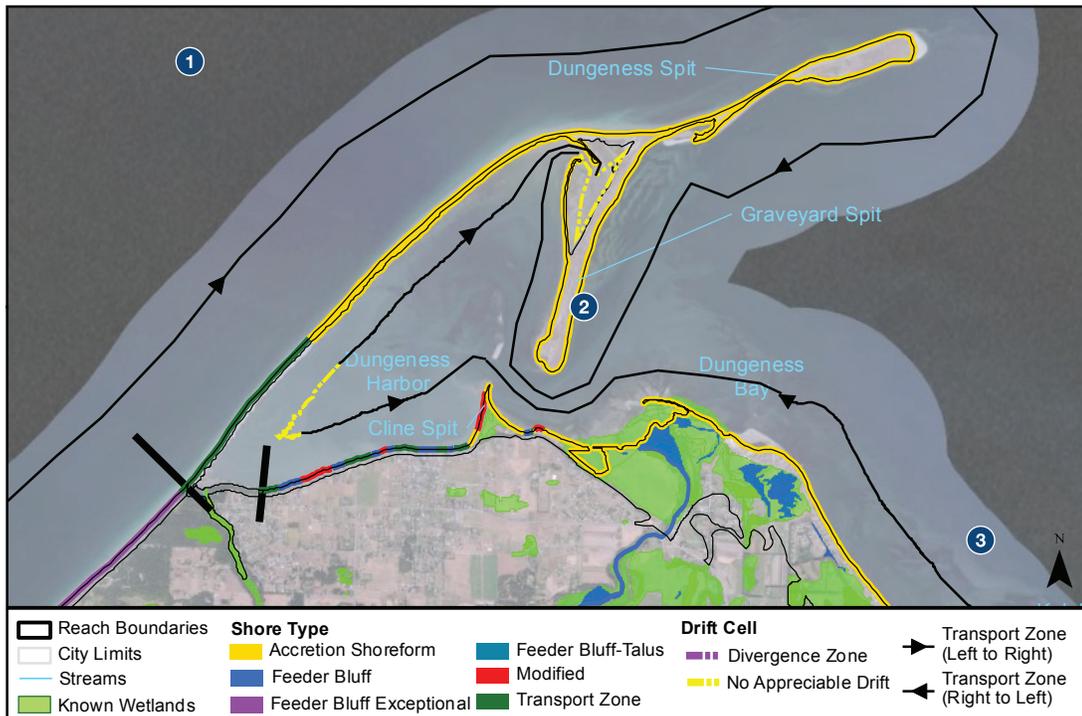
The majority of the reach is within the Dungeness National Wildlife Refuge, which provides habitat for a wide variety of species. The portions of the spit within Dungeness Harbor contain dense concentrations of submerged aquatic vegetation and significant forage fish habitat, which makes the area vital rearing habitat for salmonids.

A small portion of the reach, at the landward end of Dungeness Spit, is in private ownership. Most of the parcels are developed with homes, and cannot be further subdivided. There is generally a low risk of physical and ecological degradation of the reach.

Several bluff areas are unstable (7%) with a small slide incident along Dungeness Harbor, near existing homes. Most of Dungeness Spit is in a tsunami hazard zone (90%) and the FEMA coastal 100-year floodplain (93%).

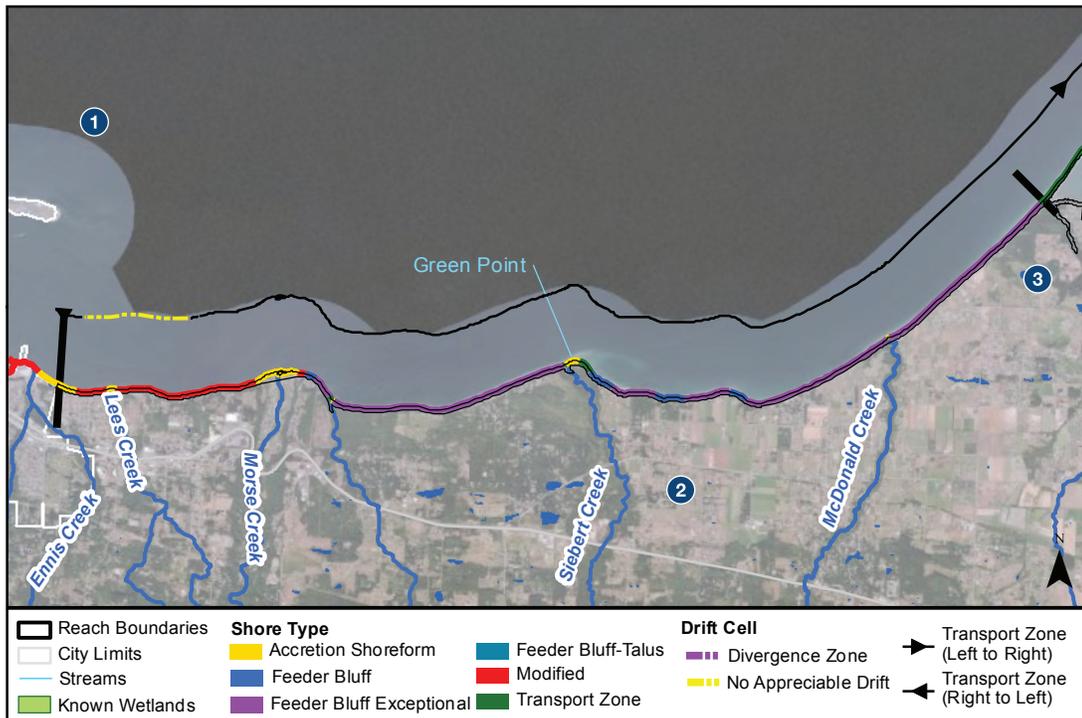
Moderate-density residential development is located throughout the reach, with lesser amounts of open space, vacant, and timber land. Many existing homes on the shoreline are at risk because of their proximity to highly-erosive feeder bluffs. There are no overwater structures and minimal amounts of shoreline armoring mapped within the reach.

Under current zoning regulations, approximately 40% of the shoreland area has potential for new residential development. Parcel sizes vary, but many of the lots have narrow shoreline frontages (75 to 150 feet), which could lead to dense shoreline development in some areas. Placing structures too close to the feeder bluffs within the area is a substantial risk to property, as well as human health and safety.

Several bluff areas are unstable (55%) with recent slides mapped near Port Angeles city limits, in addition to central and northeast portions of the reach (6%). Some recent slides are near existing homes. Most of Morse and McDonald Creek shoreline areas are in a tsunami hazard zone (28%) and FEMA coastal and stream 100-year floodplains (36%).

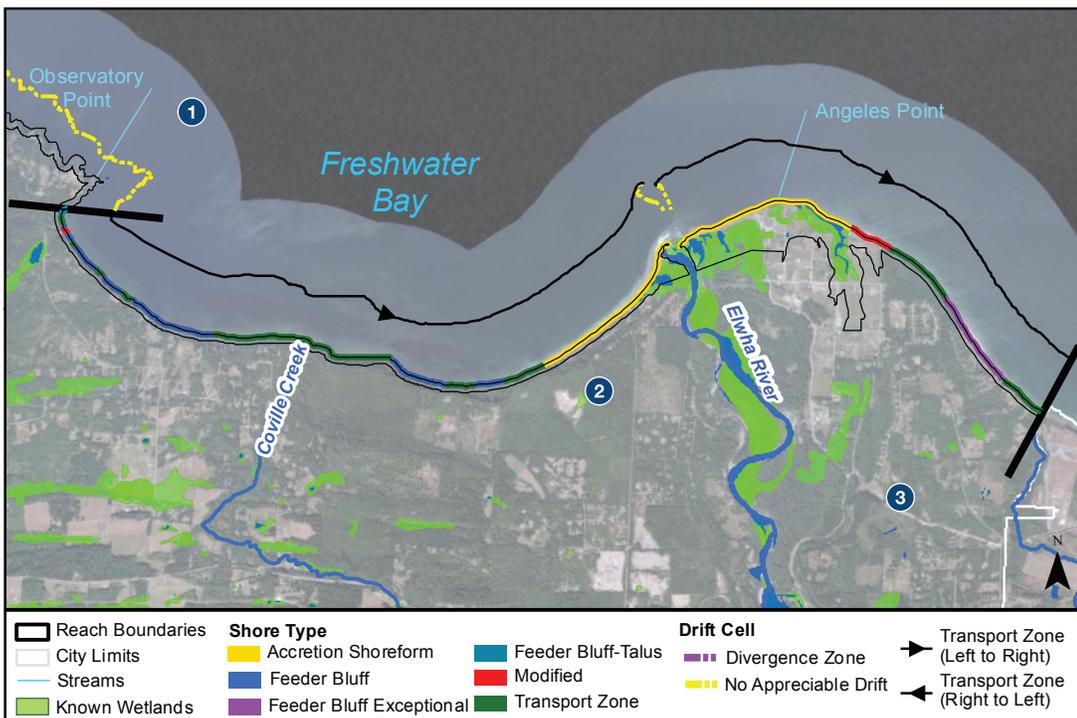
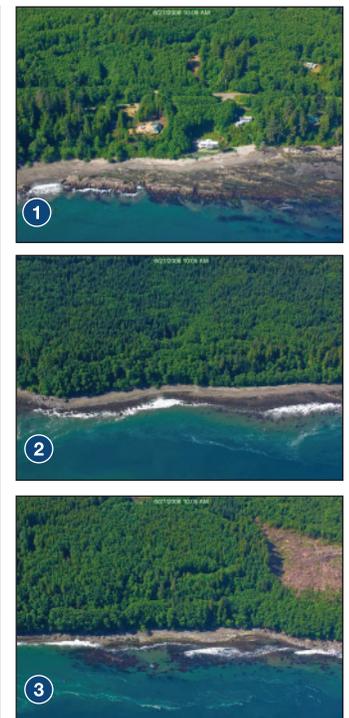
Major land uses within the reach are high- and moderate-density residential, commercial forestry, and agriculture. Some of the residential areas are located within mapped tsunami and coastal flood areas. The majority of the shoreland area is undeveloped, and in forested condition. The forest land within the reach provides habitat for a variety of wildlife species.

Under current zoning regulations, approximately two-thirds of the shoreland area has potential for new residential development. Existing parcel boundaries vary in size and shape.

Several bluff areas are unstable (26%) mapped east of Angeles Point and within Freshwater Bay with no recent slides. Freshwater Bay and Angeles Point are mostly within the tsunami hazard zone (69%) and FEMA coastal and stream 100-year floodplains (72%).

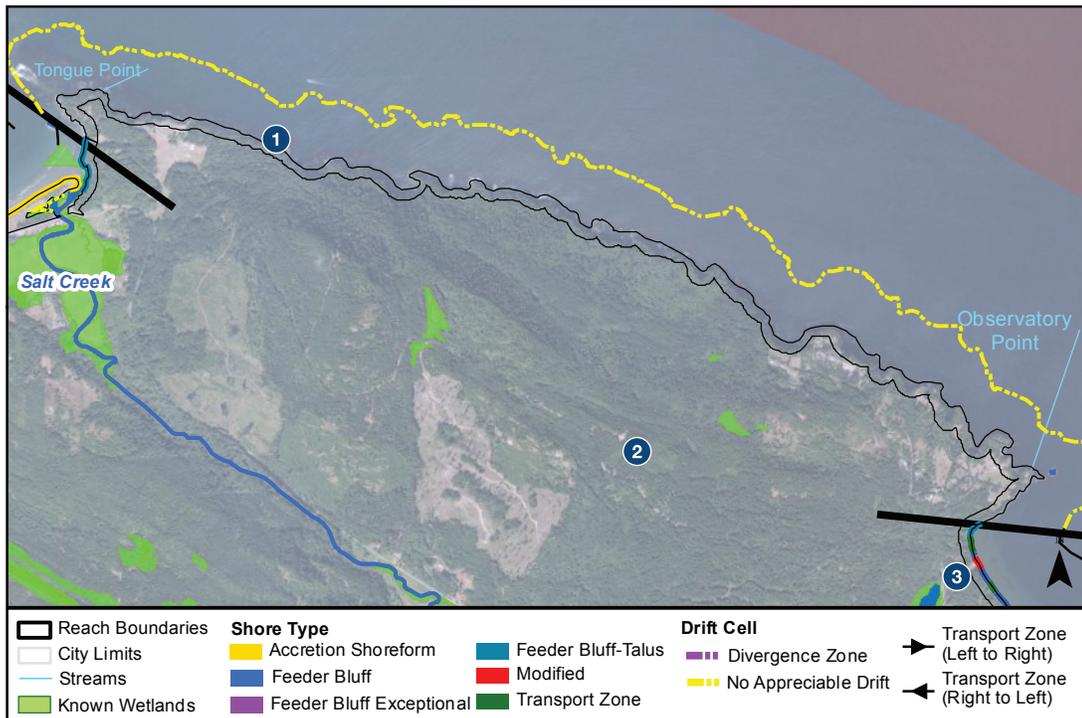
The majority of the reach is public land, contained within the Salt Creek and Striped Peak Recreation Areas. The eastern third of the reach contains moderate-density residential development. Most of the homes are set back more than 200 feet from the shoreline.

Under current zoning regulations, only 6% of the reach has potential for new residential development. Future development would consist of residential infill adjacent to existing developed parcels. Given the relatively limited area of potential development in the reach, and the stable adjacent bedrock shores, potential future development impacts to shoreline ecology are likely minimal.

An unstable bluff area (8%) is mapped in the eastern portion of the reach. However, no recent slides are mapped. A portion the shoreline between Observatory Point and Tongue Point are in a tsunami hazard zone (33%) and FEMA coastal and stream 100-year floodplains (42%).

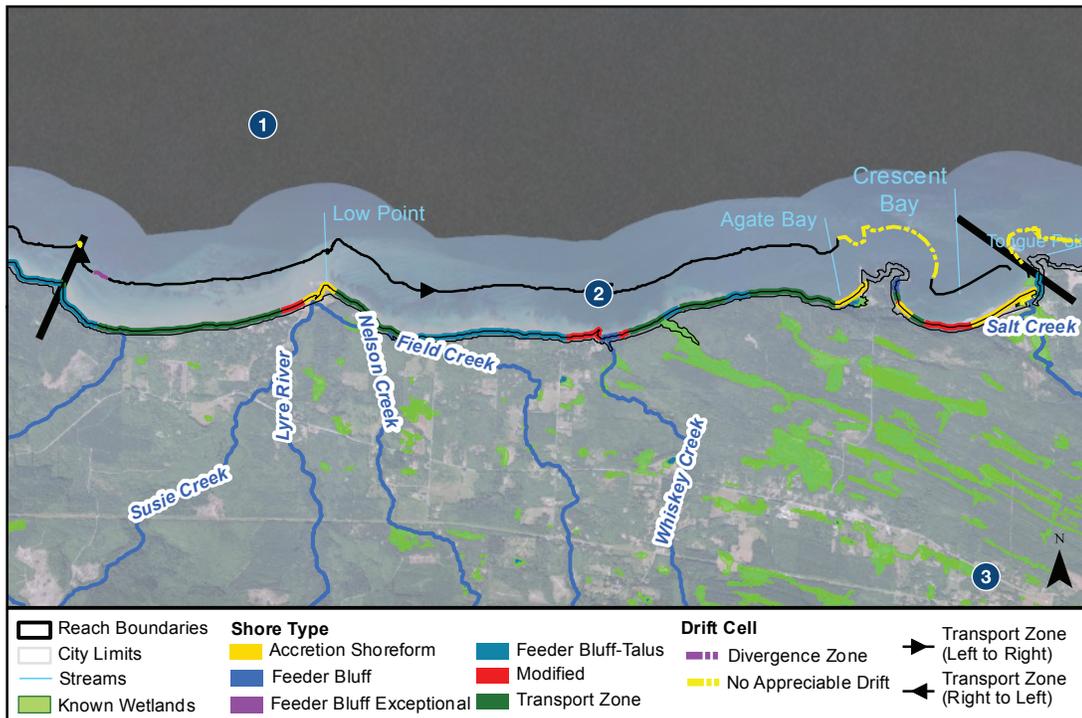
Land uses and ownership within the shoreland zone vary throughout the reach. The reach contains DNR-managed forest land, privately-owned campgrounds, residential development, and a large amount of undeveloped, privately owned land. Most of Crescent Bay, Agate Bay, and Low Point are in tsunami hazard zones and FEMA-mapped floodplain.

Under current zoning regulations, almost three-quarters of the shoreland area has potential for new residential development. Undeveloped parcel sizes, shapes, and zoning categories vary throughout the reach. Many of the parcels are large in area, and could be subdivided into 2 to 20 acre lots, depending upon the zoning category.

Most bluff areas are unstable (53%) with recent slides (1%) mapped in Agate Bay and the southwestern portion of the reach. Most of Crescent Bay thru Agate Bay, and Low Point is in a tsunami hazard zone (51%) and FEMA coastal and stream 100-year floodplains (46%).

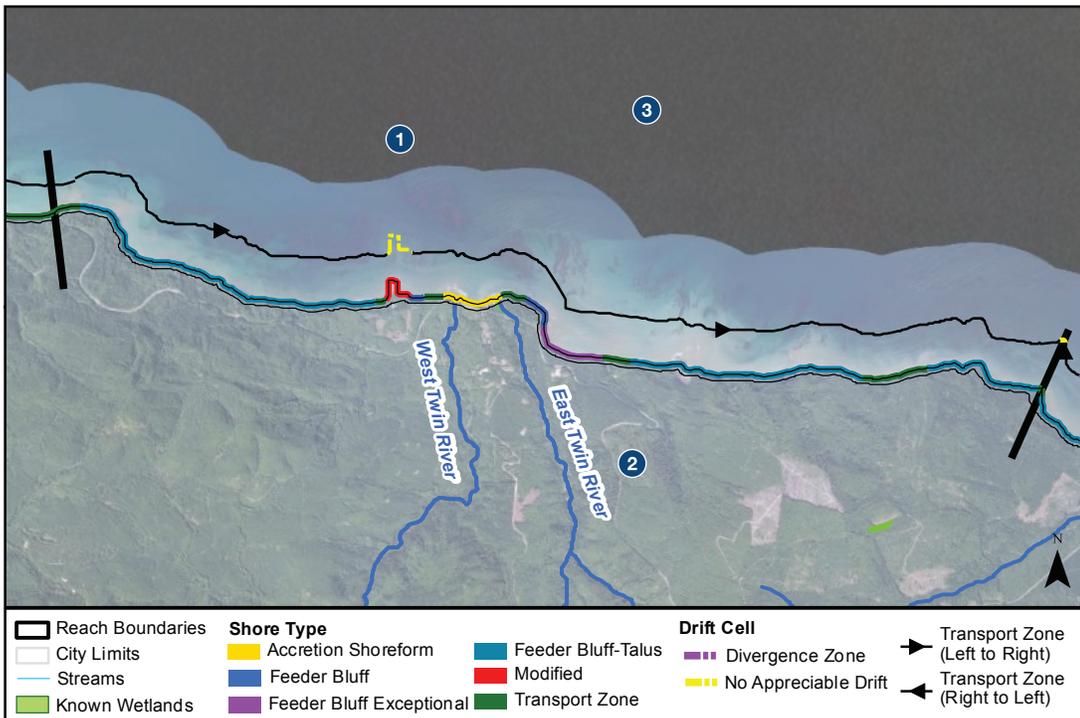
Most of the land within the shoreland zone is privately owned, and zoned for commercial forestry. Some DNR-managed forest land is located in the eastern portion of the reach. The shorelands within the reach are largely undeveloped.

Under current zoning regulations, approximately one-third of the shoreland area has potential for new residential development. However, most of this land is zoned for commercial forestry. Most of the forestry land in the reach is not eligible for subdivision. Actual development potential within this reach is minimal.

Most bluff areas are unstable (59%) with recent slides mapped in the southeastern portion of the reach (6%). The East and West Twin River shoreline areas are in a tsunami hazard zone (16%) and the FEMA coastal 100-year floodplain (16%).

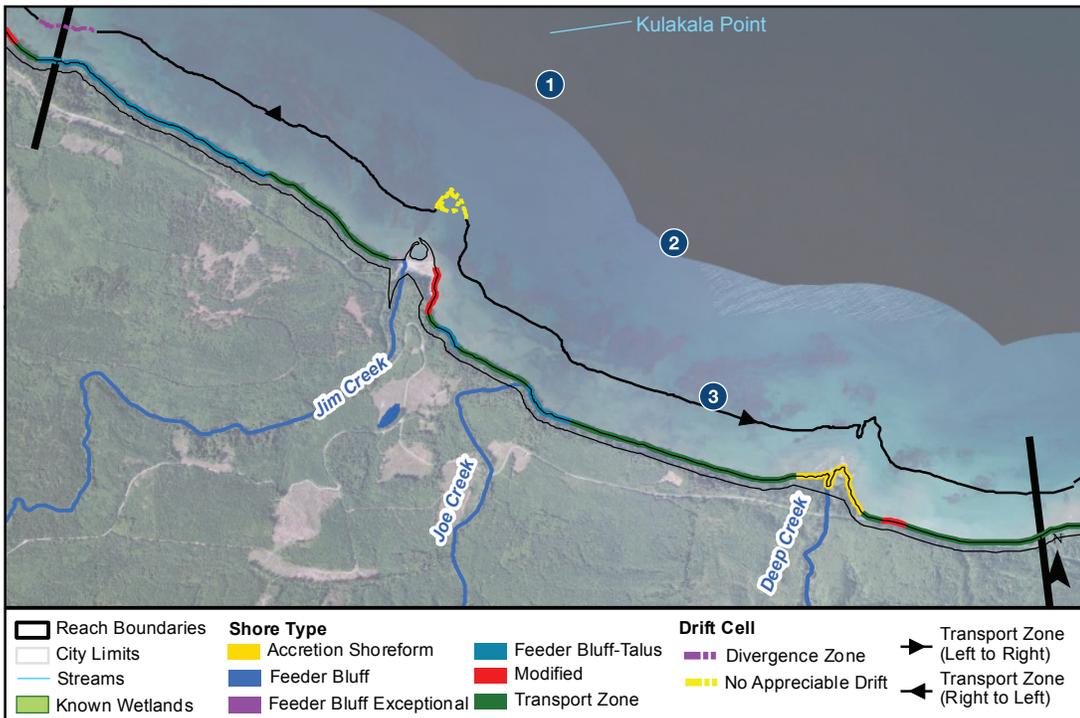
Land usage within the shoreland area is commercial forestry, with the exception of the Silver King Resort area. The shorelands within the reach are largely undeveloped.

Under current zoning regulations, almost the entire shoreland zone has potential for new residential development. However, most of this land is zoned for commercial forestry. Most of the forestry land in the reach is not eligible for subdivision. Actual development potential within this reach is minimal.

Net shore drift is entirely eastward and encompasses the origin or western extent of the same drift cell found in Reach 10. A large obstruction to littoral drift bisects the historic drift cell (breakwater) at the mouth of Jim Creek in the northern portion of the reach.

Most bluff areas are unstable (64%) with recent slides mapped directly west of Deep Creek (2%). Most of the Jim Creek and Deep Creek shoreline areas are in a tsunami hazard zone (53%) and FEMA coastal and stream 100-year floodplain (20%).

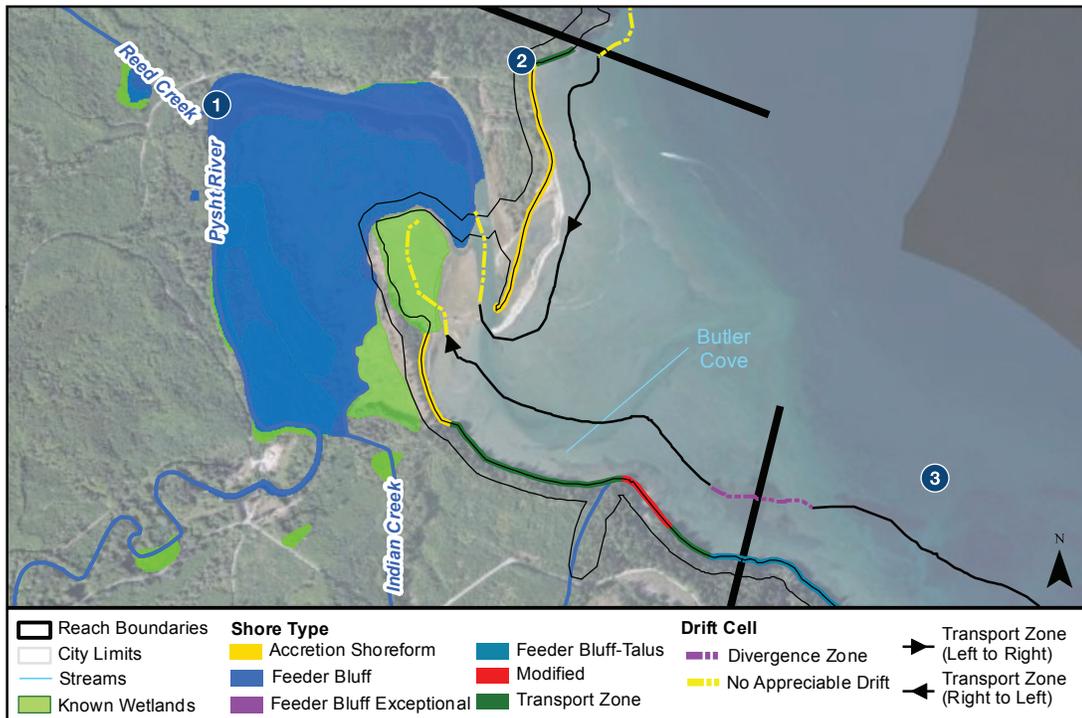
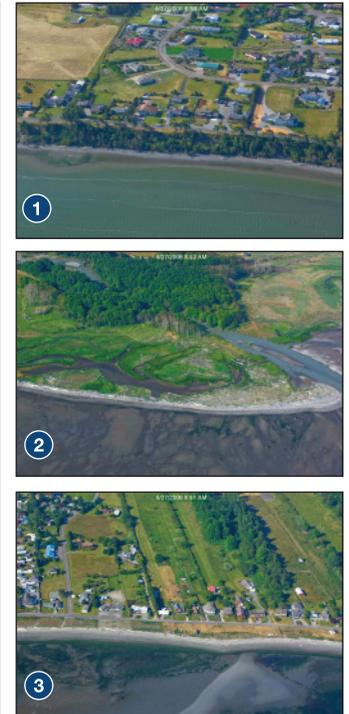
Land usage within the shoreland area is commercial forestry, low-density residential, and open space. The shorelands within the reach are largely undeveloped. A small portion of the shoreline is publically owned, and be accessed from Pillar Point Recreation Area (at Butler Cove).

Under current zoning regulations, almost the entire shoreland zone has potential for new residential development. However, most of this land is zoned for commercial forestry. Most of the forestry land in the reach is not eligible for subdivision. Actual development potential within this reach is minimal.

Several bluff areas are unstable (27%) in the southeast and northern portion of the reach with no recent slides mapped. Nearly all of the Pysht River estuary is in a tsunami hazard zone (64%) and FEMA coastal and stream 100-year floodplains (76%).

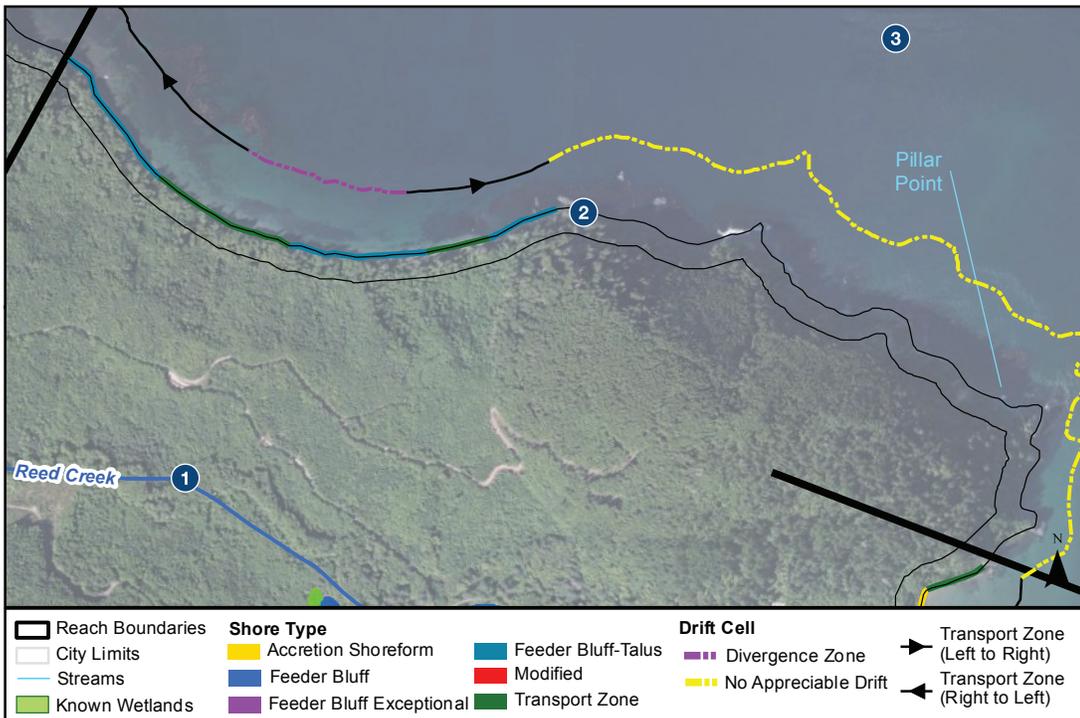
Land ownership within the reach is almost entirely private, and usage is primarily timber, with a smaller amount of low-density residential located in the eastern portion of the reach. Most of the actual shoreline is publically owned, but cannot be accessed from land.

Under current zoning regulations, more than half of the entire shoreland zone has potential for new residential development. However, most of this land is zoned for commercial forestry. Most of the forestry land in the reach is not eligible for subdivision. Actual development potential within this reach is minimal

Many bluff areas are unstable (94%) with recent slides mapped in the northwestern portion of the reach (4%). A portion of Pillar Point and the northwestern shoreline of the reach is in a tsunami hazard zone (17%) and the FEMA coastal floodplain (10%).

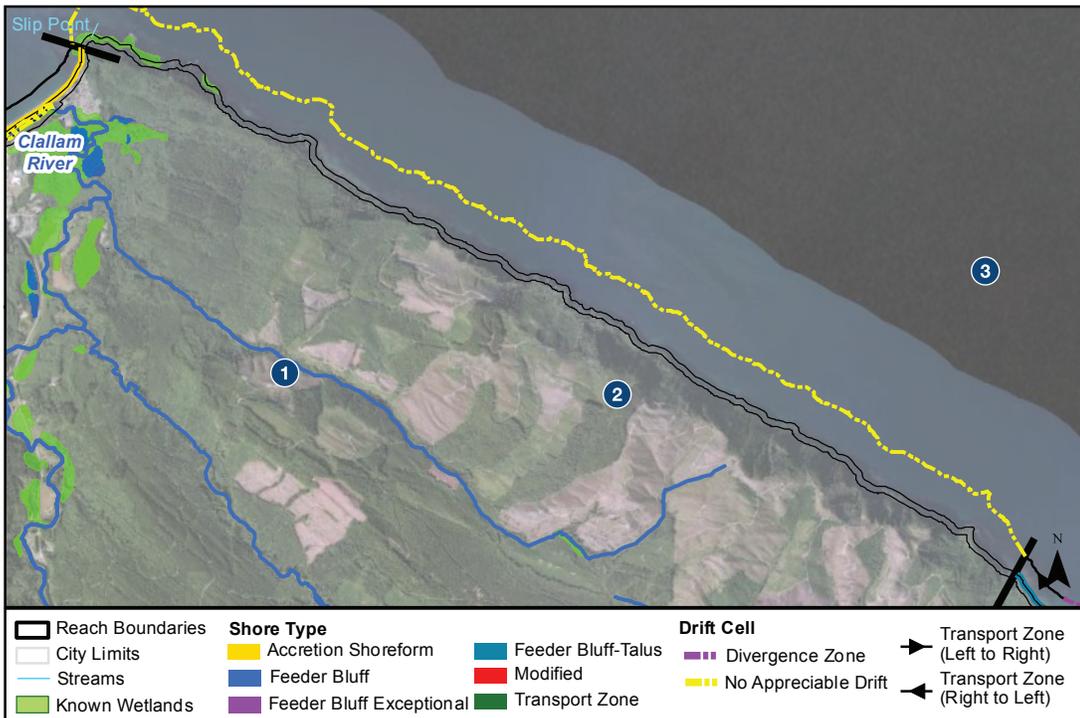
Almost the entire shoreland area is privately-owned timber land. Nearly the entire shoreline is publically owned; however, the water can be accessed from land within the reach.

Under current zoning regulations, more than 90% of the entire shoreland zone has potential for new residential development. However, all of this land is zoned for commercial forestry. Most of the forestry land in the reach is not eligible for subdivision. Actual development potential within this reach is minimal

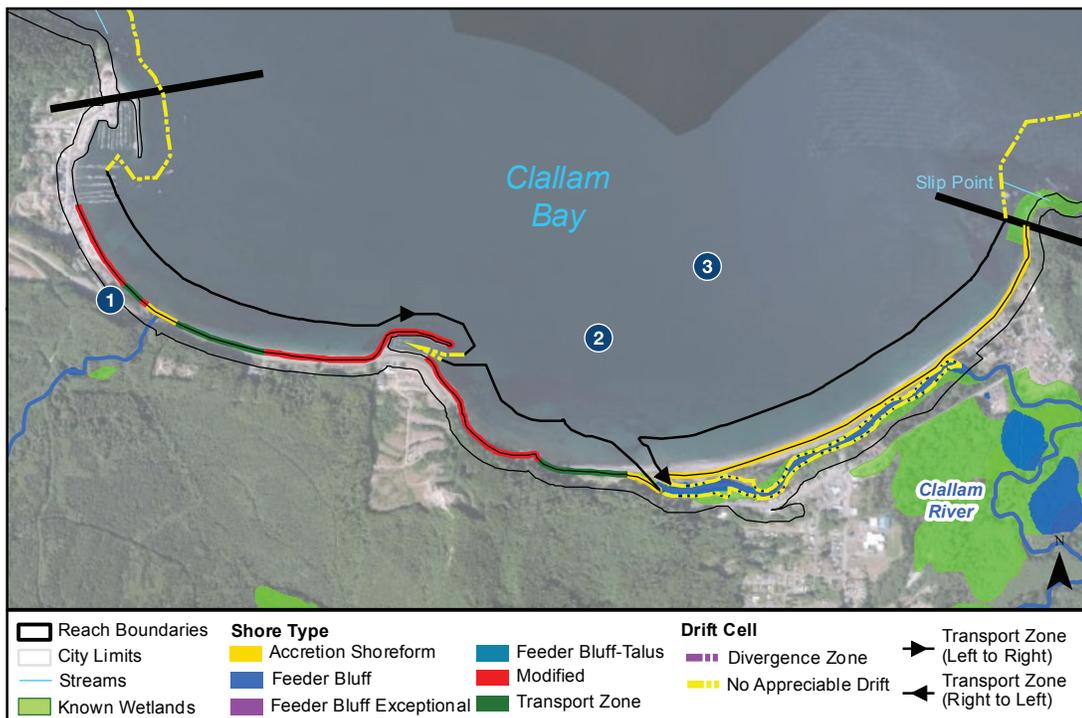
Major land uses within the shoreland area include open space, roads, lodging, high-density residential development, and commercial. Clallam Bay Spit Park is located at the eastern end of the reach. Approximately one-quarter of the reach contains forest habitat, which provides habitat for many species, including bald eagle. Most of the vegetation within the shorelands has been altered by development.

Under current zoning regulations, approximately half of the shoreland area has potential for new development. Most of the undeveloped land is zoned for lodging or commercial development. These undeveloped parcels are narrow in width, with wide water frontages. Development in these parcels would likely require the installation of shoreline armoring to protect structures, which may degrade salmon rearing habitat and impede natural sediment processes.

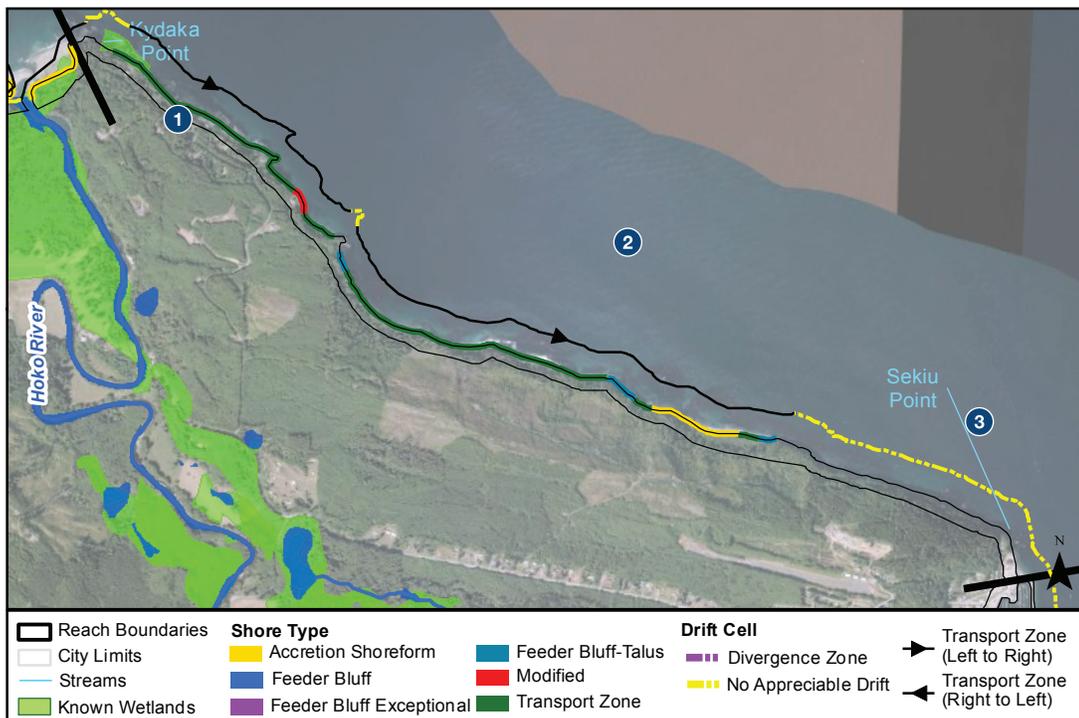
Under current zoning regulations, approximately two-thirds of the shoreland area has potential for new residential development. However, most of this land is zoned for commercial forestry. Most of the forestry land in the reach is not eligible for subdivision. Development in the western end of the reach would consist of moderately-density residential infill. The waterward ends of these parcels are within mapped tsunami and coastal flood hazard area.

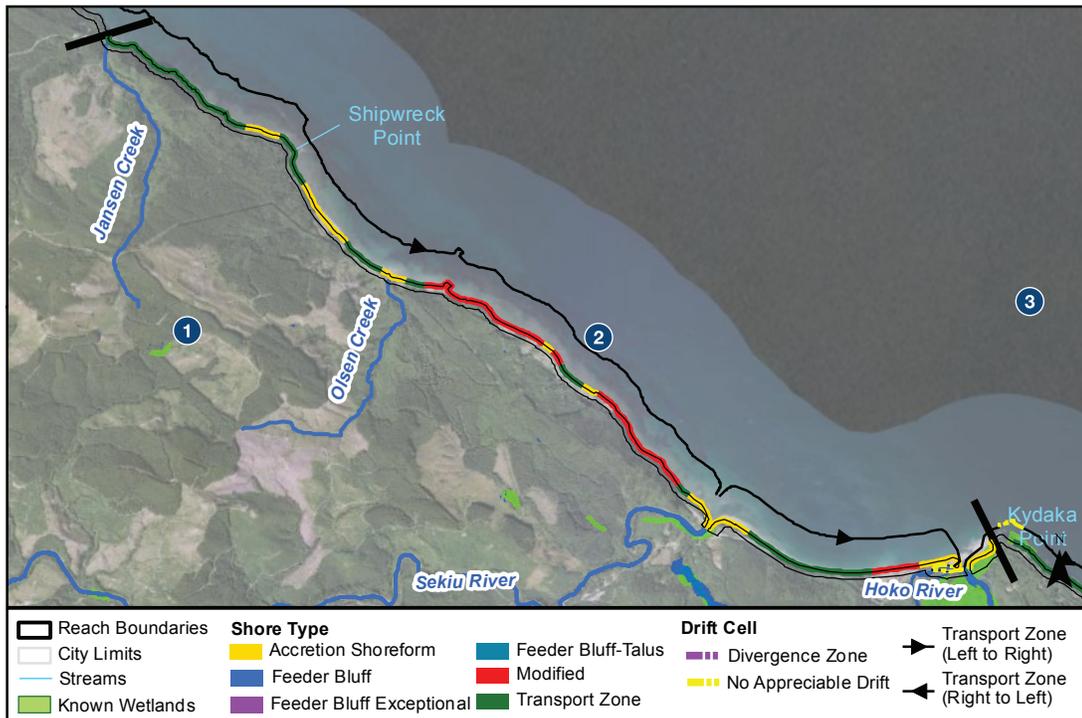
Under current zoning regulations, approximately one-third of the shoreland area has potential for new residential development. Most of the undeveloped parcels are located in a narrow strip of land between Highway 112 and the shoreline, within tsunami and floodplain hazard areas. In addition, given the shape and location of the parcels, shoreline armoring would likely be necessary to protect future structures.

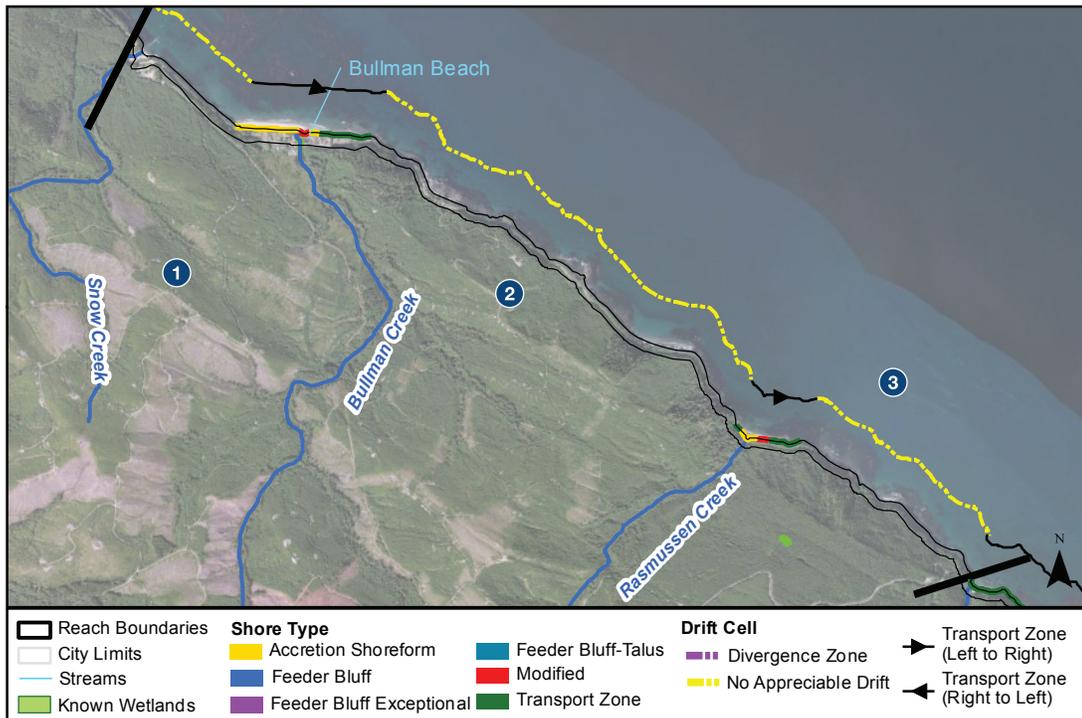
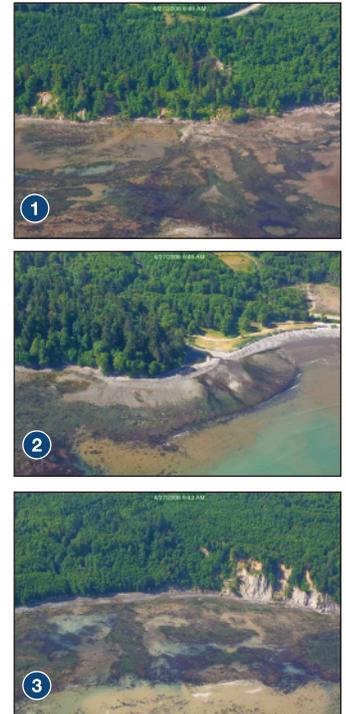
Under current zoning regulations, approximately one-third of the shoreland area has potential for new residential development. However, most of this land is zoned for commercial forestry that is not eligible for subdivision. With the exception of a few undeveloped lots, the residential-zoned land at Bullman Beach is already fully developed. However, there is potential for an increase in shoreline armoring in this area.
