# Reach Sheet Data Descriptions and Sources

## Freshwater Reach Sheet Explainer

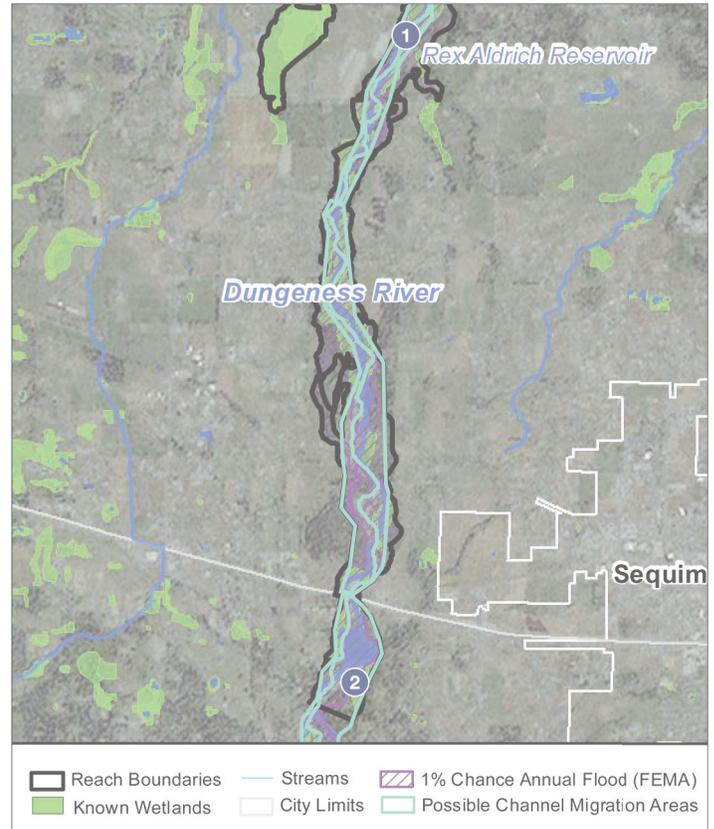
### REACH MAP

The reach maps show each “reach” or inventory segment—there are 63 freshwater reaches (encompassing 39 streams and 1 lake), which excludes incorporated areas and the Makah Reservation. Channel migration and flood hazard areas are also shown on the maps. Shoreline oblique photos taken by Ecology are provided (where available) to help orient the reader to key localities. The aerial photography is from 2009.

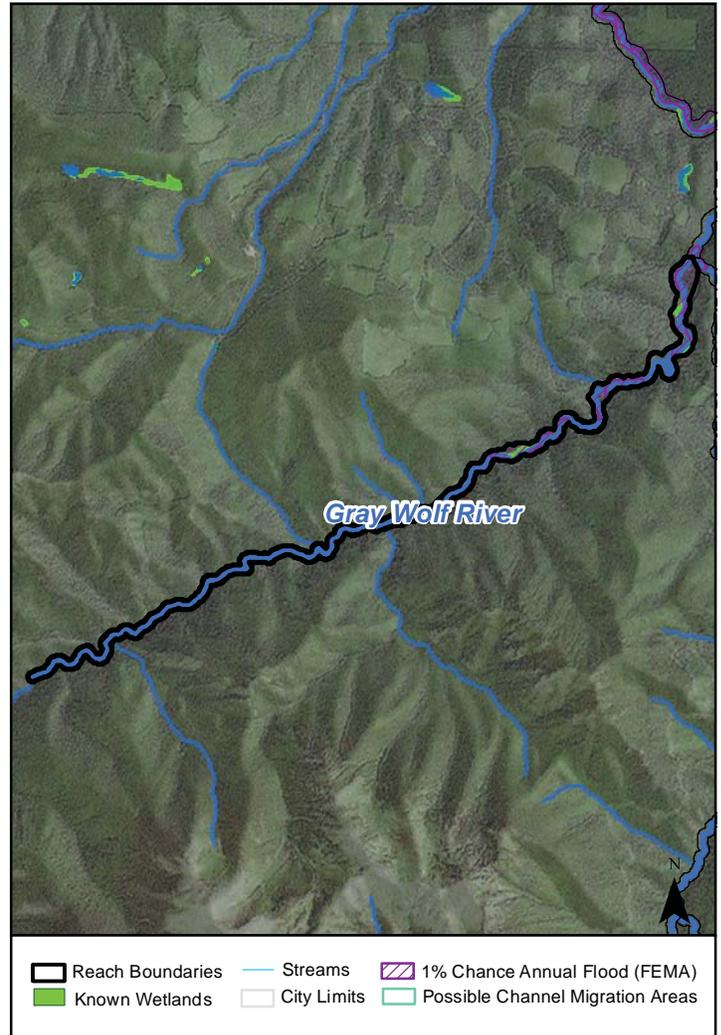
The reach extends from the Dungeness River confluence to approximately 8.0 miles upstream. Forest cover is present throughout most of the reach. The Gray Wolf River provides habitat for Chinook, coho, chum, sockeye, and pink salmon, in addition to steelhead, bull, and resident cutthroat trout. The reach also supports populations of elk and harlequin duck.

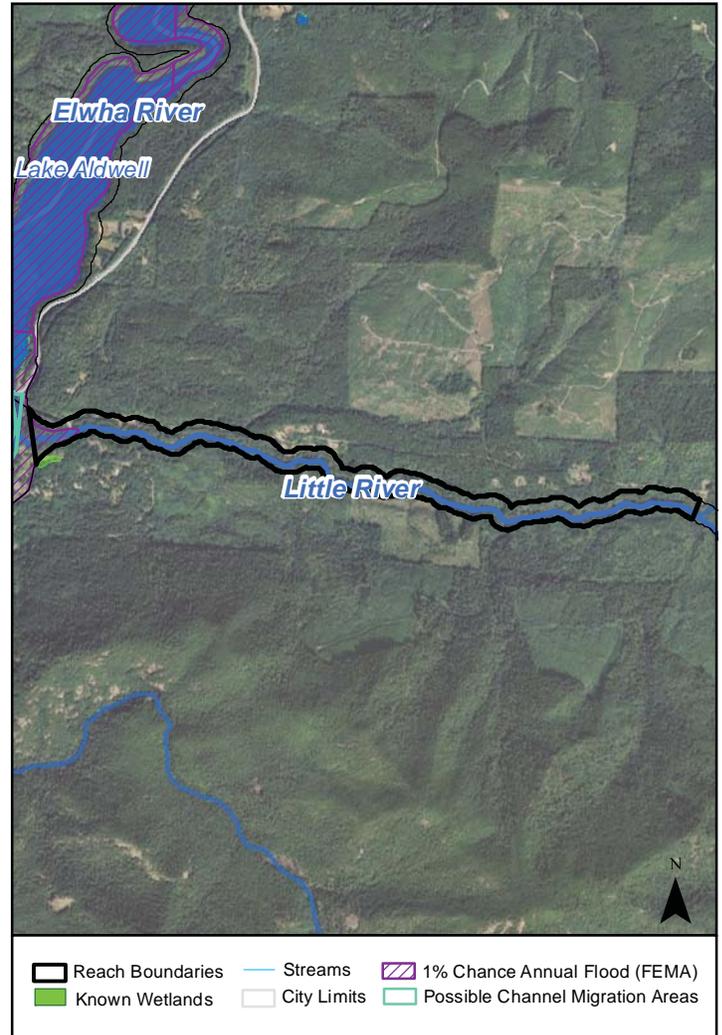
Land use within the reach is primarily commercial timber, with some rural residential development located at the east end of the reach.

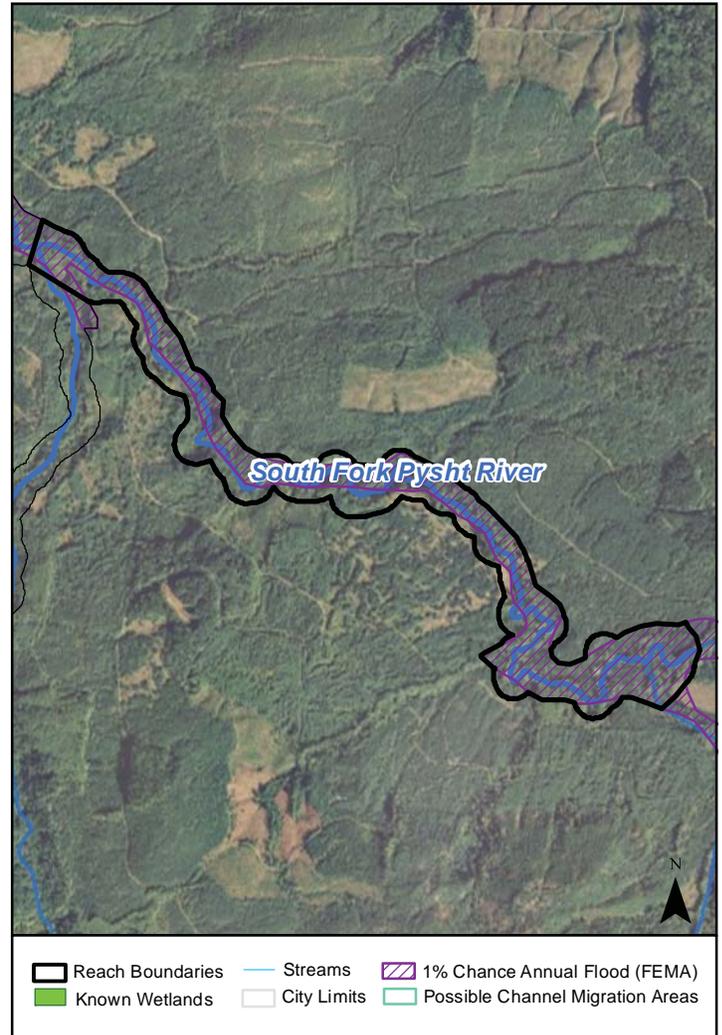
Land use within the reach is primarily commercial forestry. Most of the reach lies in the FEMA 100-year floodplain and in areas subject to geologic hazards. Three quarters of the reach is susceptible to erosion. Additionally, slide areas are located in the middle portion of the reach, along the north bank.
