SHORELINE INVENTORY AND CHARACTERIZATION REPORT

**for Portions of Clallam County Draining to the Strait of Juan de
Fuca**

Clallam County Shoreline Master Program Update

March 2012

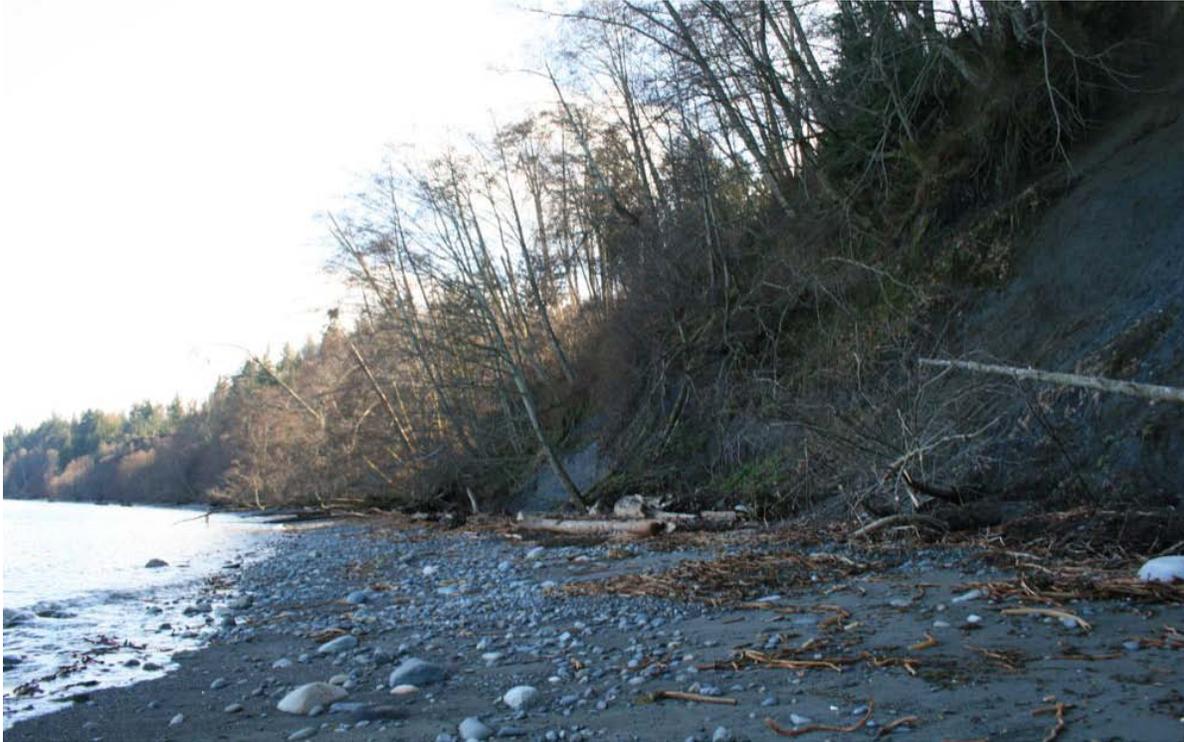
Figure 3-1. Erosion at base of bluff contributing sand, cobble and gravel to the nearshore (Photo by A. MacLennan)

The process of bluff erosion begins when sediment grains, blocks or slabs detach from the bluff face and slide down the slope. The eroded material deposited at the base or toe of the slope protects the bluff from wave attack for a while, but is gradually washed away by wind and wave action. Eventually, waves undercut the bluff toe, which destabilizes the slope making it more susceptible to failure (Johannessen and MacLennan 2007). Bluff toe erosion can occur rapidly during wet weather periods, storm surges or during extraordinary high tides. Evidence of marine or wave-induced bluff erosion is visible all along the Strait of Juan de Fuca (Figure 3-1).

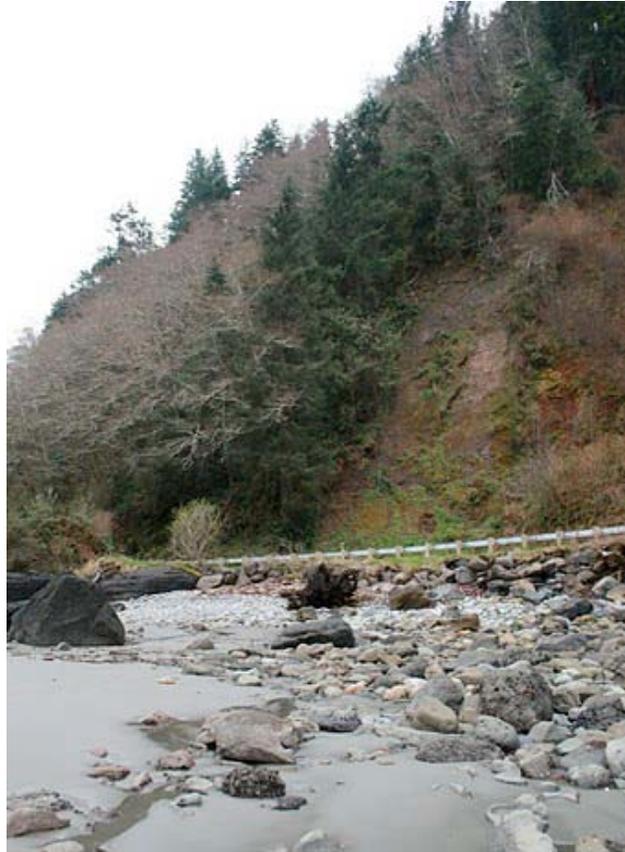
Figure 3-2. Evidence of recent landslide activity near Shipwreck Point (Photo by A. MacLennan)

exposure (to wind and waves), groundwater and surface water conditions and the extent of development on the bluff. Heavy precipitation and/or high groundwater levels can cause concavities to form at the top of the bluff. These depressions can grow into gullies and larger slumps that initiate shallow failures or reactivate large, deep-seated landslides. Bluffs that lack vegetation due to clearing or other development-related actions are often at greater risk for these events (Shipman 2004, Johannessen and MacLennan 2007). Figure 3-2 shows evidence of a recent landslide near Shipwreck Point.

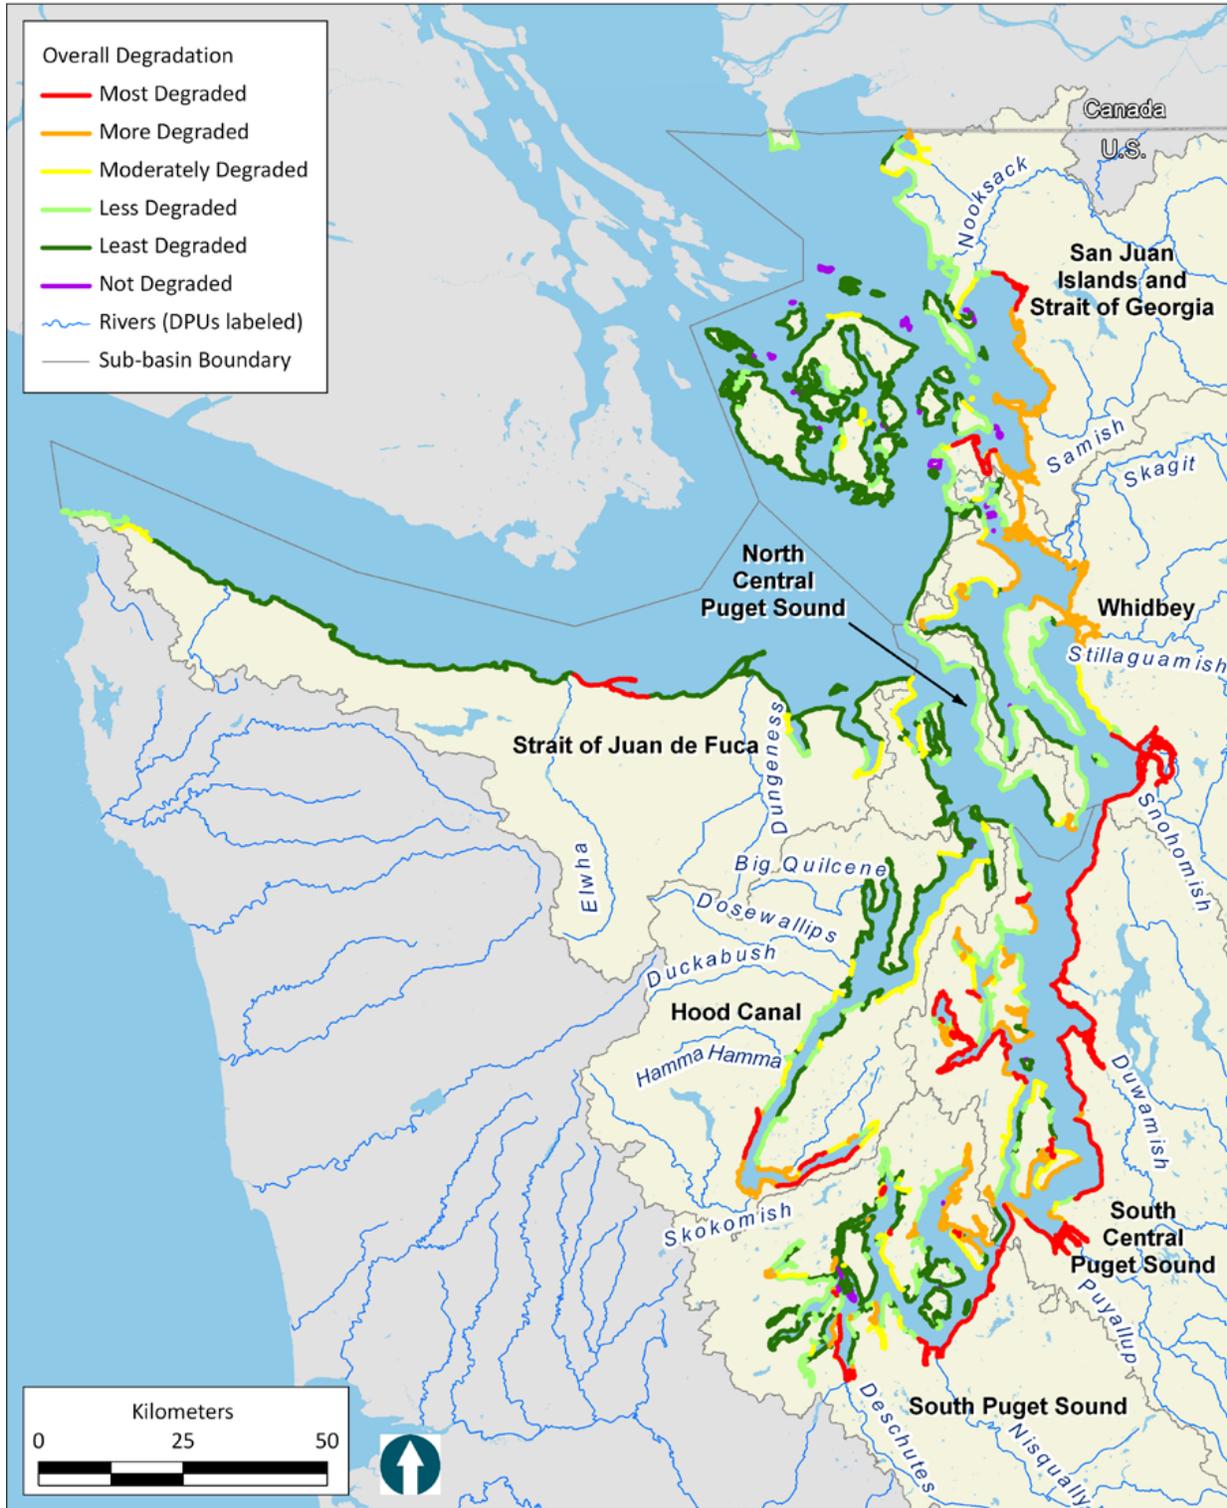
Figure 3-5. Relative degradation of Strait of Juan de Fuca nearshore reaches in terms of nearshore processes (Schlenger et al. 2010)

The level of degradation was rated on a relative scale from most degraded to not degraded. It is important to note that PSNERP did not evaluate biological conditions (such as vegetation or habitat availability) per se, but assessed the configuration of the shoreline compared to historic conditions and the presence of modifications or ecological stressors such as fill, armoring, marinas, dams and other features. Overall the reaches of the Strait were less degraded than most other areas of Puget Sound (Schlenger et al. 2010) (Figure 3-5). The low level of degradation

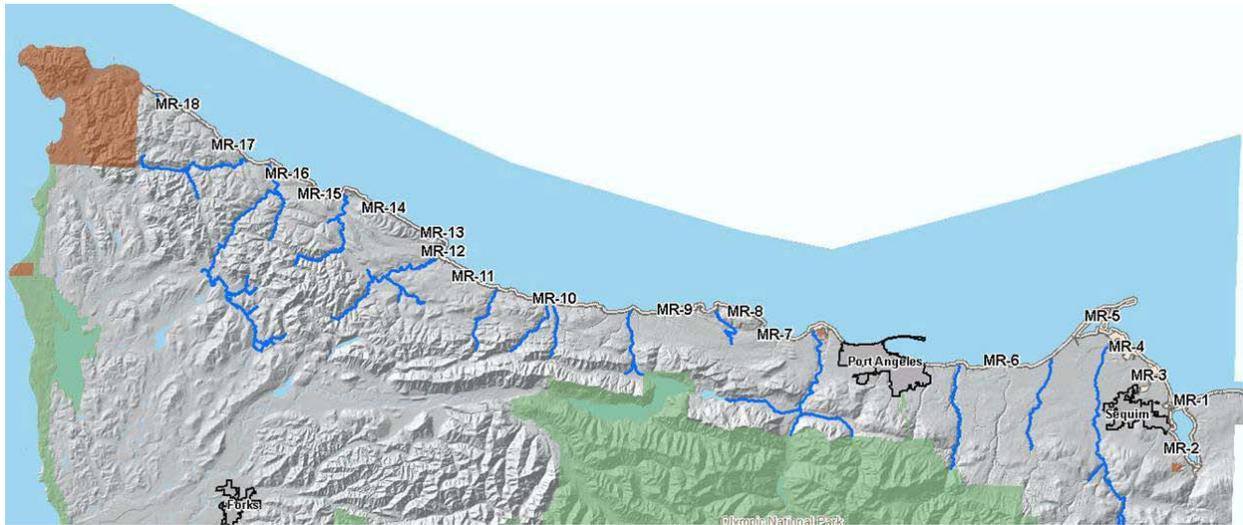
Figure 3-8. Inventory reaches along the Strait of Juan de Fuca numbered from east to west (MR= marine reach)

Within Clallam County, the Strait of Juan de Fuca shoreline consists of 18 reaches, each composed of different shoretypes that reflect the underlying geology, degree of exposure to wind/waves, long-term patterns of sea level change, the ongoing redistribution of sediment by net shore-drift processes and the influence of freshwater systems including the Dungeness, Elwha, Lyre and other rivers. The reaches are numbered sequentially from east to west and do not include the incorporated areas or tribal lands of the Makah Indian Reservation (Figure 3-8). All marine shorelines inventoried in this chapter are “shorelines of statewide significance” (Strait of Juan de Fuca).

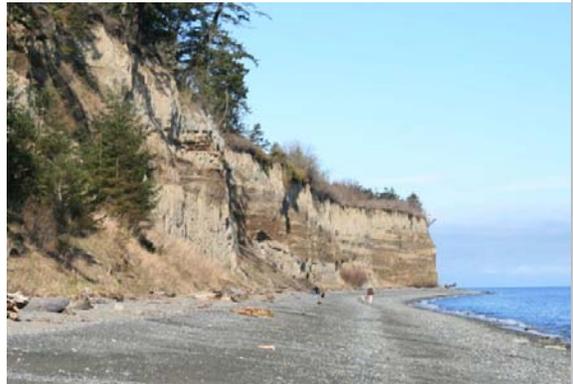
<p>South of Dungeness River (Reach 4)</p>

Shoretype	Criteria		Photo Example
	Presence of (priority in order):	Absence of:	
Feeder Bluff Exceptional (FBE)	<ol style="list-style-type: none"> 1. Bluff/ bank 2. Recent landslide scarps 3. Bluff toe erosion 4. Abundant sand/gravel in bluff 5. Colluvium/ slide debris 6. Primarily unvegetated or vegetated slumps 7. Trees across beach 8. Boulder/ cobble lag 9. Steep bluff (relative 	<ol style="list-style-type: none"> 1. Shoreline bulkhead/ fill 2. Backshore 3. Old/ rotten logs 4. Coniferous bluff vegetation 5. Bulkhead

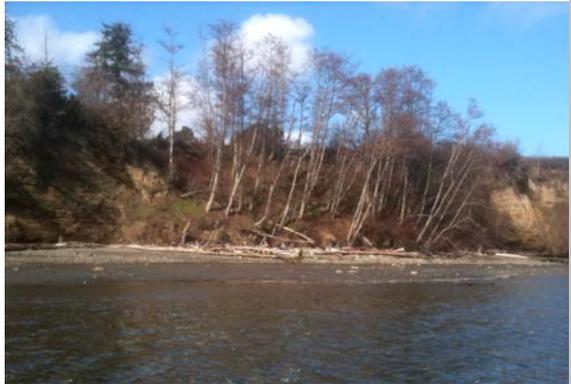
Shoretype	Criteria		Photo Example
	Presence of (priority in order):	Absence of:	
	alongshore)		
Feeder Bluff (FB)	<ol style="list-style-type: none"> 1. Bluff/ bank 2. Past landslide scarp 3. Intermittent toe erosion 4. Moderate sand/gravel in bluff 5. Intermittent colluvium 6. Minimal vegetation 7. Trees across beach 8. Boulder/ cobble lag 9. Steep bluff (relative alongshore) 	<ol style="list-style-type: none"> 1. Shoreline bulkhead/fill 2. Backshore 3. Old/rotten logs 4. Coniferous bluff vegetation 5. Bulkhead

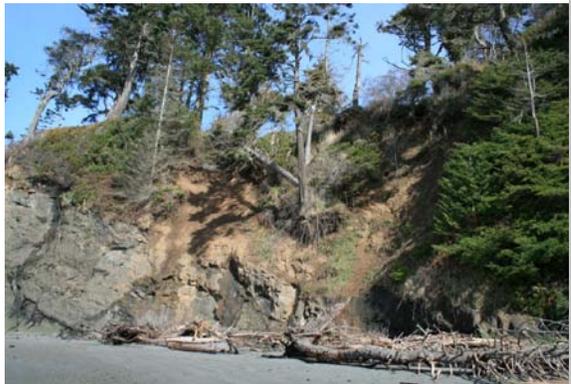
<p>East of Salt Creek (Reach 9)</p>

<p>Northwest Sequim Bay (Reach 3)</p>
Feeder Bluff -Talus (FBT)	<ol style="list-style-type: none"> 1. Bluff/ bank 2. Past landslide scarp, mapped landslides 3. Bedrock with particle size relevant to beach material, bedding or jointing conducive to breaking and abrasion 3. Intermittent toe erosion 5. Intermittent colluvium 6. Minimal vegetation on bluff face 	<ol style="list-style-type: none"> 1. Shoreline bulkhead/fill 2. Backshore 3. Old/rotten logs 4. Basalt 5. Bulkhead

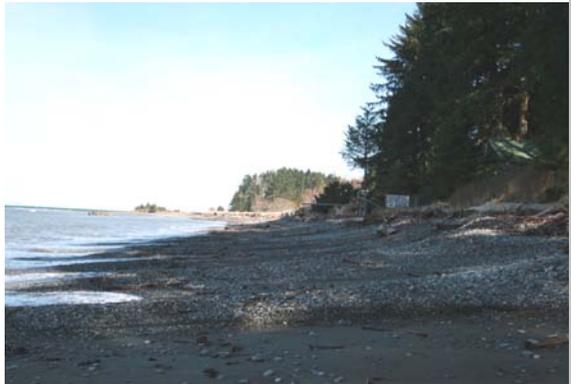
Shoretype	Criteria		Photo Example
	Presence of (priority in order):	Absence of:	
	<ul style="list-style-type: none"> 7. Trees across beach 8. Boulder/ cobble lag 9. Steep bluff (relative alongshore) 		
Transport Zone (TZ)	<ul style="list-style-type: none"> 1. Coniferous bluff vegetation 2. Apparent relative bluff stability 3. Gentle slope bluff (relative alongshore) 4. Unbulkheaded transport zone adjacent 	<ul style="list-style-type: none"> 1. Visible landslide scarps 2. Toe erosion 3. Backshore & backshore vegetation 4. Old/rotten logs 5. Colluvium 6. Trees across beach 7. Bulkhead

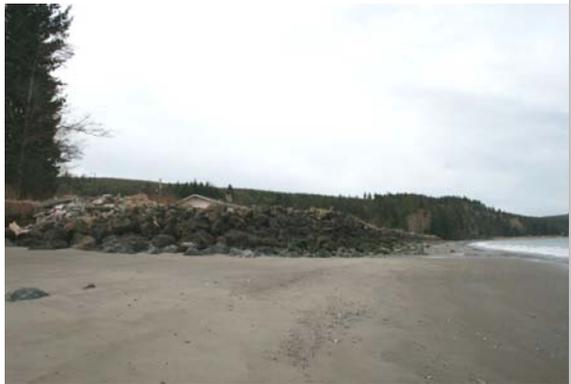
<p>West of Hoko River (Reach 17)</p>

<p>Harrison Beach (Reach 10)</p>
Modified (M)	<ul style="list-style-type: none"> 1. Bluff/bank 2. Shoreline bulkhead (mostly intact) 3. Substantial shoreline fill 	<ul style="list-style-type: none"> 1. Backshore & backshore vegetation 2. Lagoon/wetland /marsh behind berm 3. Backshore “platform” 4. Old/rotten logs 5. Fine, well sorted sediment (relative alongshore)

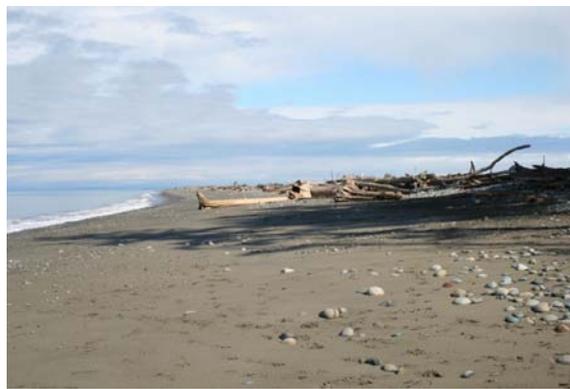
<p>Dungeness Spit (Reach 5)</p>

Shoretype	Criteria		Photo Example
	Presence of (priority in order):	Absence of:	
Accretion Shoreform (AS)	<ol style="list-style-type: none"> 1. Backshore & backshore vegetation 2. Lagoon/wetland /marsh behind berm 3. Backshore “platform” 4. Old/rotten logs 5. Fine, well-sorted sediment (relative alongshore) 	<ol style="list-style-type: none"> 1. Bluff/bank in backshore 2. Toe erosion at bank 3. Landslide scarps 4. Boulders on beachface 5. Bulkhead

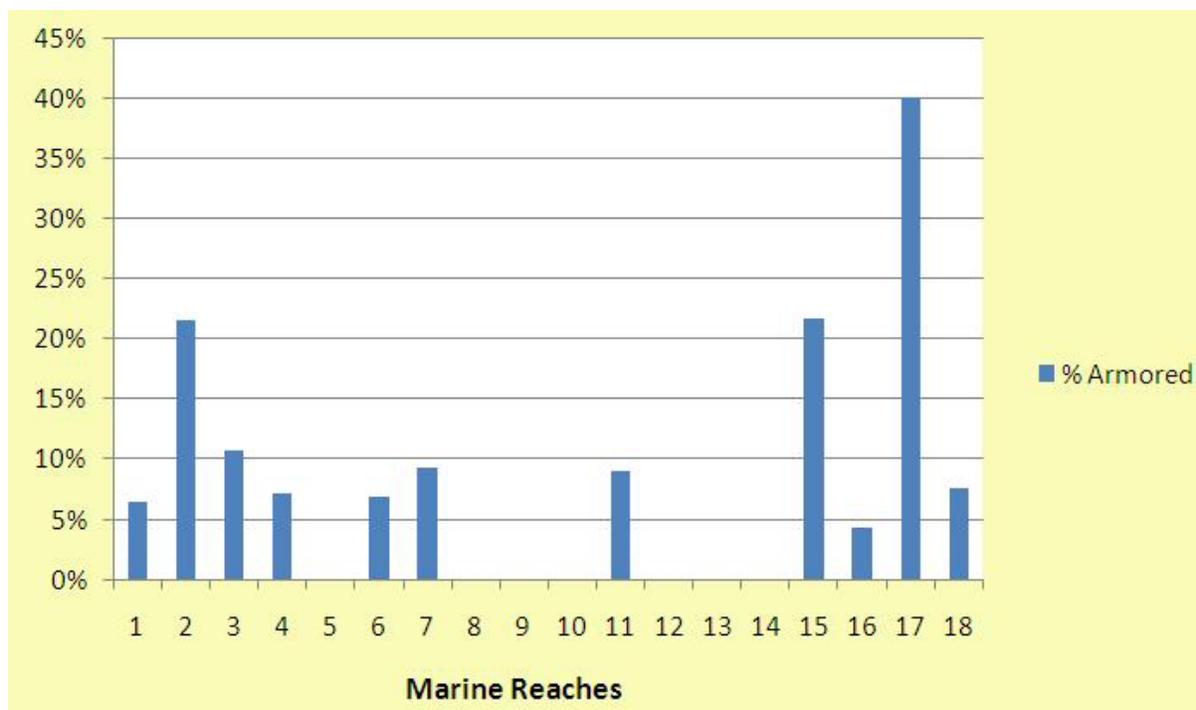
Figure 3-9. Percent of each reach with hard armoring along the Strait of Juan de Fuca in Clallam County (data from point PSNERP 2009, Battelle 2008)

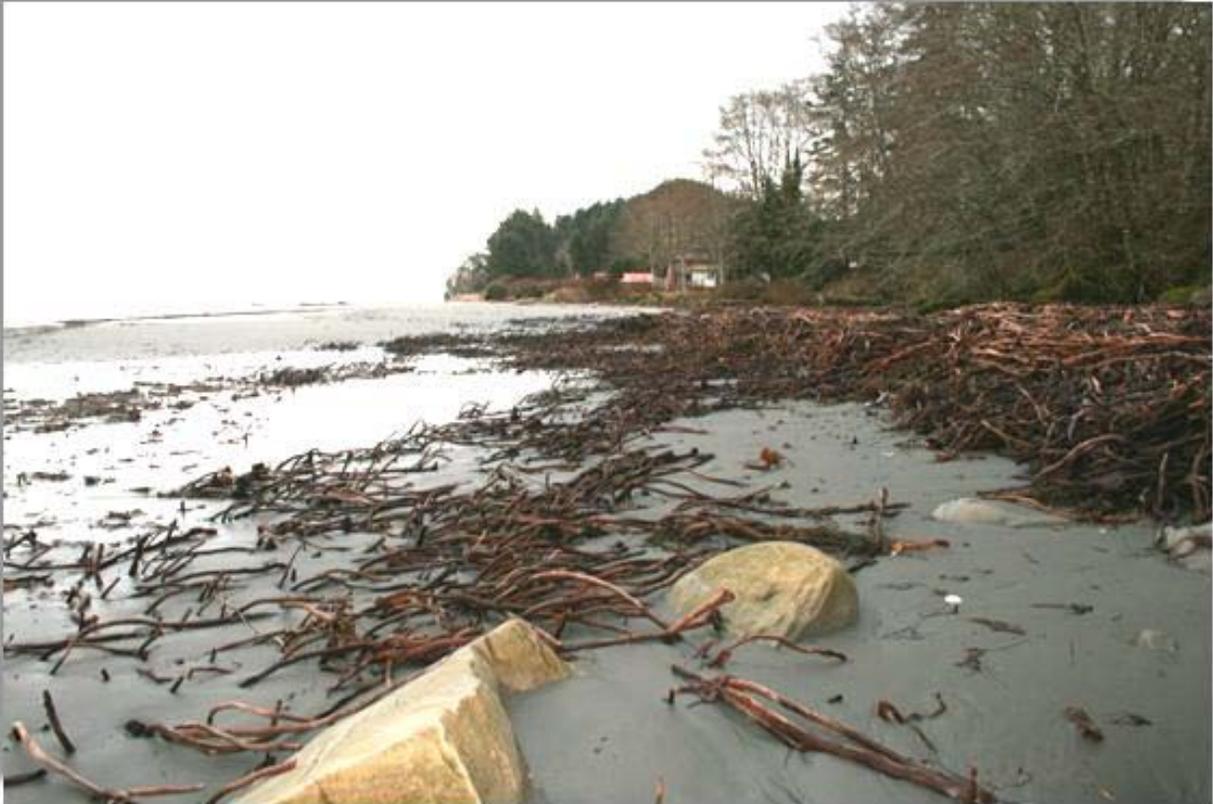
Figure 3-11. Kelp on Bullman Beach (Photo by A. MacLennan)

Kelp and eelgrass species occur primarily in the shallow subtidal areas, although some plants can be found low on the shore (Figure 3-11). Kelp prefer hard substrate in shallow water and can grow where pilings and other artificial surfaces exist (Mumford 2007). Eelgrass thrives in softer substrates (such as mud to clean sand) and can grow from the mid to upper intertidal zone down to the shallow subtidal area to the depth of light penetration. Humans use kelp as a source of micronutrients and as a stabilizing agent in foods, paints and inks (Mumford 2007).

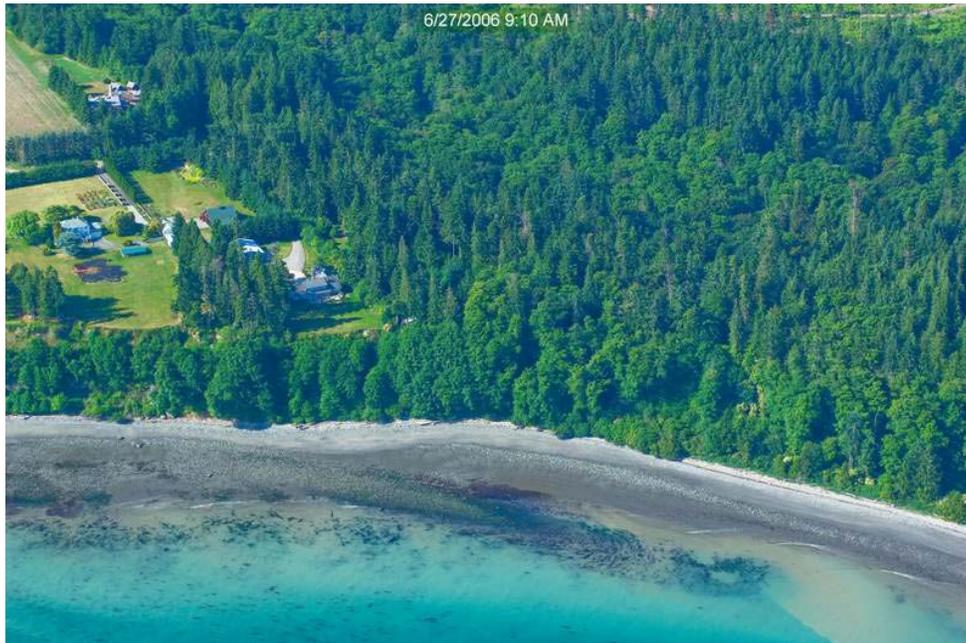
Figure 3-13. Healthy stands of marine riparian vegetation, such as this area just east of Green Point, perform important functions related to wildlife habitat, water quality, slope stability and food web support (photo: Ecology)

Healthy, sustainable marine ecosystems require well established riparian vegetation in addition to productive aquatic plant communities (Figure 3-13). There is a growing body of evidence to suggest that marine riparian systems play a key role in supporting marine biota and the integrity of the nearshore environment (Brennan and Culverwell 2004; Desbonnet et al. 1994). Some of the key functions provided by marine riparian vegetation include: soil and slope stability, sediment control, wildlife habitat (for example perching, nesting, cover and breeding for various species), water quality enhancement, nutrient and prey input from overhanging vegetation, shade to control temperature on beach spawning substrates; and large woody debris input (which provides roosting, nesting, foraging, spawning and attachment substrate for invertebrates and plants. Woody debris can also serve to stabilize beaches and backshore areas (Penttila 2000; Brennan et al. 2009).

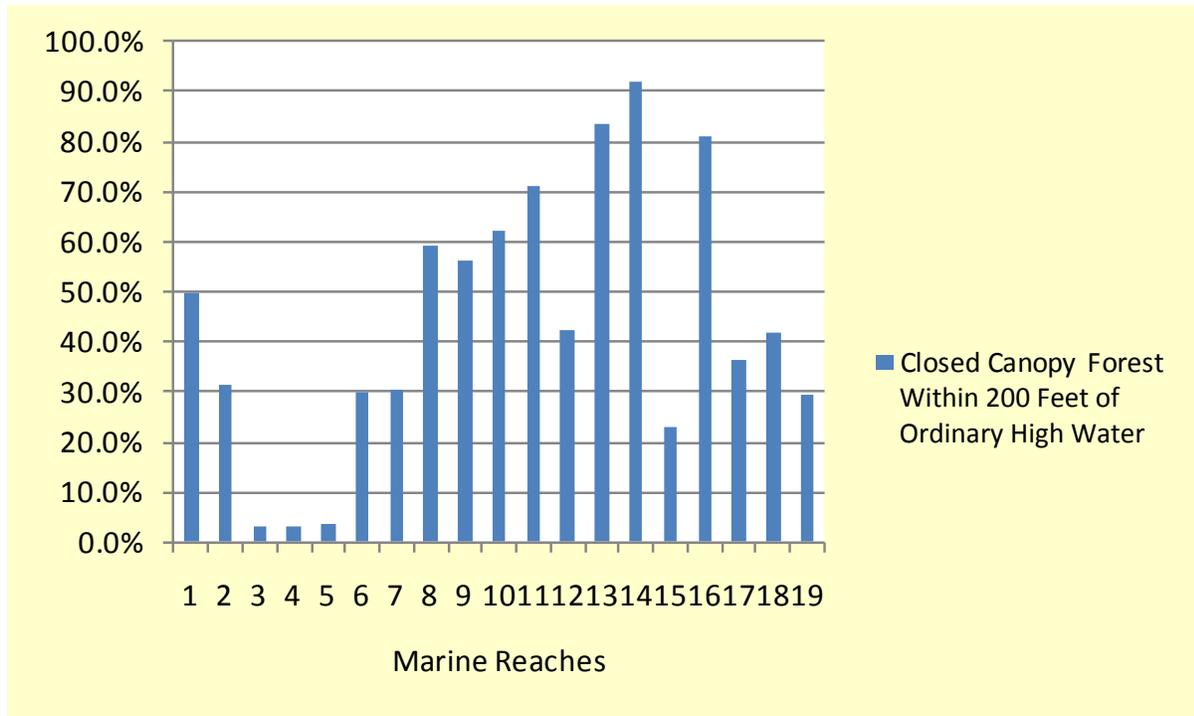
Figure 3-14. Percent of each marine reach with closed canopy forest cover along the Strait of Juan de Fuca in Clallam County (data from Point No Point Treaty Council 2011)

To help inform effective management of riparian vegetation in Clallam County, the Point No Point Treaty Council conducted a detailed assessment of riparian cover along Clallam County's marine and freshwater shorelines, mapping vegetation composition/ canopy cover within 200 feet of the ordinary high water line of the marine shoreline (Figure 3-14). Some reaches (mostly in western Clallam County where commercial forestry is the dominant land use) are almost totally forested, while other reaches (between Sequim and Port Angeles, for example) lack well developed marine riparian communities. Because vegetation plays such an essential role in performing so many ecological functions, maintenance of forest cover and revegetating areas that have lost forest cover should be important goals of the SMP update.

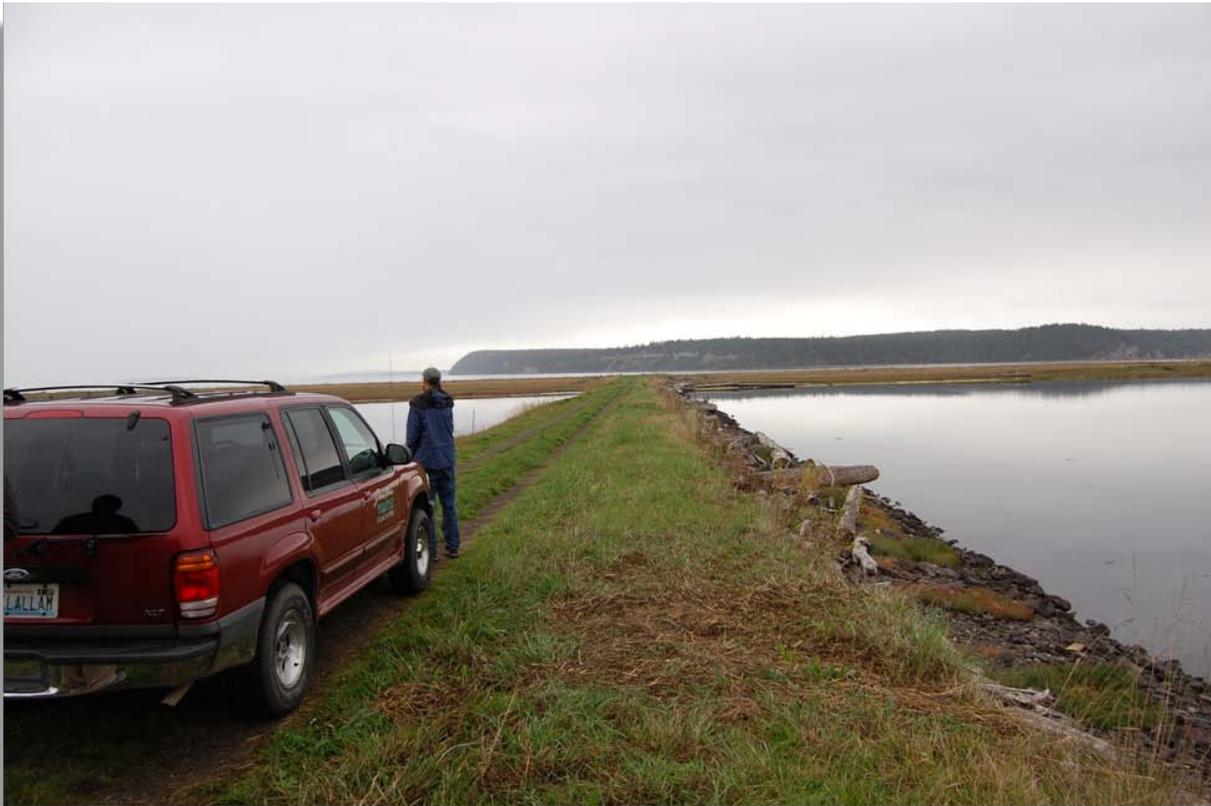
Figure 4-2. View of the partial tidal barrier within Washington Harbor; the road/ dike contains a sewer outfall pipe

Four segments (15% total) of this reach are armored including a small portion of the feeder bluff exceptional southeast of Graysmarsh. There are partial tidal barriers at Graysmarsh, at the mouth of Bell Creek and within the embayment at Washington Harbor (Figure 4-2). Other shoreline modifications include fill and/or overwater structures, most of which appear to be in the divergence zone of the drift cell. Approximately one-acre of nearshore fill occurs within the sediment transport zone near the county park end of Port Williams Road and may be disrupting transport toward the Spit. There are also numerous overwater structures identified within Graysmarsh. These appear to be part of a trail or boardwalk system crossing channels and other open water areas within the marsh itself.

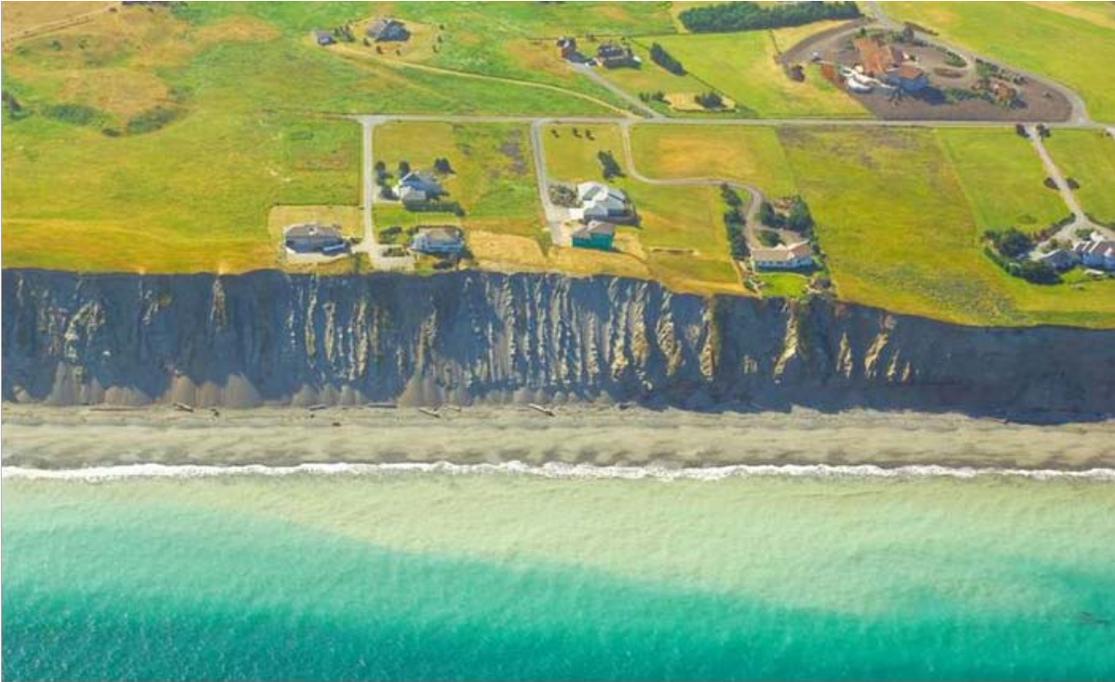
Figure 4-3. Segment of exceptional feeder bluff west of Dungeness Spit lacking native riparian forest cover. Note proximity of existing homes to edge of retreating bluffs (Photo: Ecology Coastal Atlas)

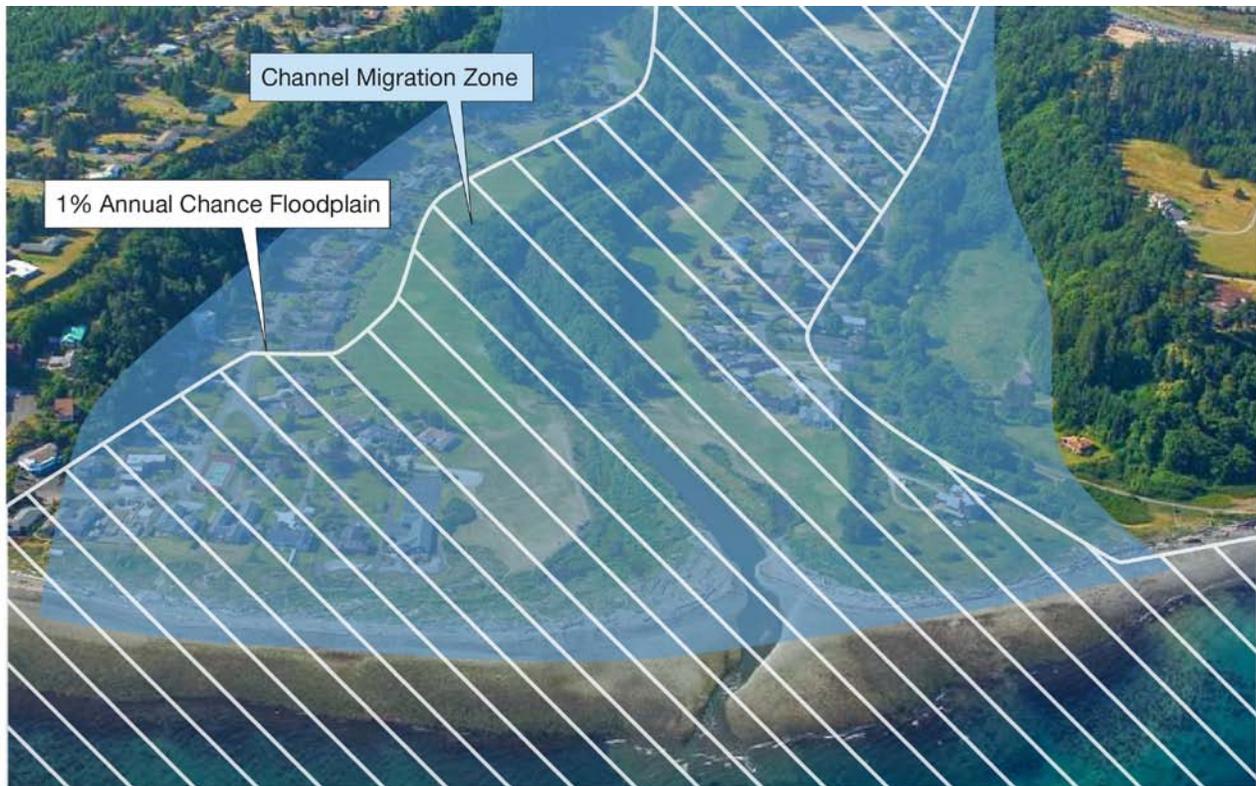
Figure 4-4. Development at the mouth of Morse Creek with the mapped floodplain and channel migration zone. (Photo: Ecology Coastal Atlas)

The mouths of Morse and McDonald Creek are in tsunami hazard areas and mapped FEMA 100-year floodplains (coastal and stream). There is limited development adjacent to the McDonald Creek mouth; however, dense residential development is located near the Morse Creek mouth, and many of these homes are within the floodplain and/or channel migration zone of the creek (Figure 4-4). The mouth of Siebert Creek has been the focus of a coordinated program by the North Olympic Land Trust and other organizations to acquire conservation easements.

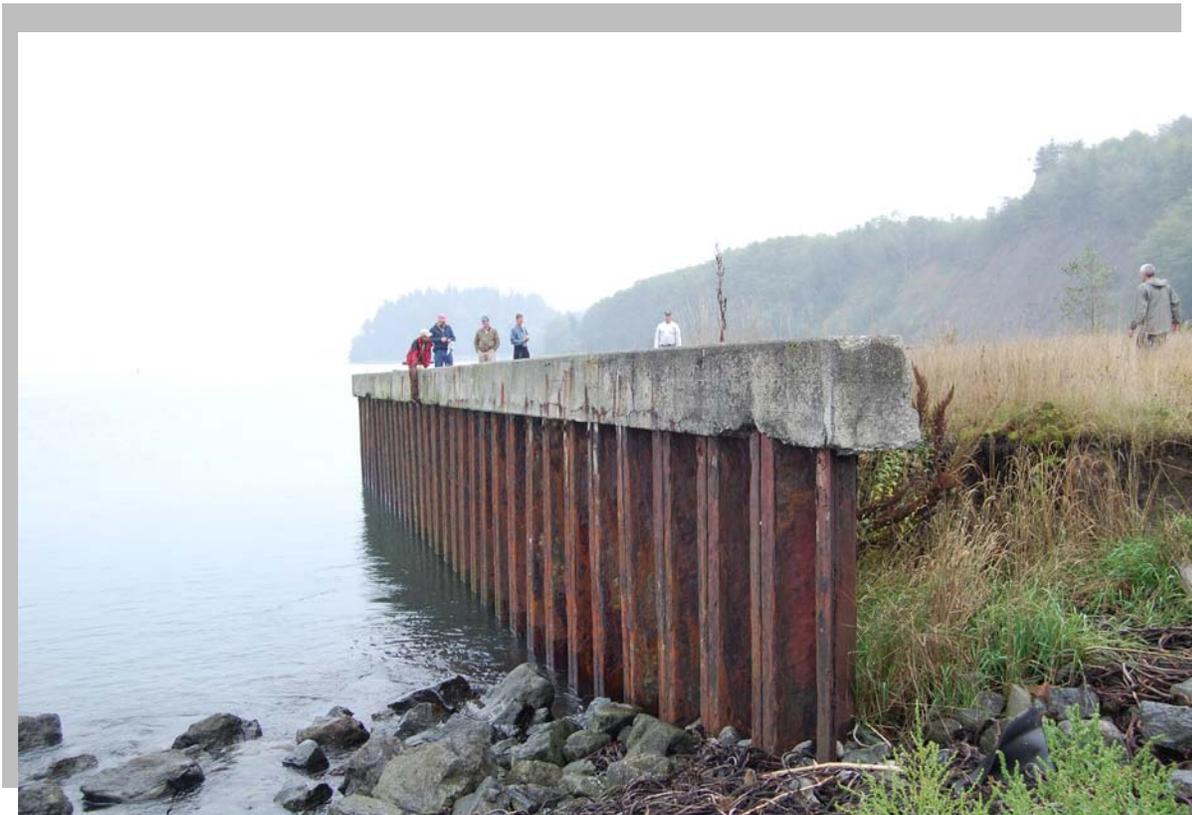
Figure 4-7. Retailed fill (“mole”) extending into the nearshore zone just west of West Twin River.

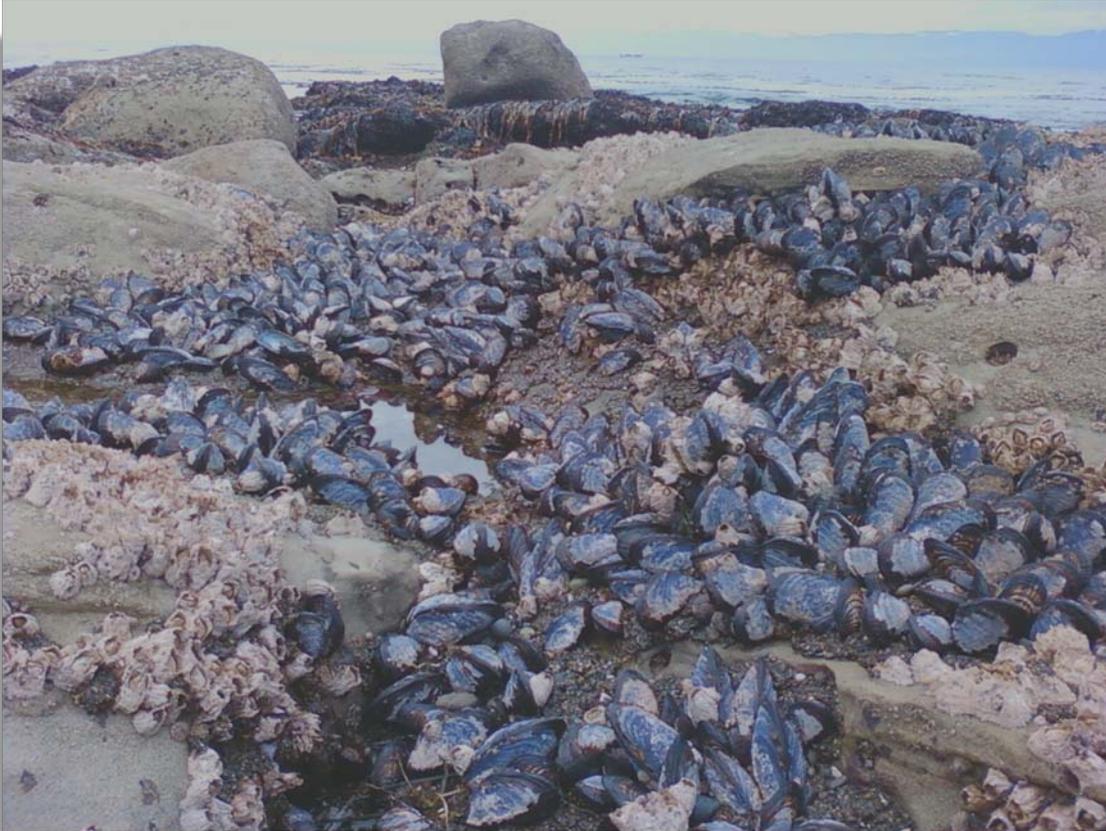
Figure 4-9. Mussels and other fauna on the rocky beach west of Sekiu Point

armoring is located at the eastern end of the reach, near Sekiu. The remainder of the shoreline is unaltered (Figure 4-9).

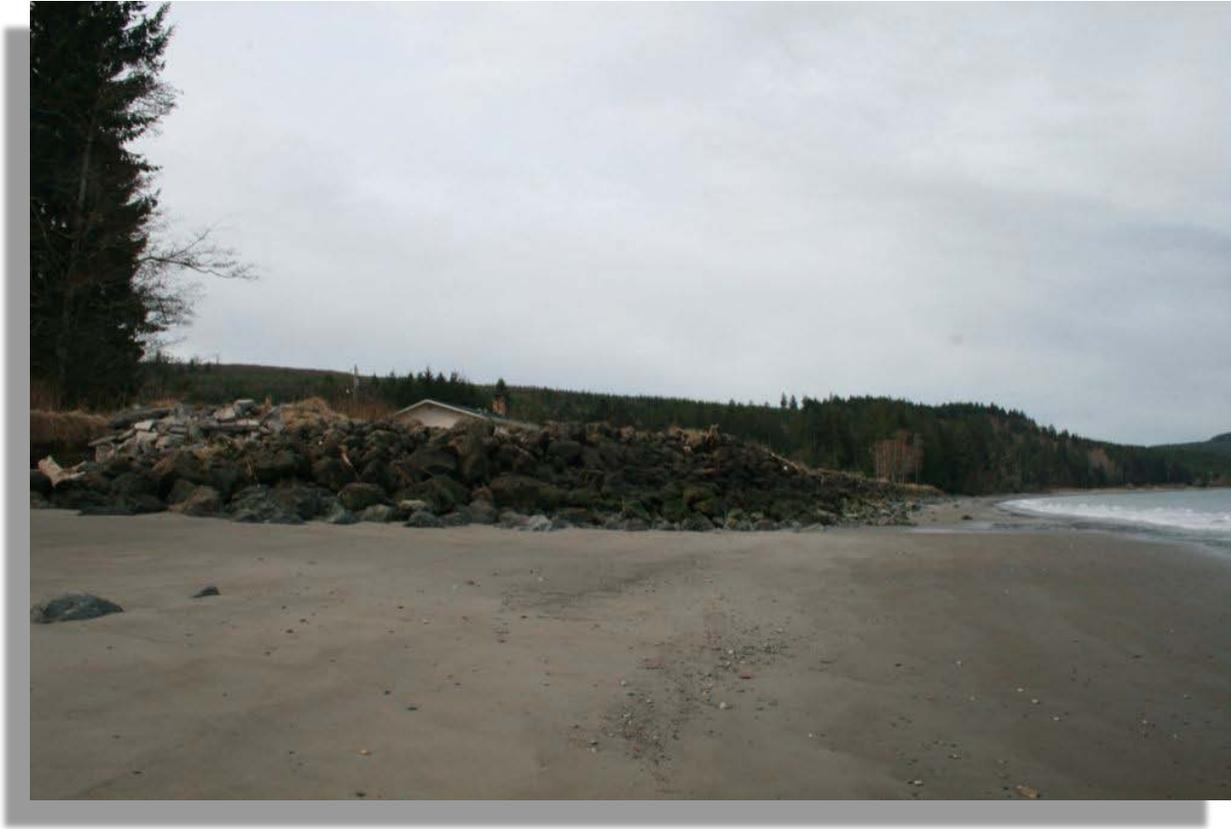
Figure 4-10. Riprap or “hard” shoreline armor and homes on the beach near the Hoko River (Photo by A. MacLennan)

Shoreland landowners whose homes are close to the shore along low beach areas may seek to construct bulkheads or other shoreline armoring structures to protect their property from wind and wave action (Figure 4-10). In addition, given the location of the underdeveloped properties, shoreline armoring may be necessary if future structures are built. An increase in shoreline armoring could negatively impact natural sediment transport and beach maintenance processes.

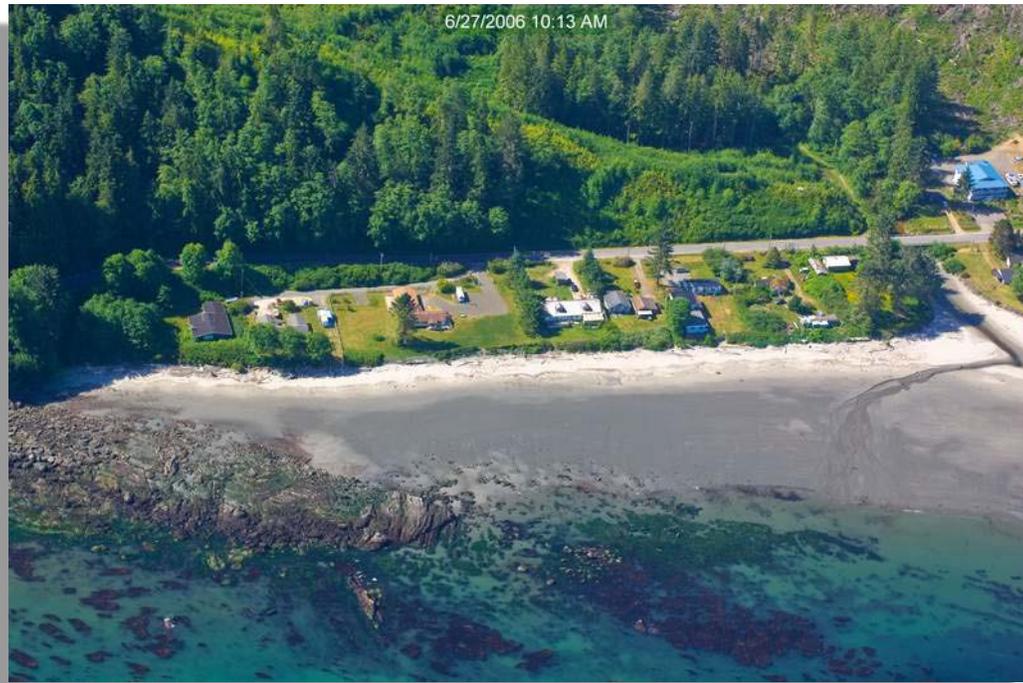
Figure 4-11. Pocket of residential development at Bullman Beach (Photo: Ecology Coastal Atlas)

Bullman Beach, and most of the homes are fairly close to the shoreline (approximately 50 feet) (Figure 4-11). A few of the homes are protected by shoreline armoring. The entire residential area is within mapped tsunami and coastal floodplain hazard areas.

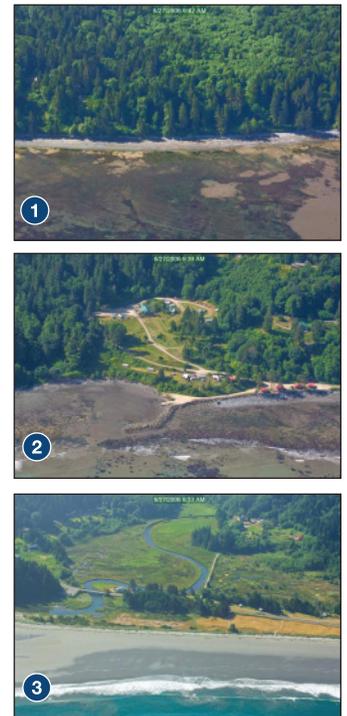
Shoreline Oblique Photos (Ecology, 2005)

Several bluff areas in the reach are unstable (11%) no with recent slides. Most of the Sekiu and Hoko River shoreline areas are in a tsunami hazard zone (70%) and FEMA coastal and stream 100-year floodplains (28%).

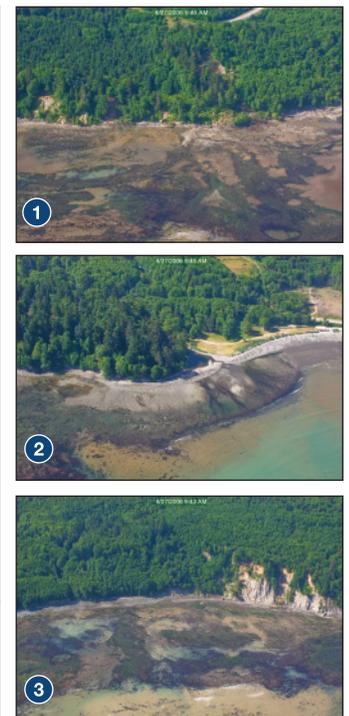
Shoreline Oblique Photos (Ecology, 2005)

Some slopes are mapped as unstable (33%) with recent slides mapped in the southeast portion of the reach and west of Bullman Creek (4%). Most of Snow and Bullman Creek shoreline areas are in a tsunami hazard zone (47%) and the FEMA coastal and stream 100-year floodplains (48%).

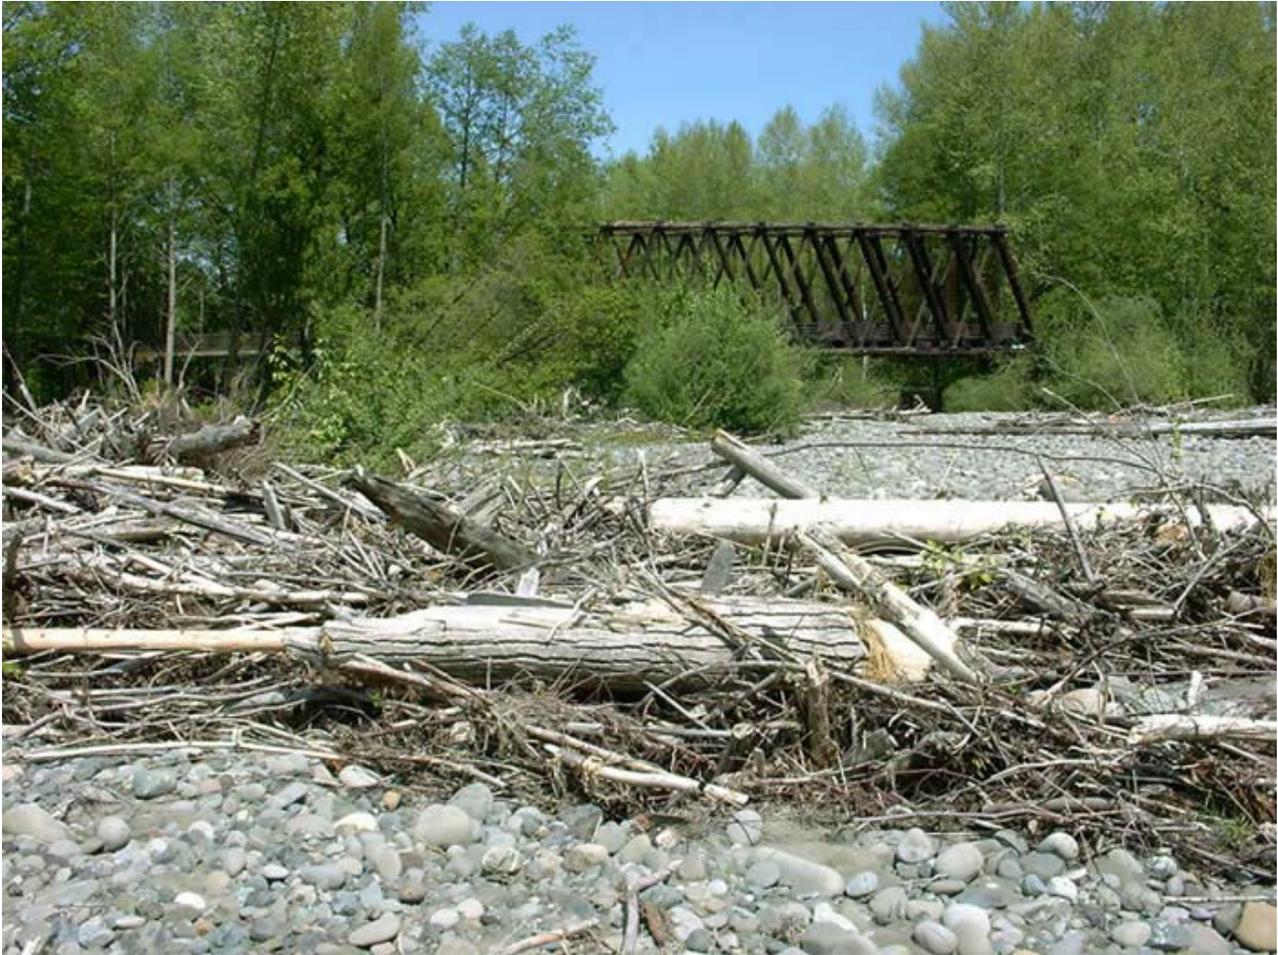
Figure 5-4. Large woody debris “recruited” from adjacent riparian forest (Photo: Dungeness River Audubon Center)

Organic material, including large woody debris, enters freshwater systems primarily via streambank erosion and treethrow/windthrow processes operating within roughly 200 feet of stream channels. These processes play a significant role in stream channel maintenance and in-stream habitat formation and are therefore critical to the health of freshwater systems. Woody debris adds roughness to the stream channel, which slows water velocities and traps sediment (Shirvell, 1990). Because coniferous logs are slower to decompose, they generally provide more benefit as large woody debris than deciduous species (May et al., 1997). Riparian forest cover is the primary source of organic / woody debris. According to some studies more than half of all large woody debris recruitment is from within 25 feet of streams, and about 90 percent comes from trees growing within about 50 feet of streams (Murphy and Koski, 1989; McDade et al., 1990; Van Sickle and Gregory, 1990). In addition, for larger streams that are prone to avulsion (such as the lower Dungeness River), large woody debris can be recruited from distances much greater than 50 feet. For these reasons, forested riparian buffers are essential for healthy streams (Figure 5-3).

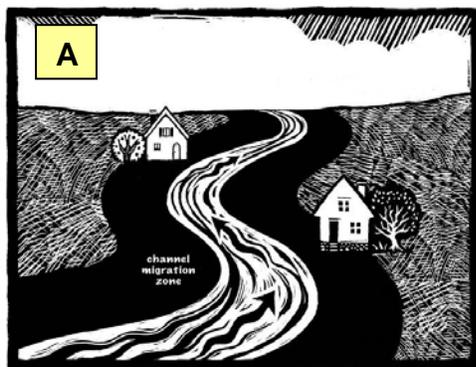
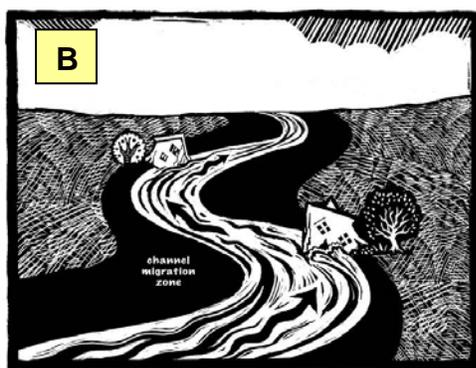
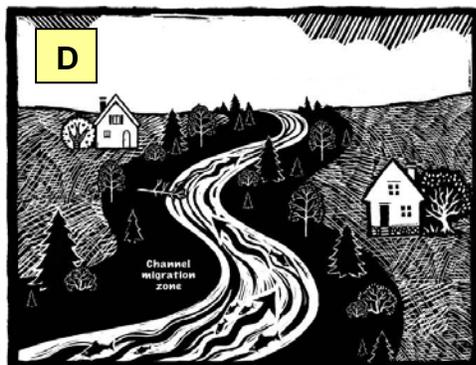
Figure 5-5a-d. Channel migration areas are potentially hazardous areas and development within these areas should be avoided to reduce safety risk and prevent ecological impacts (From the Dungeness Flood Hazard Management Plan; sketches by Amanda Kingsley, used with permission)

Channel migration is a natural process that has a dramatic effect on freshwater rivers and streams and the people who live near them (Figures 5 and 6). River channels naturally move across and sometimes outside of their mapped floodplains by eroding the outside banks of a meander bend, or through channel avulsion. This can create very hazardous situations for development within the channel migration zone (CMZ), which can be damaged or destroyed by gradual or sudden channel shifts (Figure 5-5b). Where vegetation along the river has been removed, the risk of channel migration is generally greater.

People often try to contain rivers within their channels by hardening the banks with riprap or other materials that resist erosion (Figure 5-5c). Bank hardening reduces the quality for the stream for salmon and other species and can accelerate the flow, transferring the erosive energy downstream and potentially creating problems for other property owners. Locating development outside of the CMZ and maintaining riparian vegetation along stream banks is a safer, less costly and ecologically preferred alternative (Figure 5-5d).

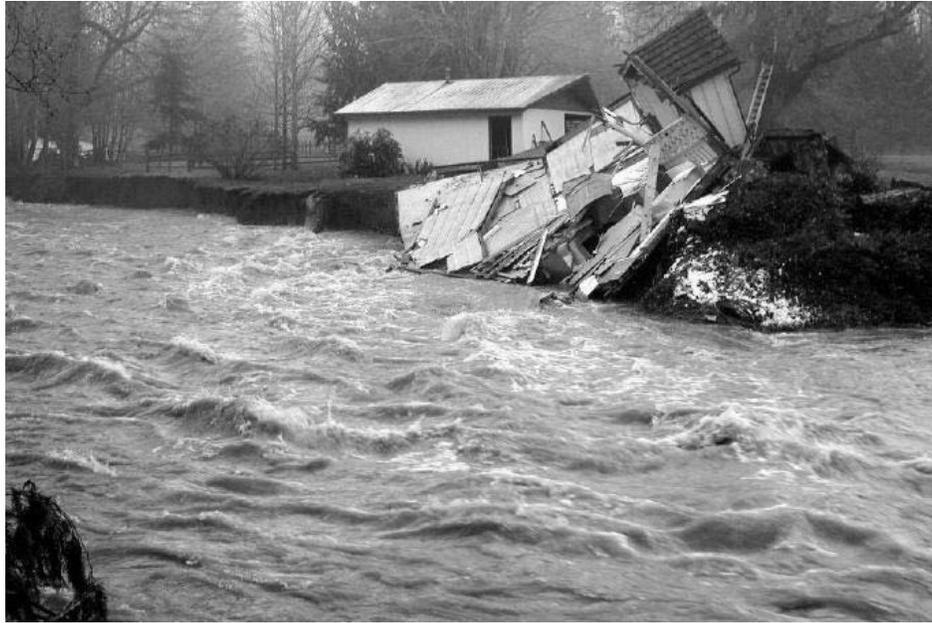
Figure 5-6. Dungeness River channel migration event (Photo: Randy Johnson)
