SHORELINE INVENTORY AND CHARACTERIZATION REPORT

**for Portions of Clallam County Draining to the Strait of Juan de
Fuca**

Clallam County Shoreline Master Program Update

March 2012

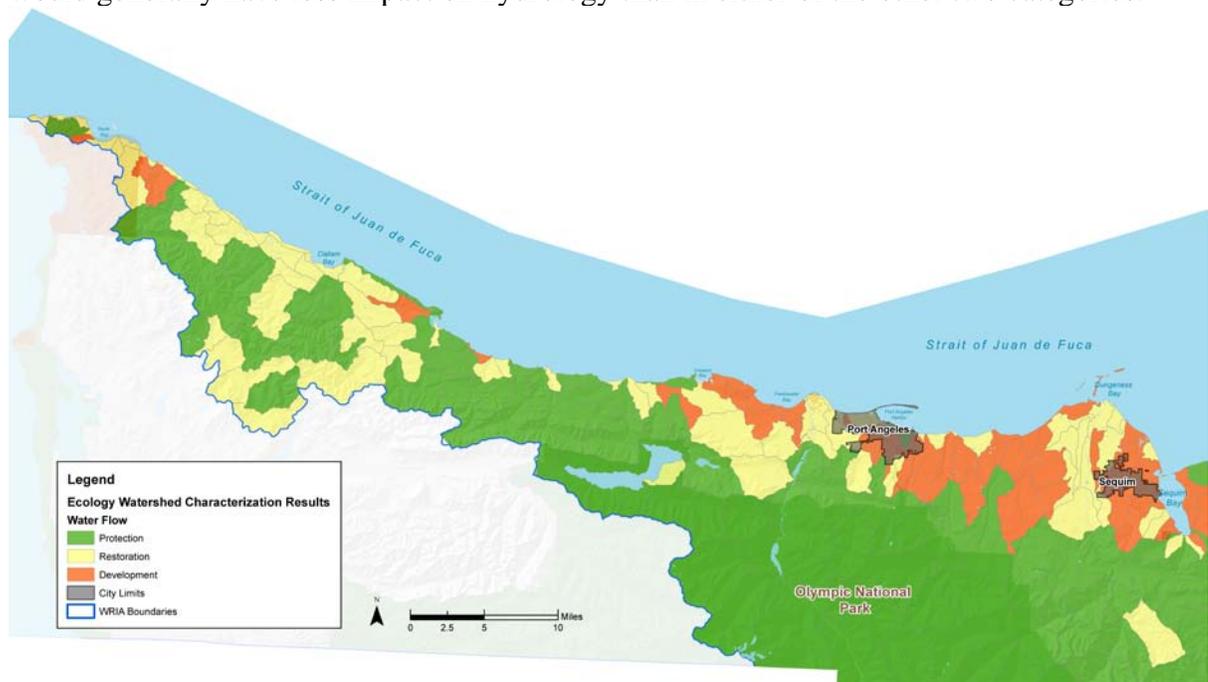
Figure 5-7. • Ecology’s relative ranking of the water flow processes for each sub basin draining to the Strait of Juan de Fuca

- Protection – these sub basins are highly important in terms of infiltration, recharge, water storage and other natural water flow processes and have minimal alteration. Protection of the existing conditions is a high priority.
- Restoration – these sub basins areas are also very important to natural hydrology, but have experienced alteration. Restoration in these areas could help to increase ecological process and functions.
- Development – these sub basins are less important—on a relative scale—for hydrology processes and they have been moderately to highly altered. Development in these areas would generally have less impact on hydrology than in either of the other two categories.

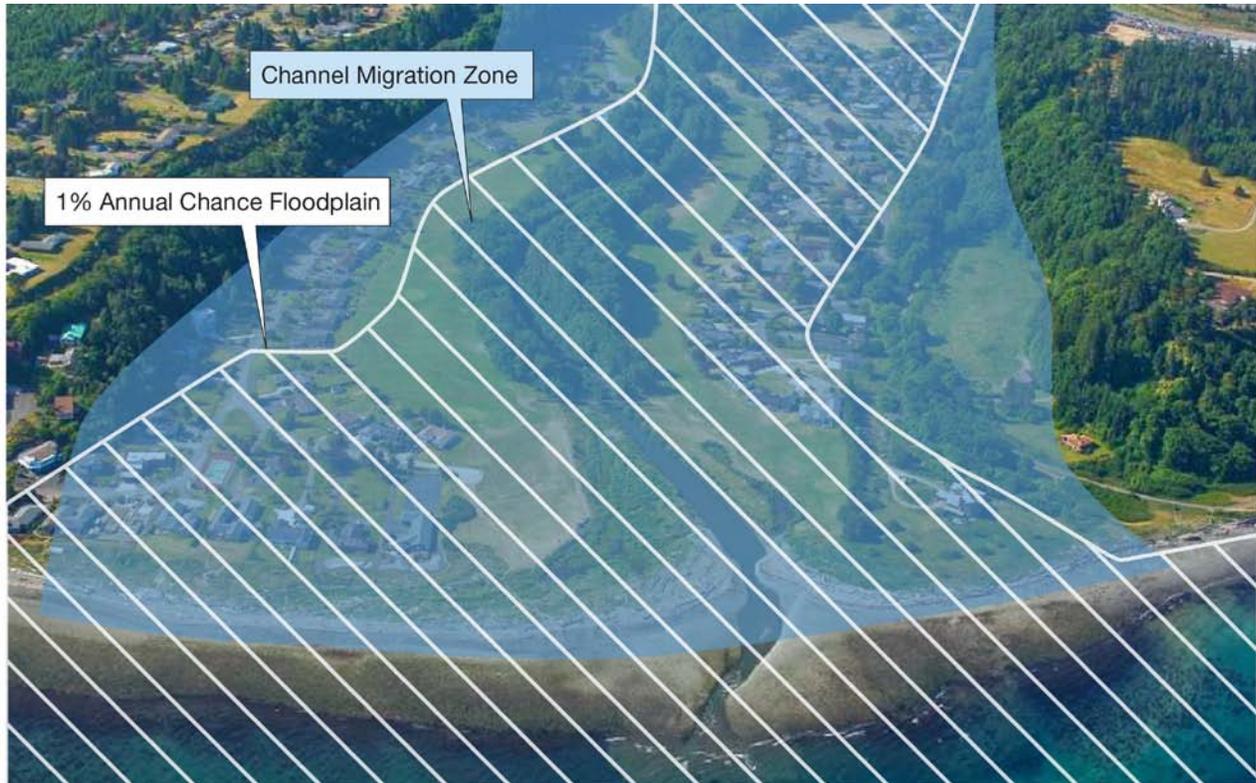
Figure 6-3. Channel migration zone and floodplain with existing development on Morse Creek

Much of the upper portion of the Morse Creek riparian corridor lies within identified erosion and landslide hazard areas. These hazard areas generally contain dense forest cover. Channel migration zones and FEMA-mapped flood hazard areas are present along the lower portion of Morse Creek, where the creek passes through a broad, low-gradient floodplain. Many homes are present within these hazard areas (Figure 6-3).

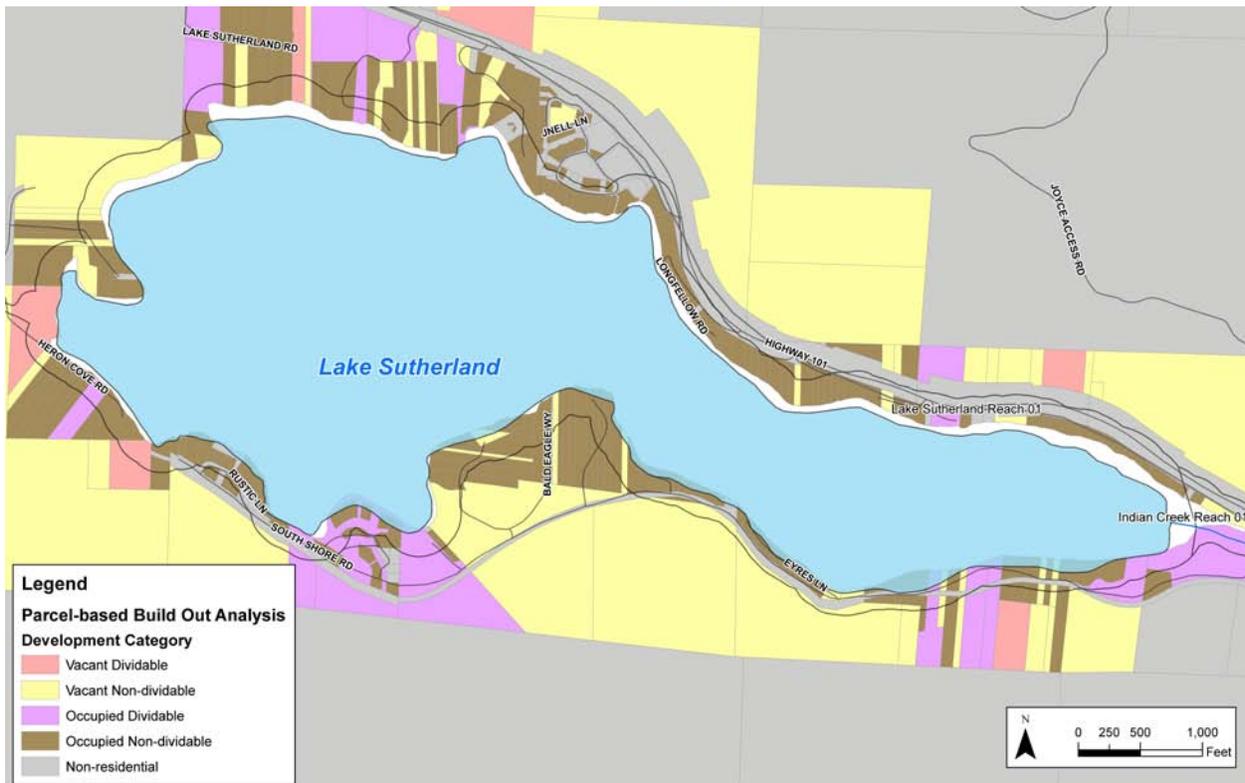
Figure 6-5. Existing and potential future development patters at Lake Sutherland. Brown and yellow parcels are not subdividable.

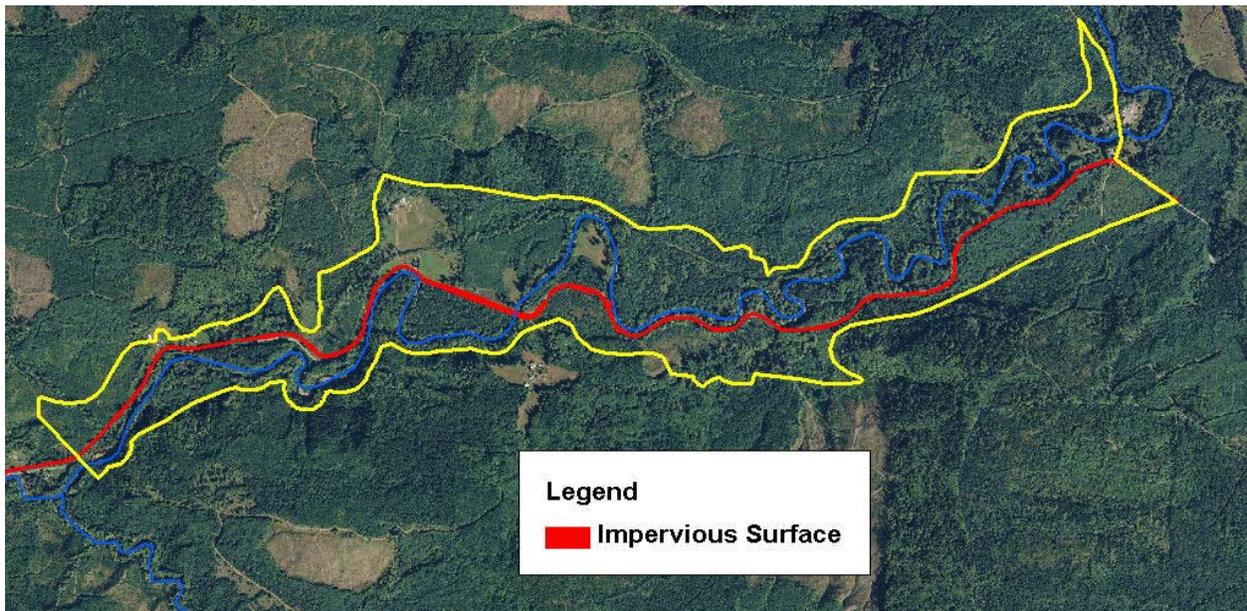
Figure 6-6. Impervious surface along the middle reach of the Pysht River

The Pysht River has a high degree of documented floodplain impacts per stream mile compared to other rivers in WRIA 19 (Clallam County 2008). The two greatest impacts are associated with Highway 112 (on the right bank RM 2 to RM 8.4) and a railroad grade (on the left bank in the lower reaches) (Figure 6-6). These two impediments increase channel instability by acting as dikes, contribute to sediment, and reduce access to juvenile rearing habitat. Further upstream the Crown Zellerbach Road impacts the floodplain from RM 9.8 to RM 11.5. As a result of road and railroad grades within the floodplain, side-channel habitat in the mainstem Pysht has been significantly impaired and poses a threat to continued production of anadromous fish within the watershed.

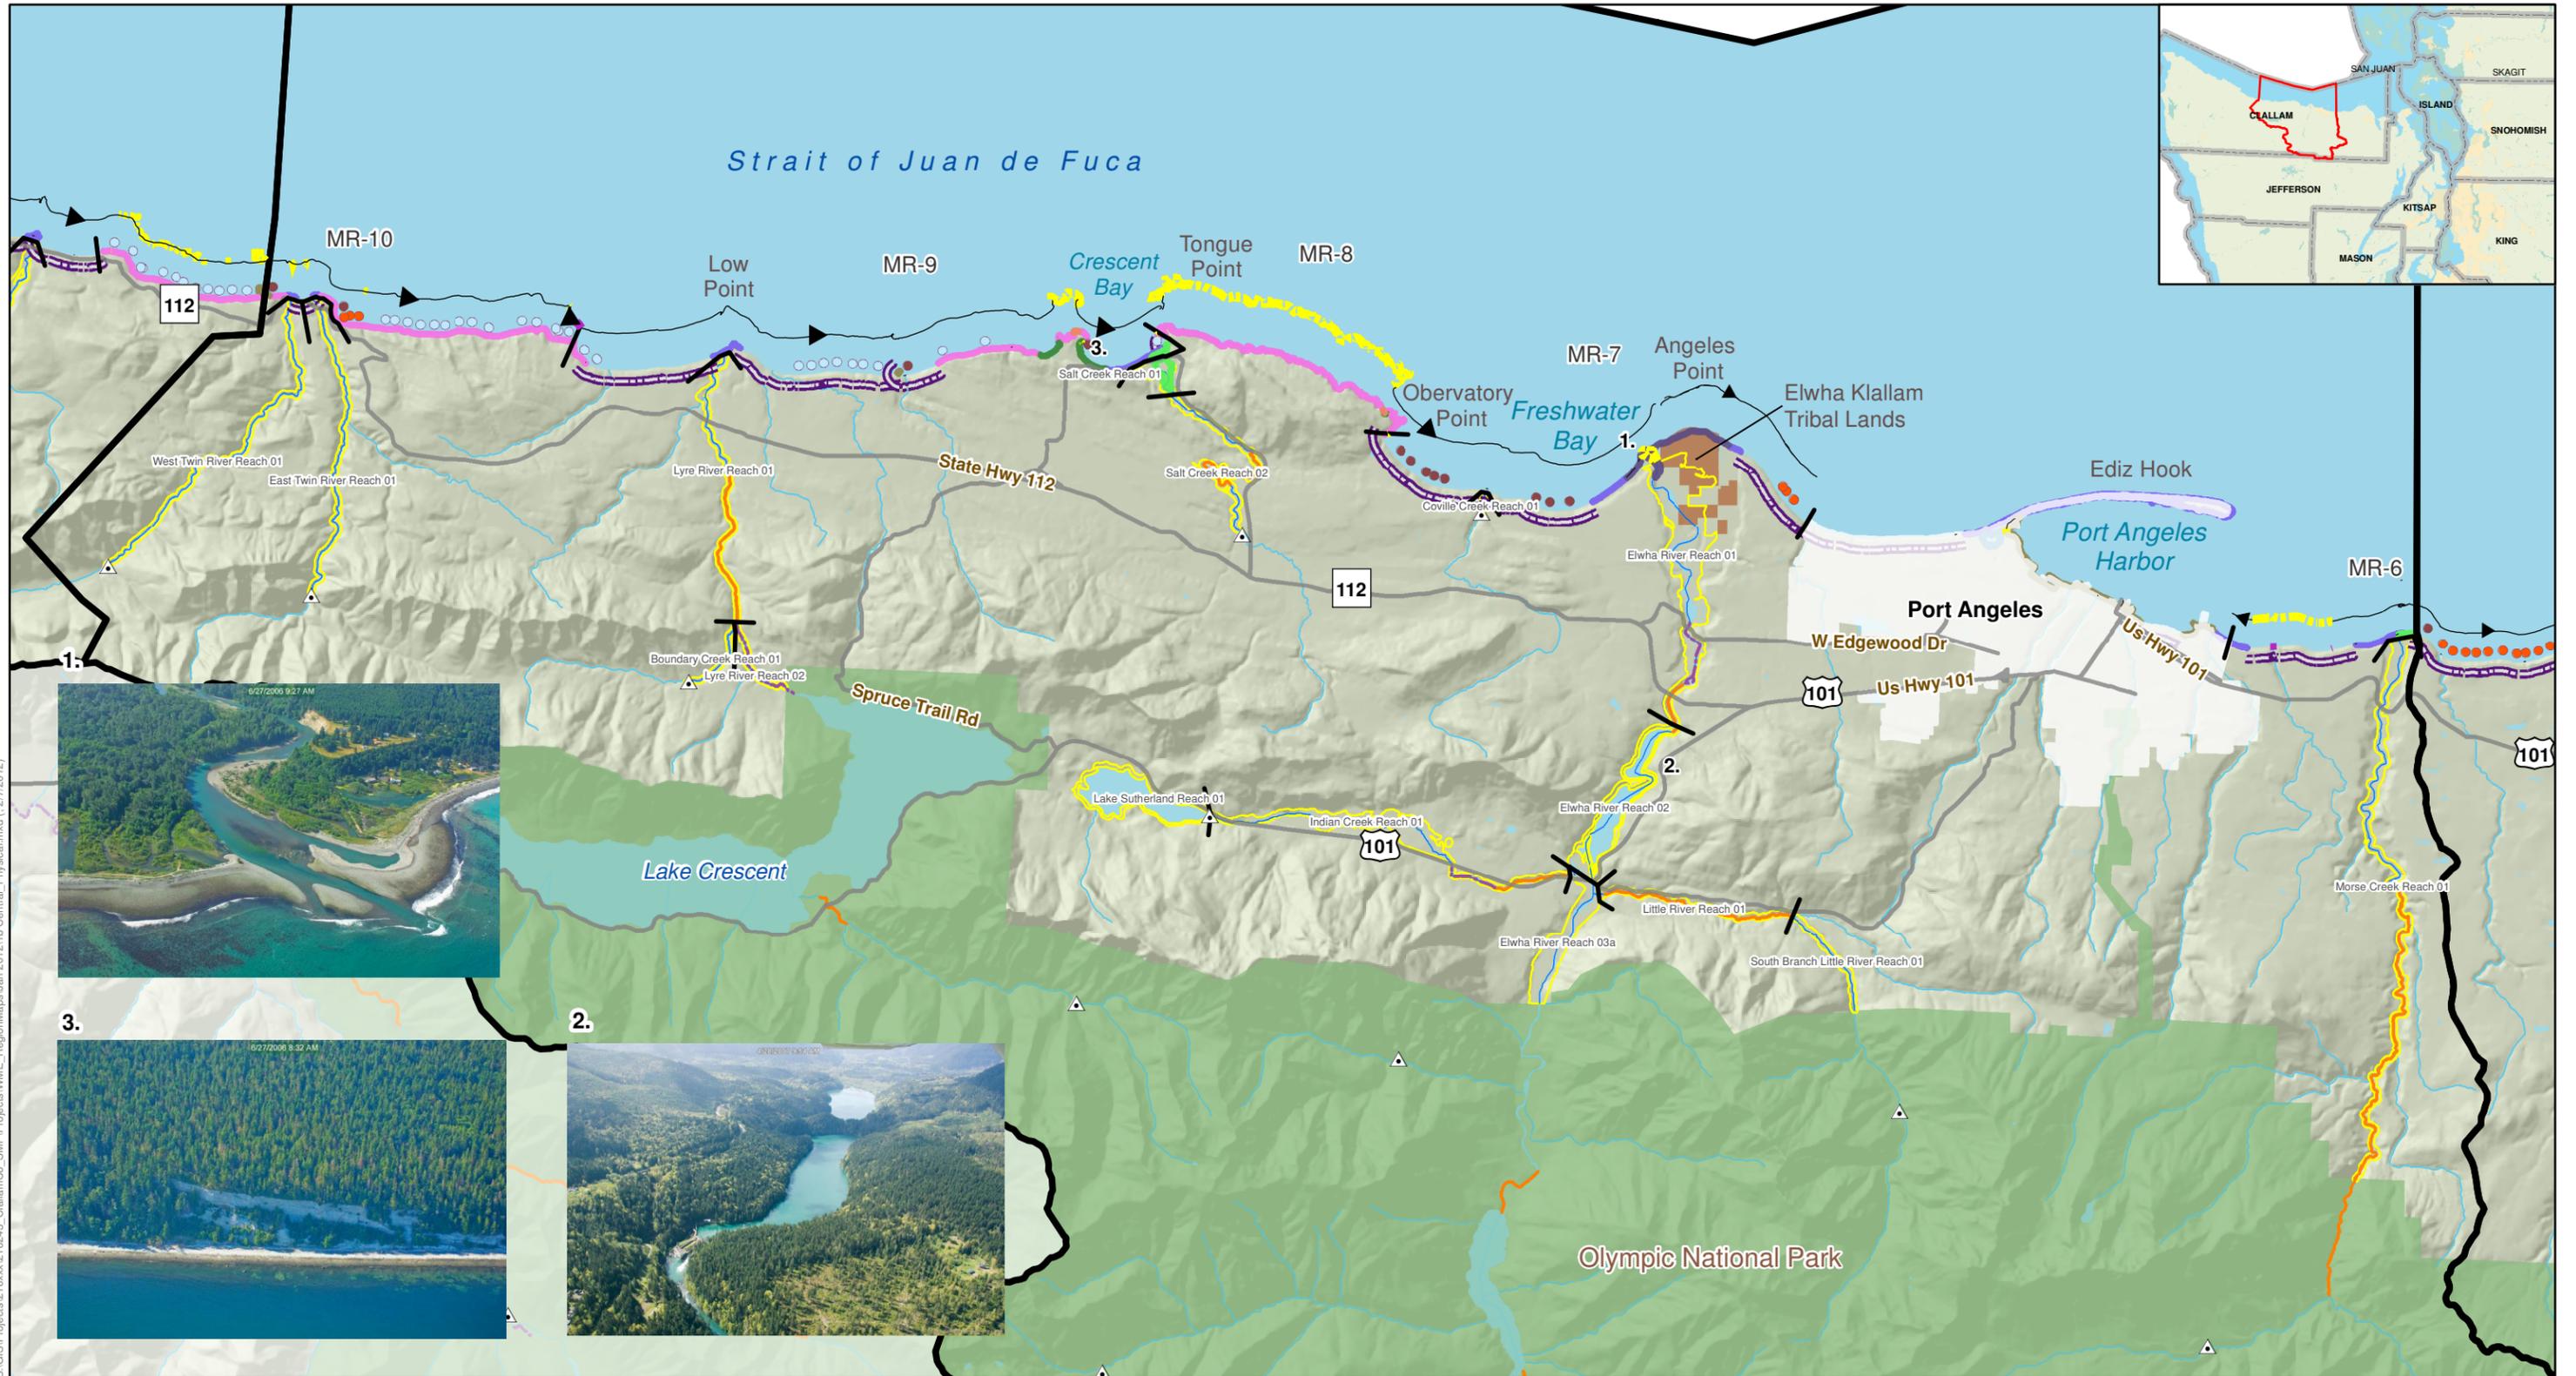
CLALLAM COUNTY
Central Region - Shoreline Master
Program (SMP) Update
Map 1b - Physical Characteristics

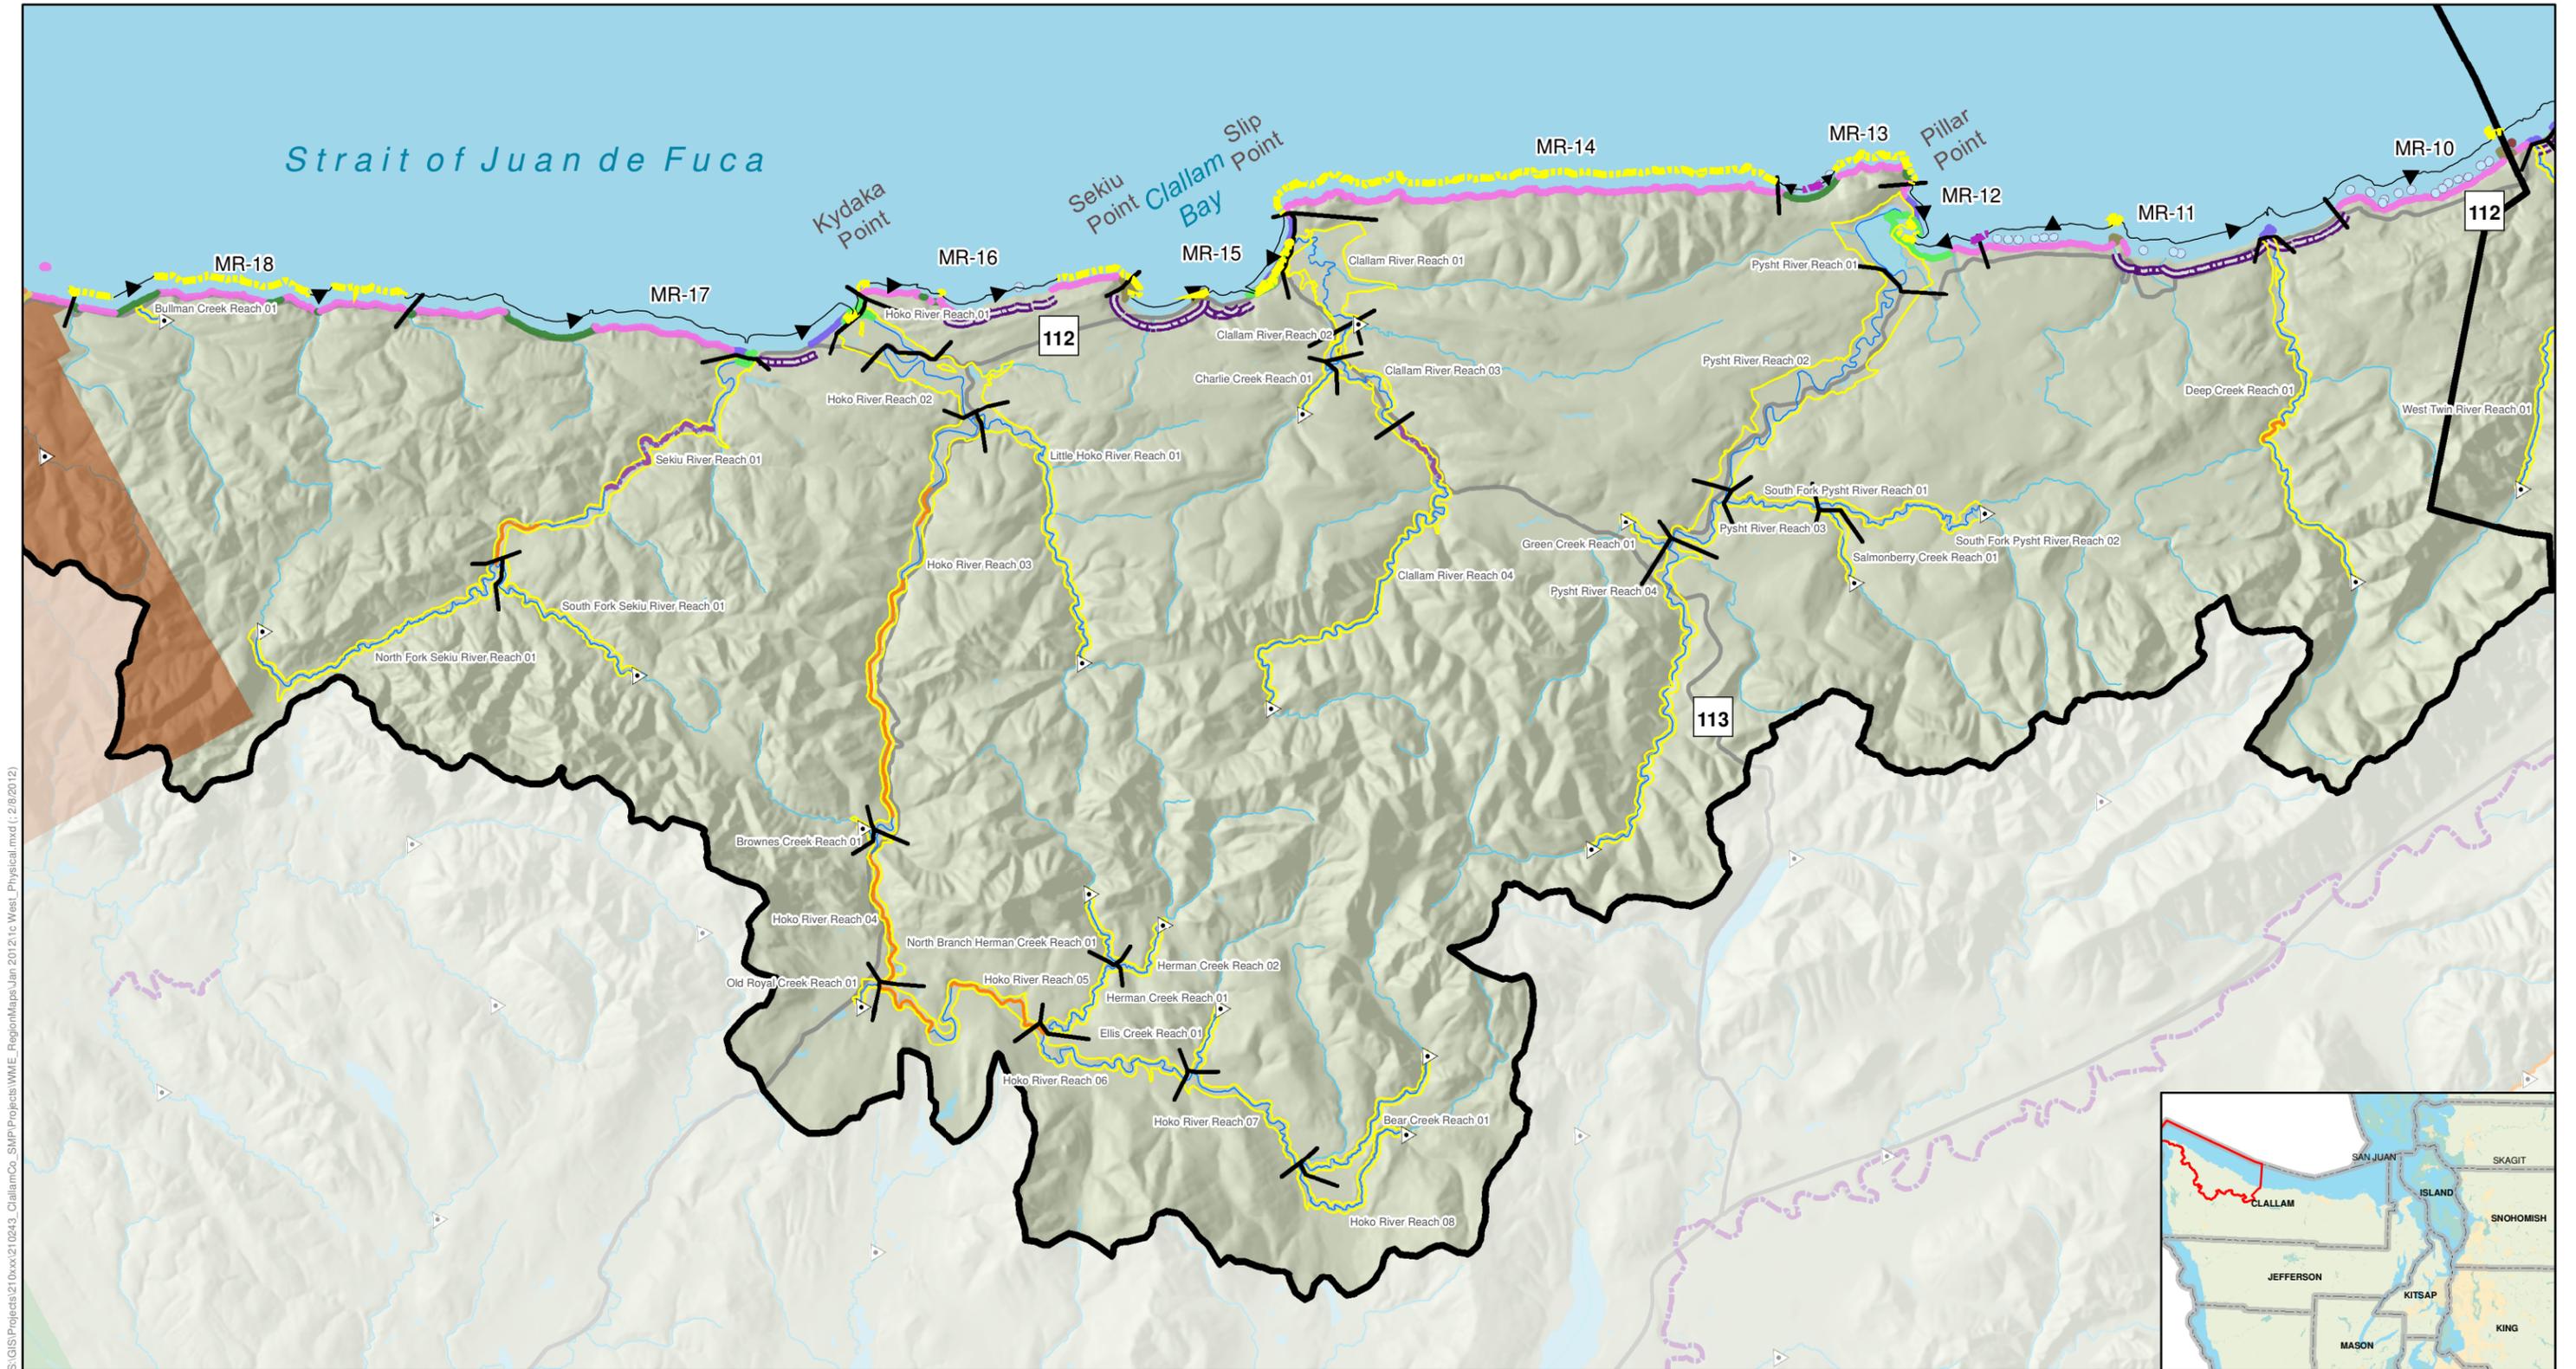
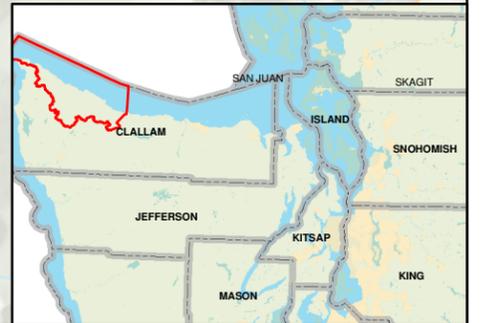
CLALLAM COUNTY
West Region - Shoreline Master
Program (SMP) Update
Map 1c - Physical Characteristics

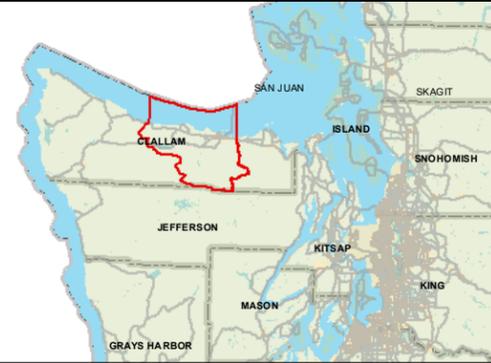
CLALLAM COUNTY
Central Region - Shoreline Master
Program (SMP) Update
Map 2b - Hazard Areas

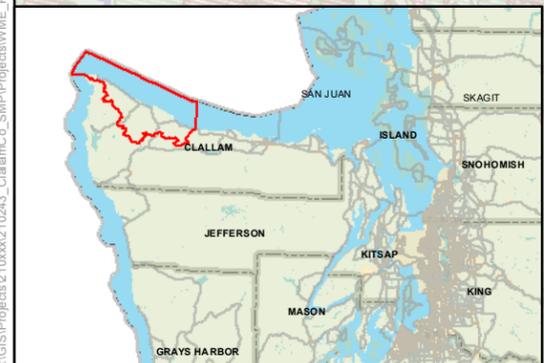
CLALLAM COUNTY
West Region - Shoreline Master
Program (SMP) Update
Map 2c - Hazard Areas

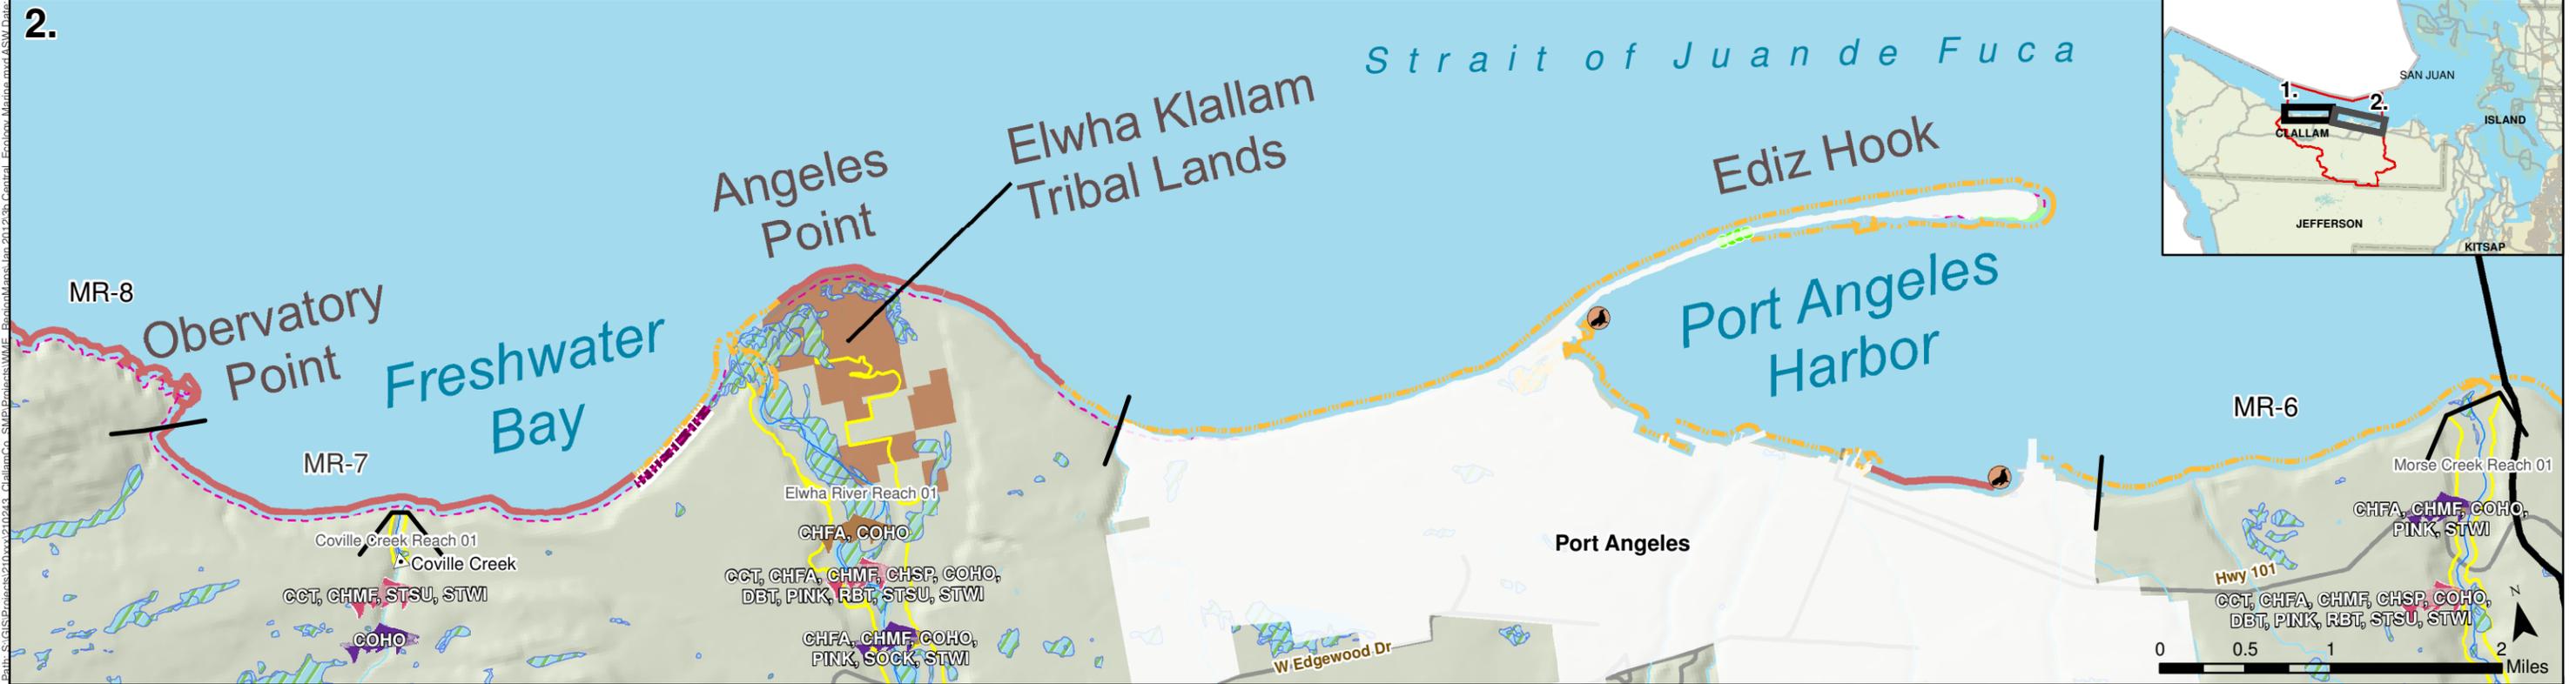
CLALLAM COUNTY
Central Region - Shoreline Master
Program (SMP) Update
Map 3b - Marine Ecological Characteristics

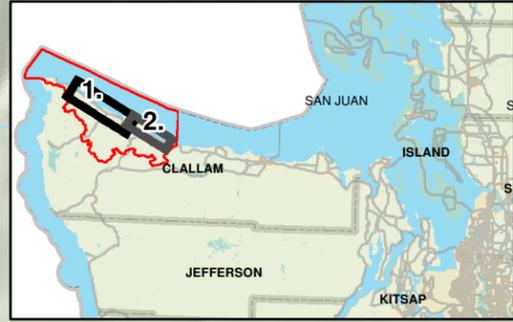
CLALLAM COUNTY
West Region - Shoreline Master
Program (SMP) Update
Map 3c - Marine Ecological Characteristics

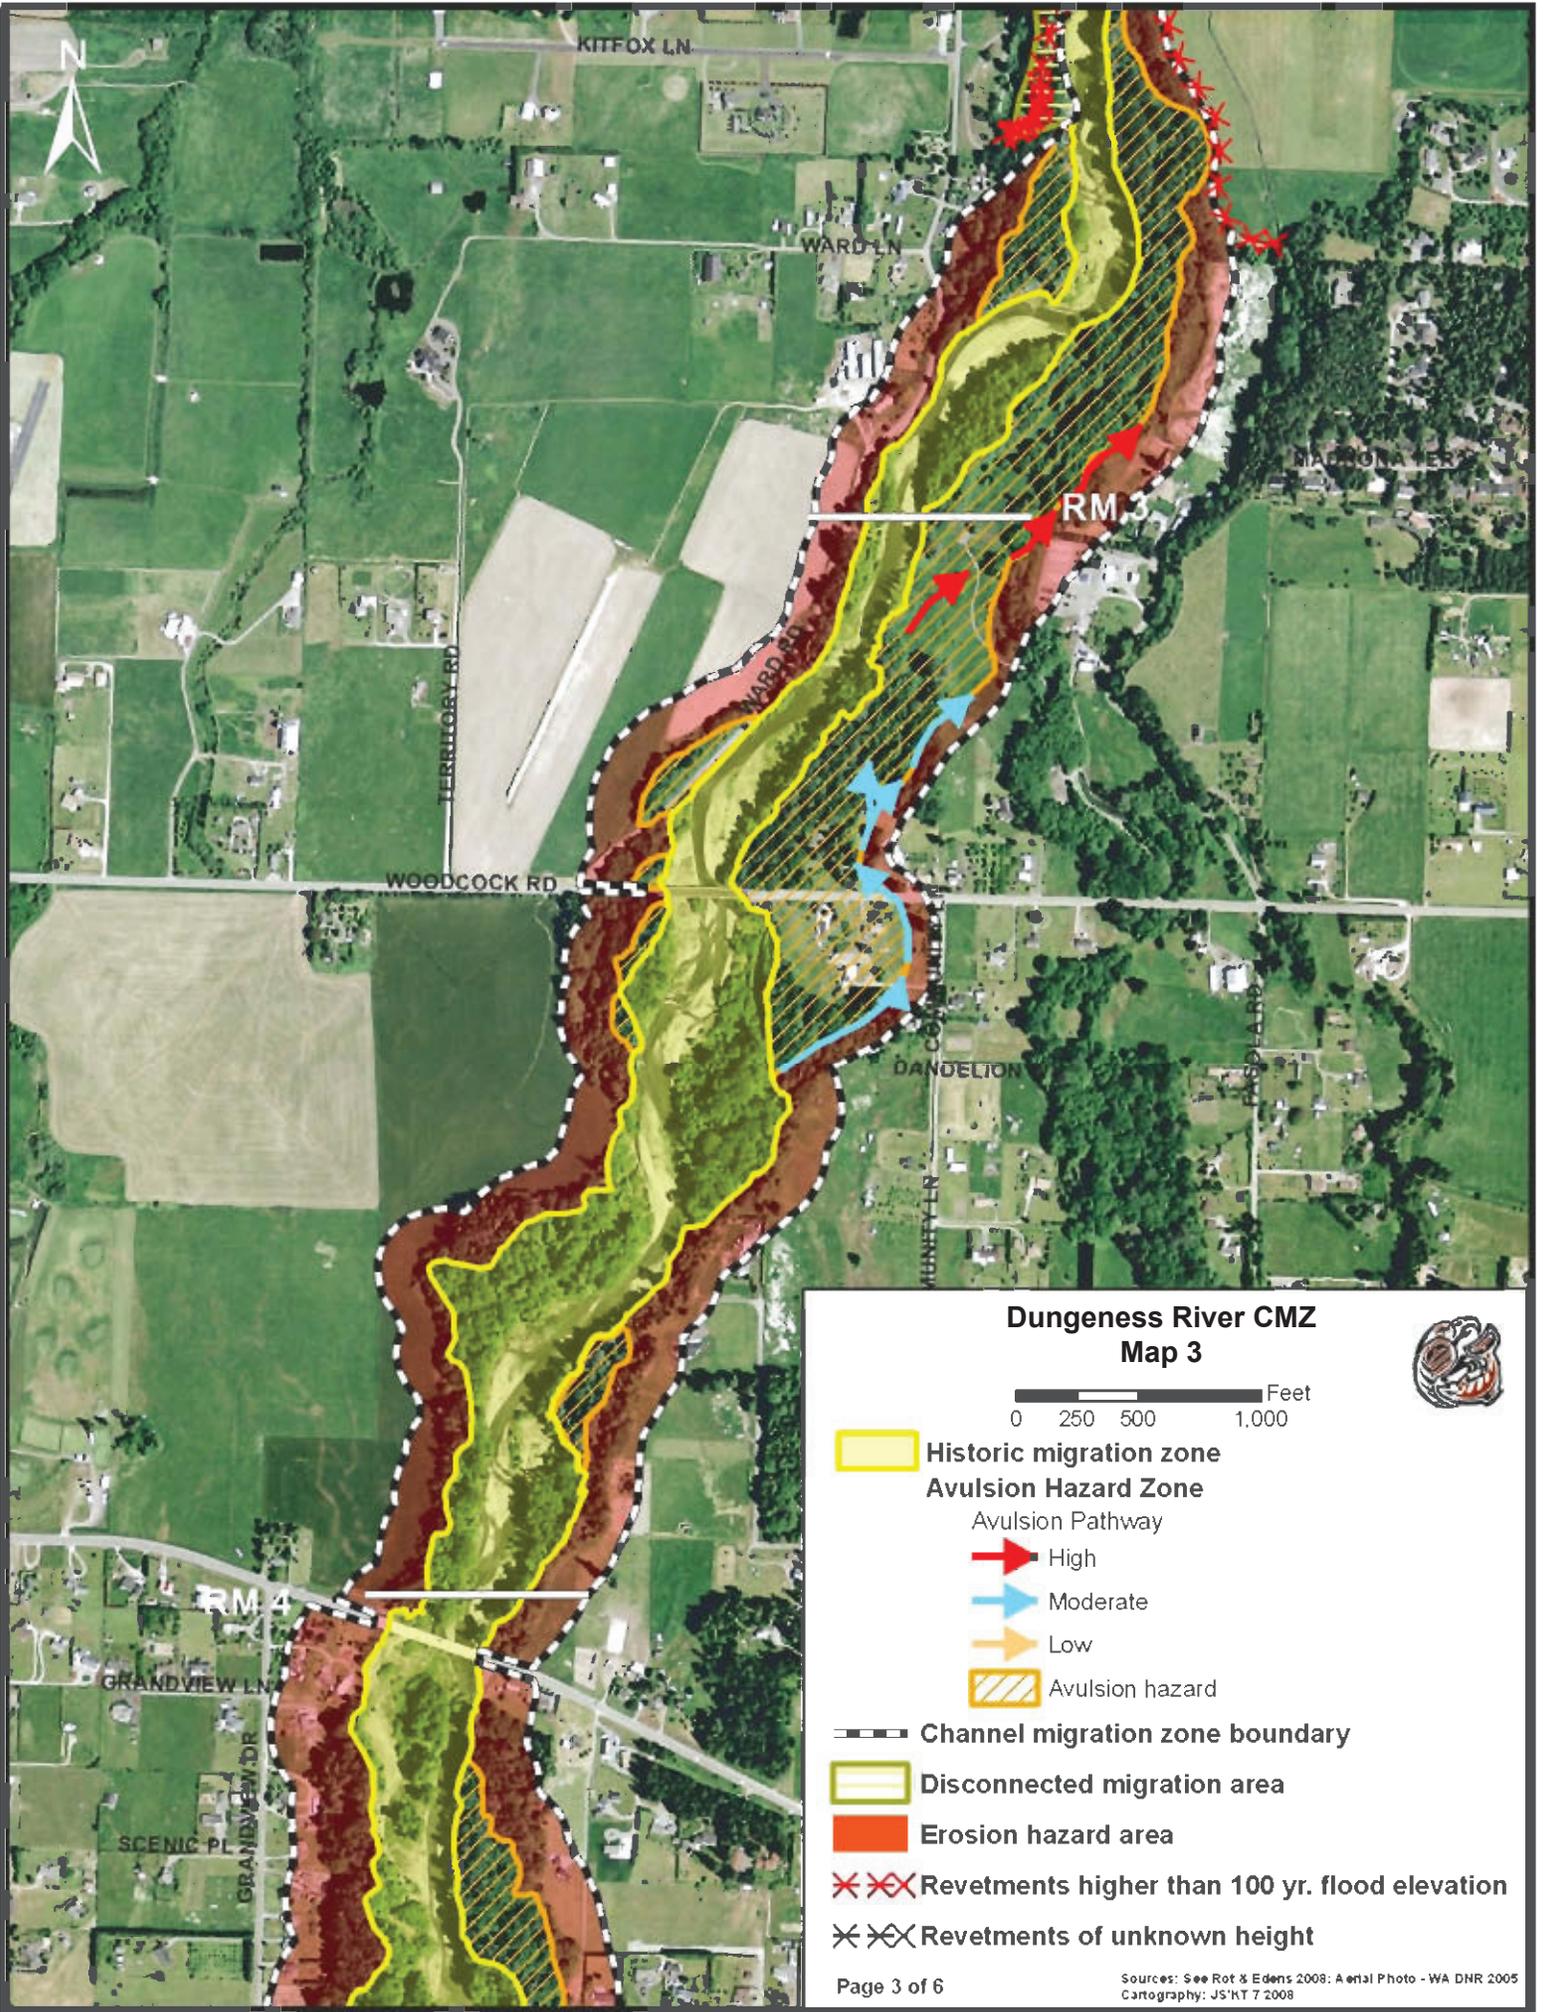
**Dungeness River CMZ
Map 3**

- Historic migration zone
- Avulsion Hazard Zone**
- Avulsion Pathway
- High risk
- Moderate risk
- Low risk
- Avulsion hazard

- Channel migration zone boundary
- Disconnected migration area
- Erosion hazard area

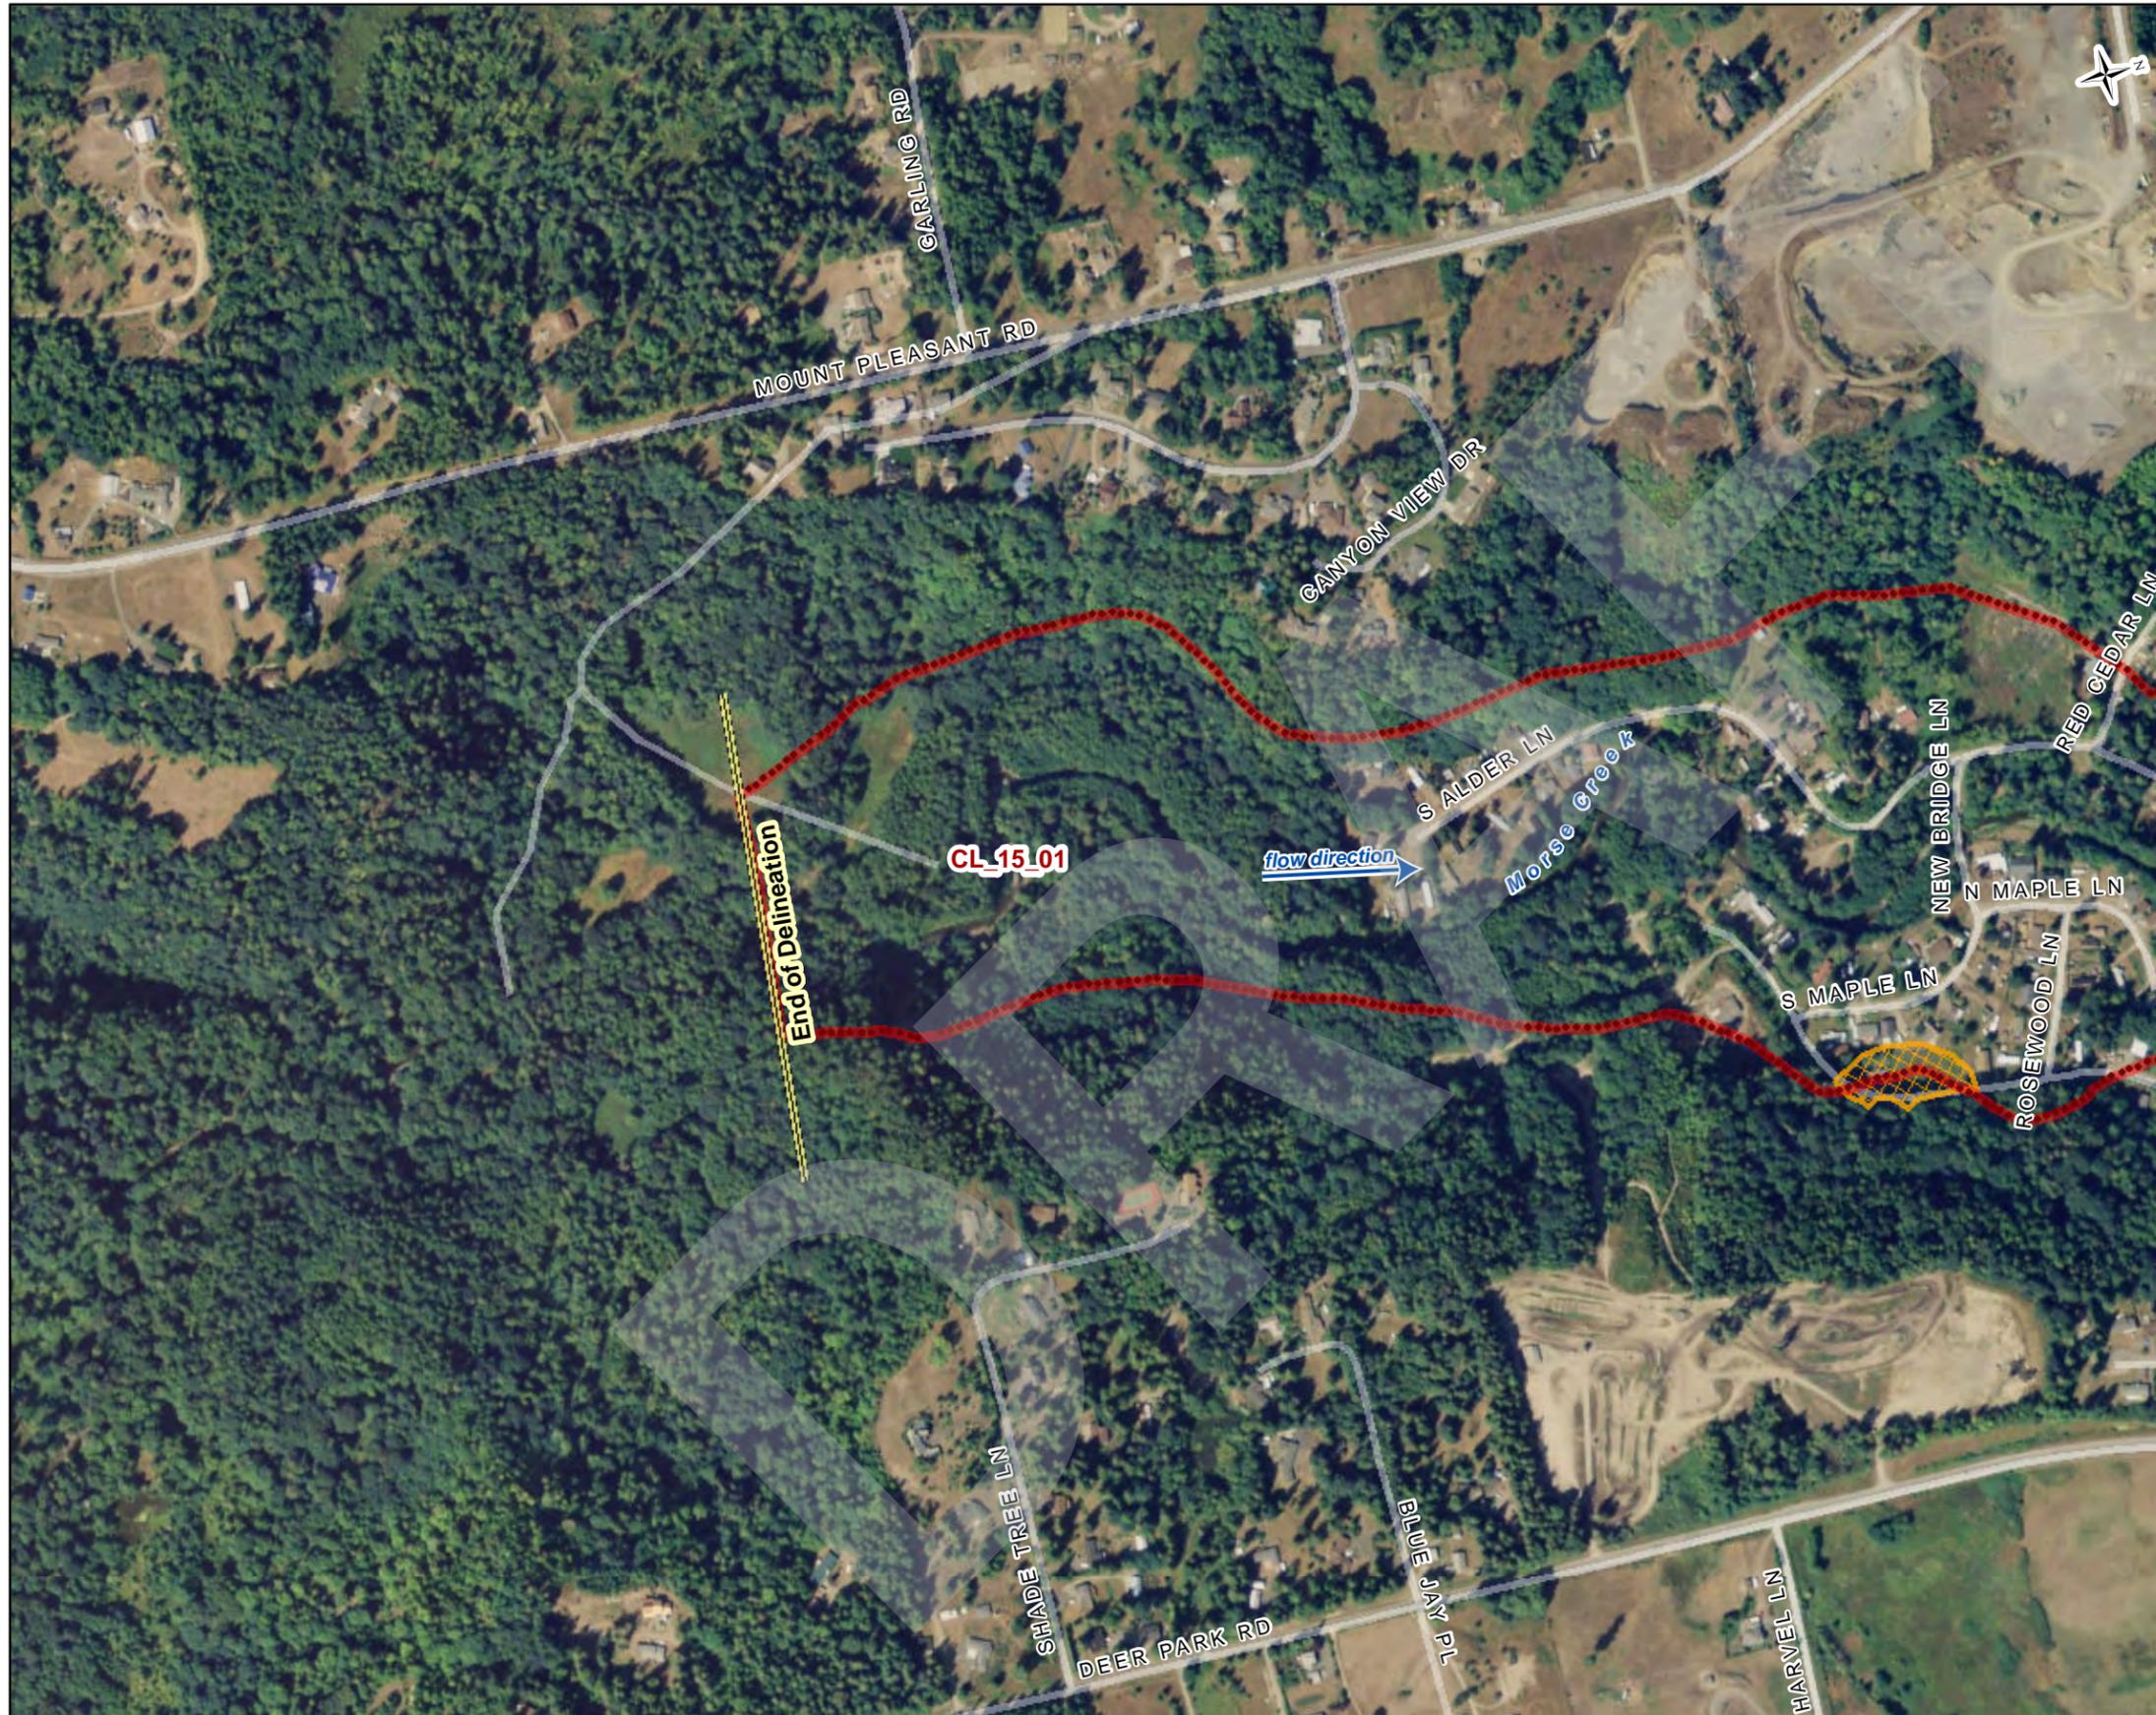
Morse Creek **Map 49**

2004 LIDAR topography (Puget Sound LIDAR Consortium).
 10 m USGS Hillshade
 2006 and 2009 aerials from ESRI World Imagery
 WA State Dept of Nat. Resources 1:100,000 Geology
 River miles calculated from NHD stream alignment (USGS)
 Roads from TIGER (US Census Bureau)
 Coordinate System: State Plane Washington North
