SHORELINE INVENTORY AND CHARACTERIZATION REPORT

**for Portions of Clallam County Draining to the Strait of Juan de
Fuca**

Clallam County Shoreline Master Program Update

March 2012

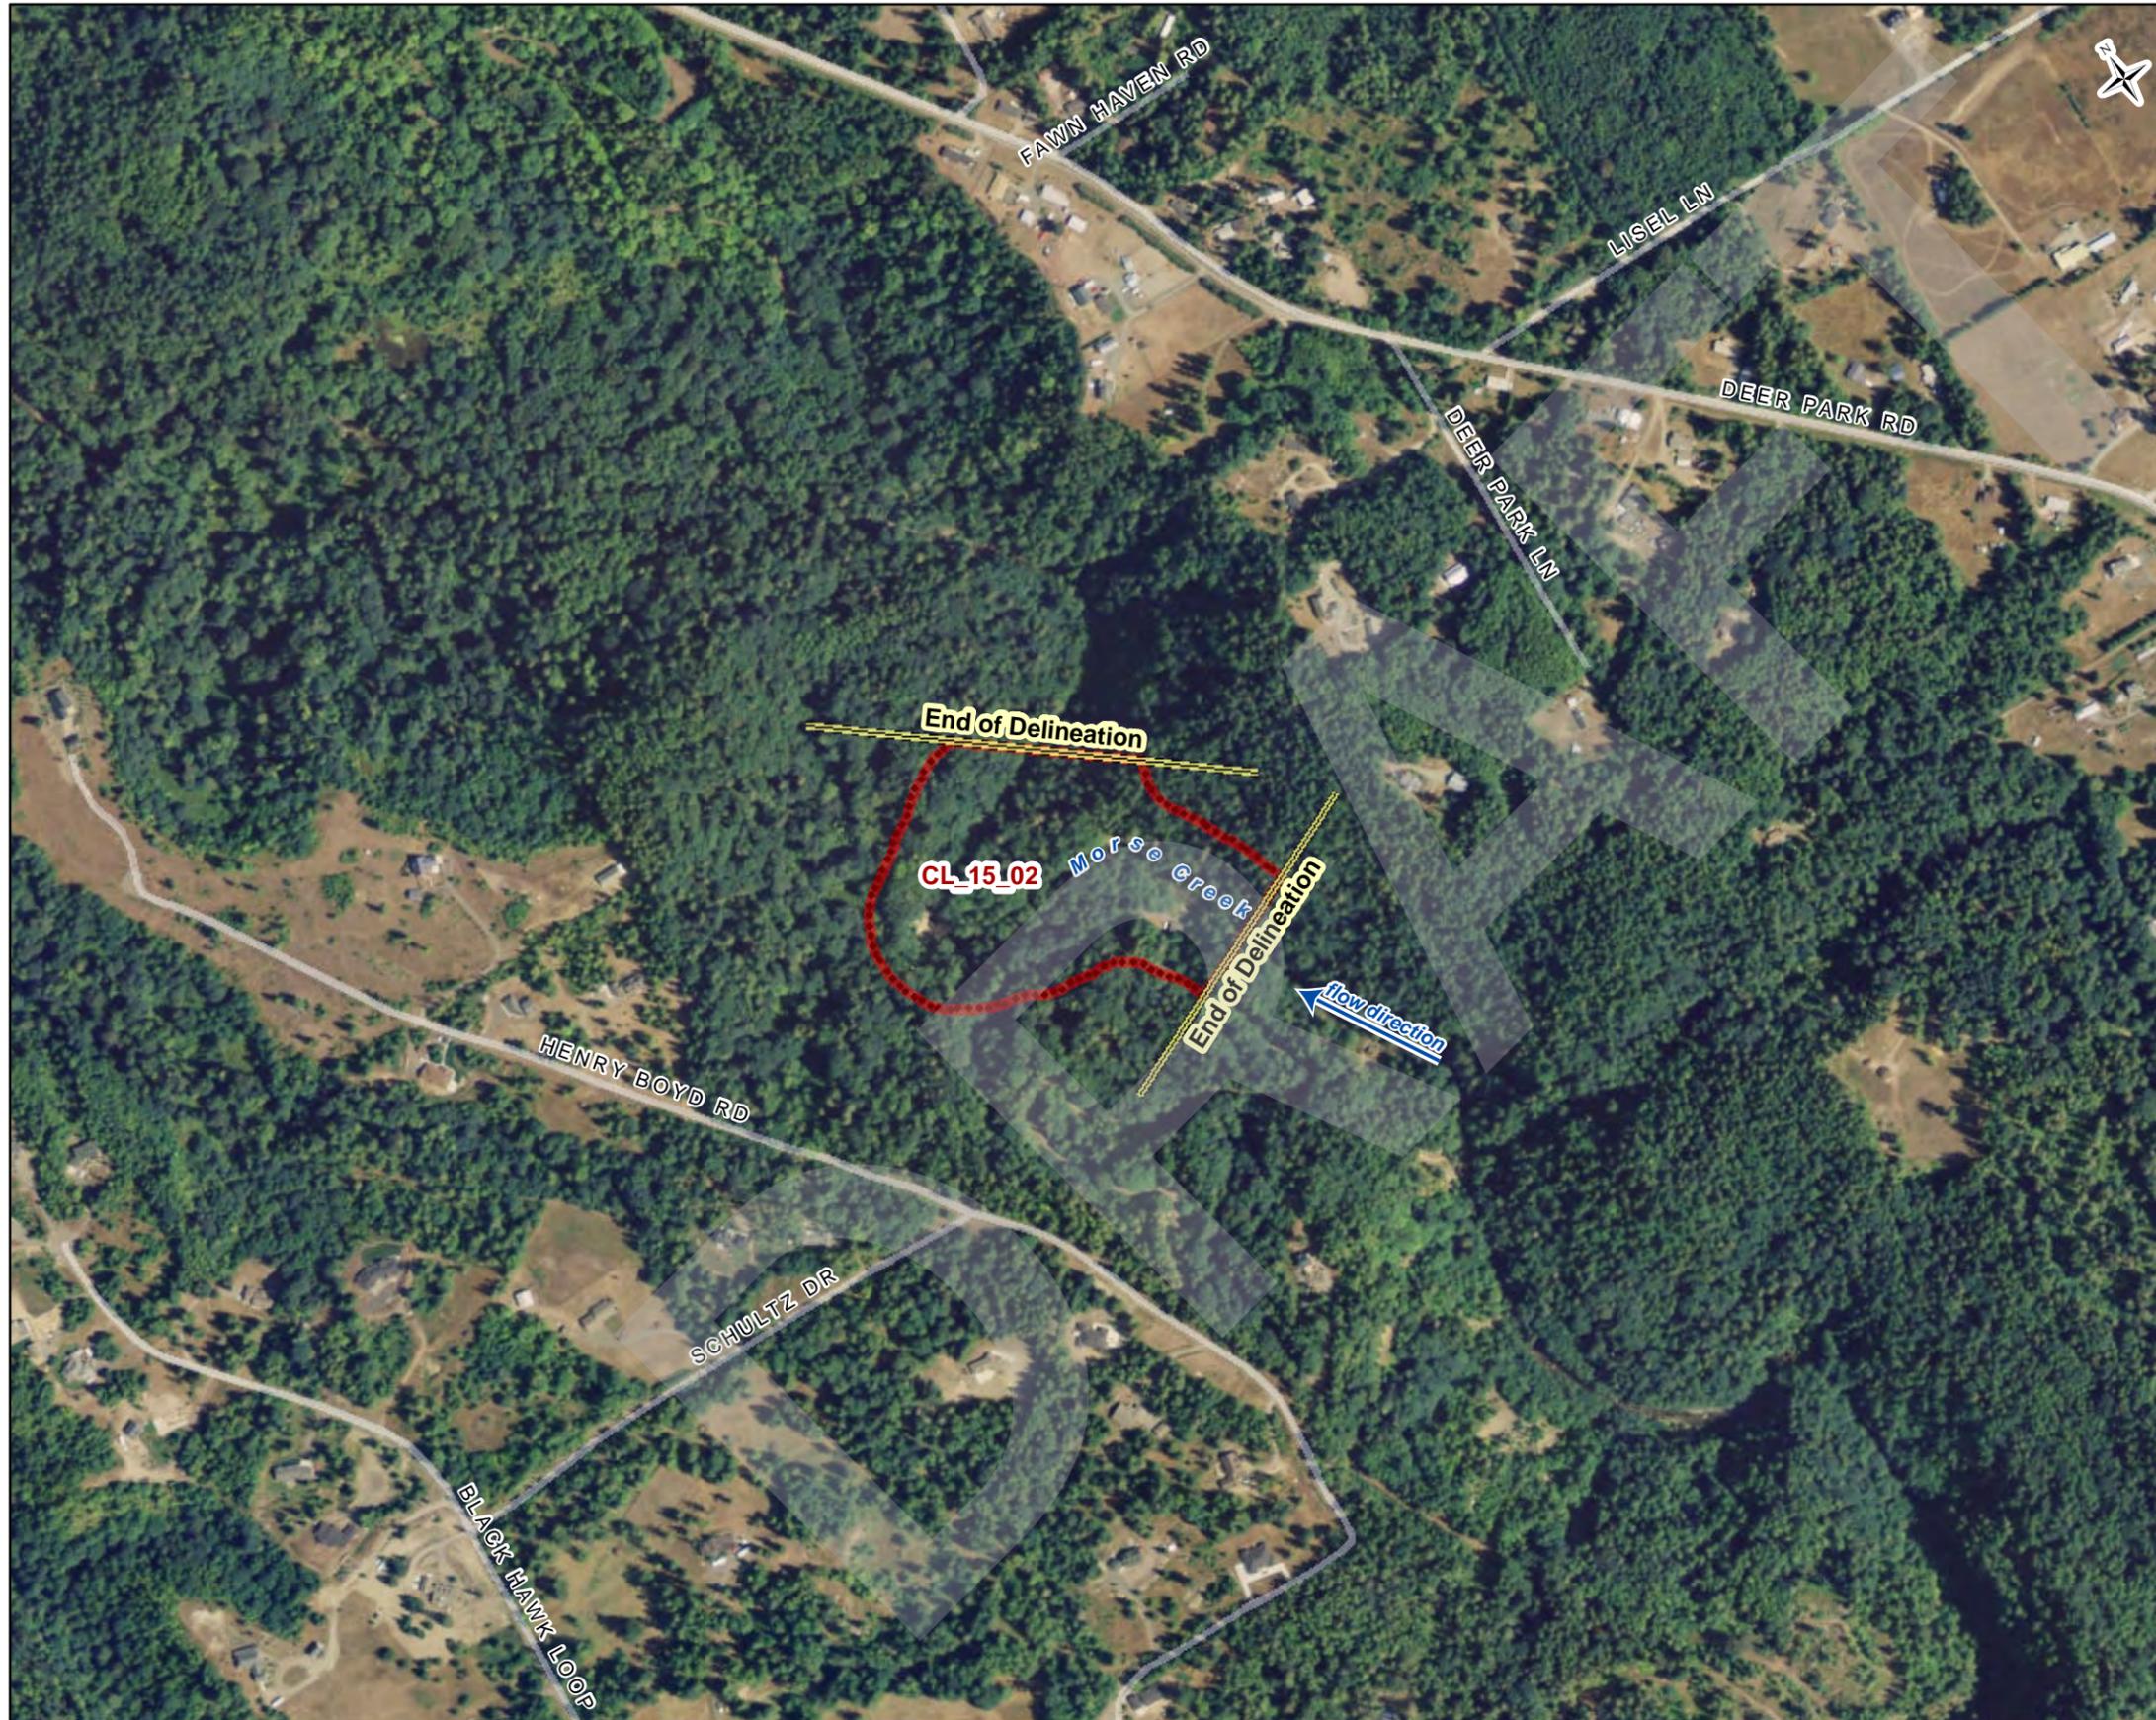
Map 50

2004 LIDAR topography (Puget Sound LIDAR Consortium).
 10 m USGS Hillshade
 2006 and 2009 aeriels from ESRI World Imagery
 WA State Dept of Nat. Resources 1:100,000 Geology
 River miles calculated from NHD stream alignment (USGS)
 Roads from TIGER (US Census Bureau)
 Coordinate System: State Plane Washington North

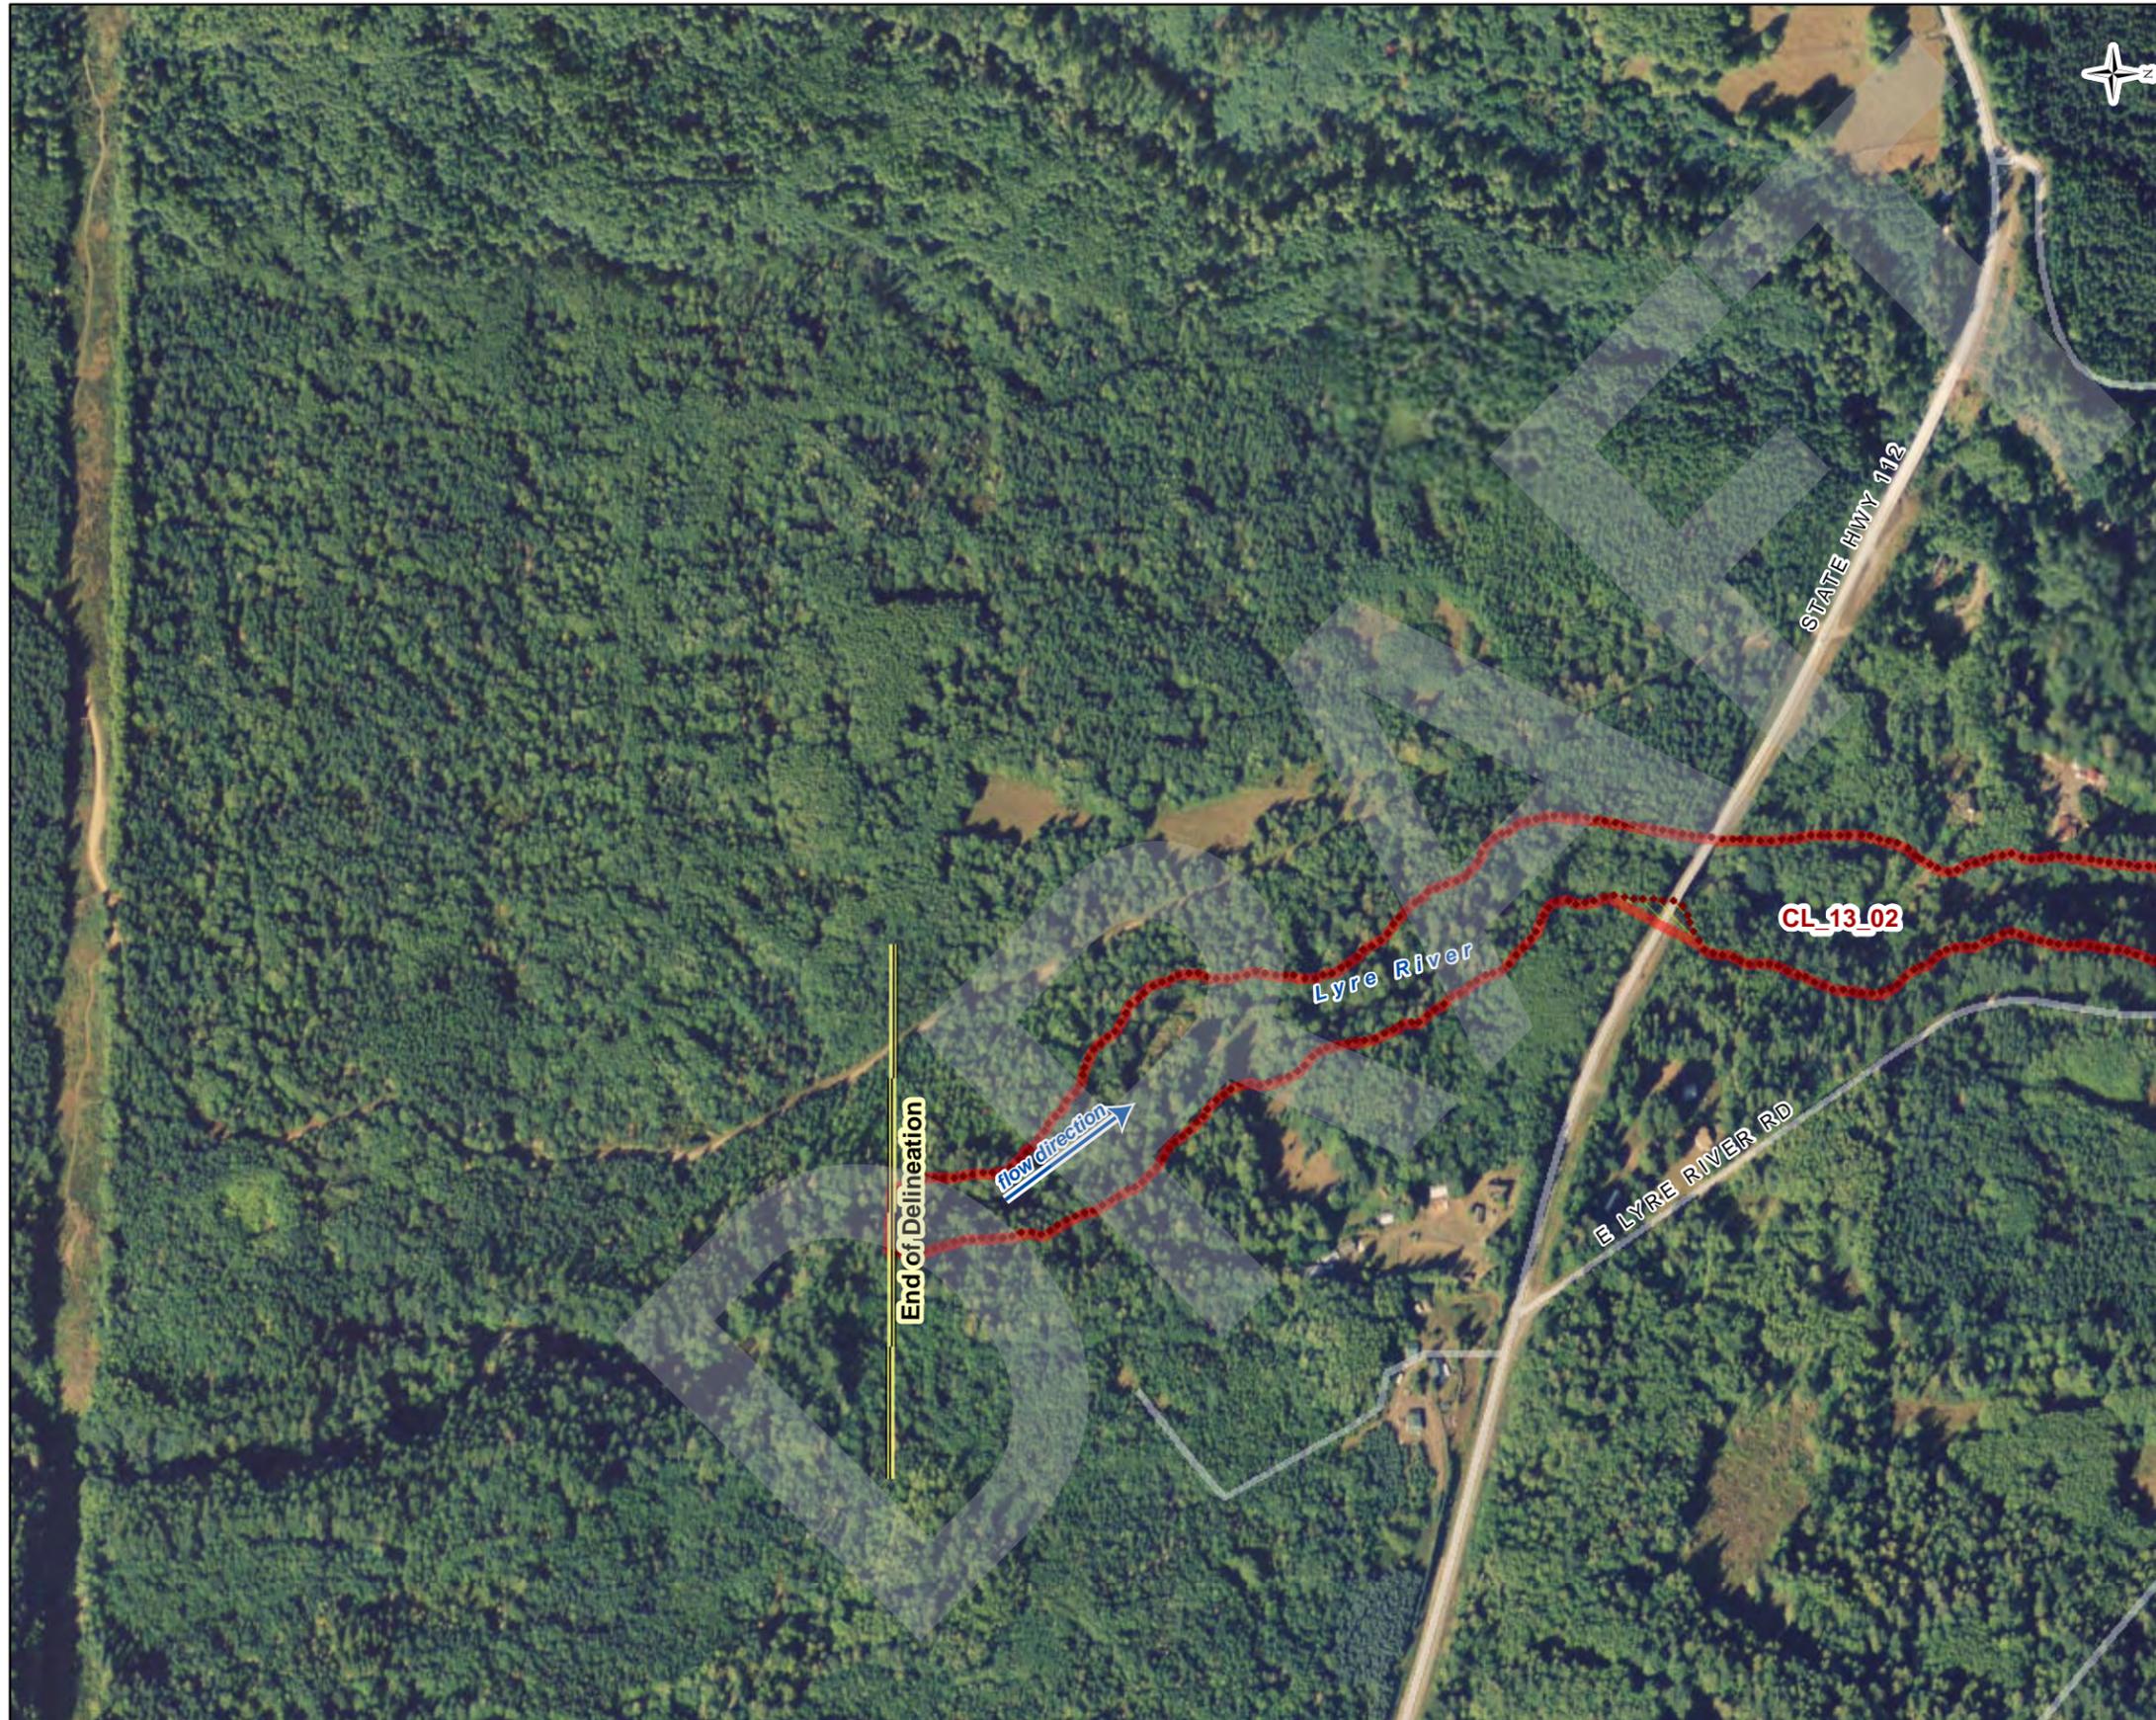
Map 46

2004 LIDAR topography (Puget Sound LIDAR Consortium).
 10 m USGS Hillshade
 2006 and 2009 aeriels from ESRI World Imagery
 WA State Dept of Nat. Resources 1:100,000 Geology
 River miles calculated from NHD stream alignment (USGS)
 Roads from TIGER (US Census Bureau)
 Coordinate System: State Plane Washington North

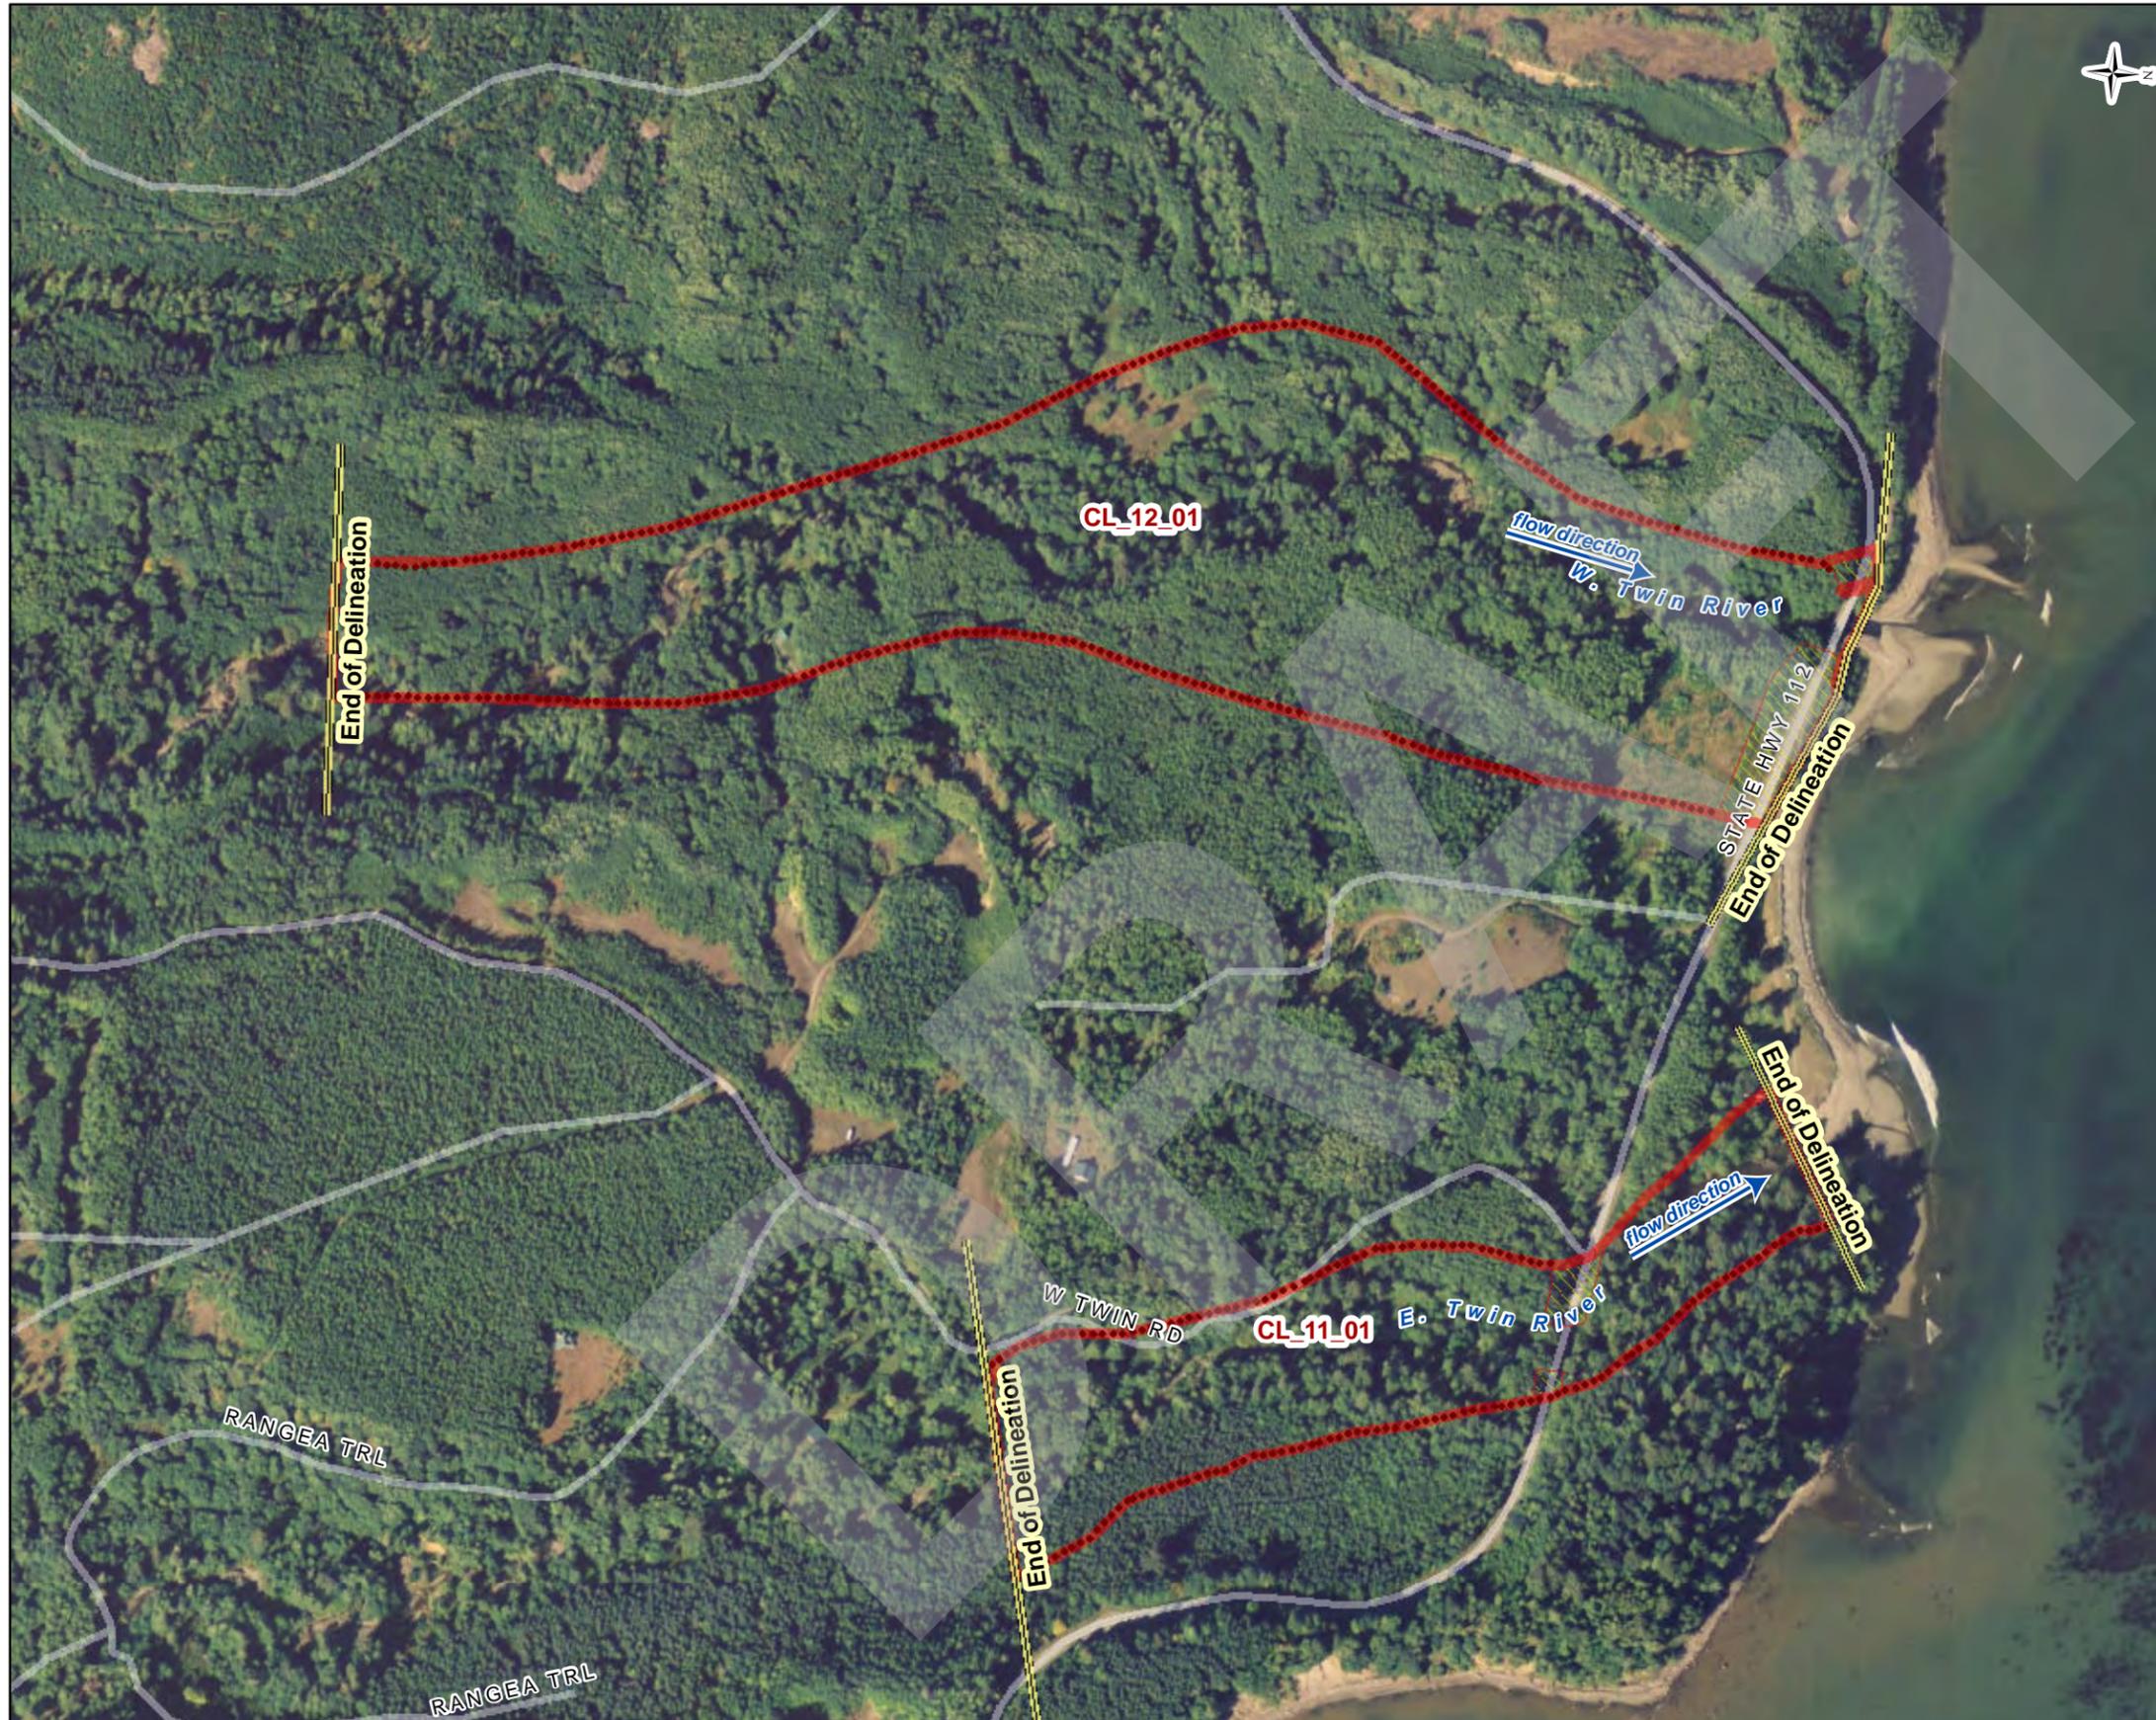
Lyre River **Map 47**

2004 LIDAR topography (Puget Sound LIDAR Consortium).
 10 m USGS Hillshade
 2006 and 2009 aerials from ESRI World Imagery
 WA State Dept of Nat. Resources 1:100,000 Geology
 River miles calculated from NHD stream alignment (USGS)
 Roads from TIGER (US Census Bureau)
 Coordinate System: State Plane Washington North

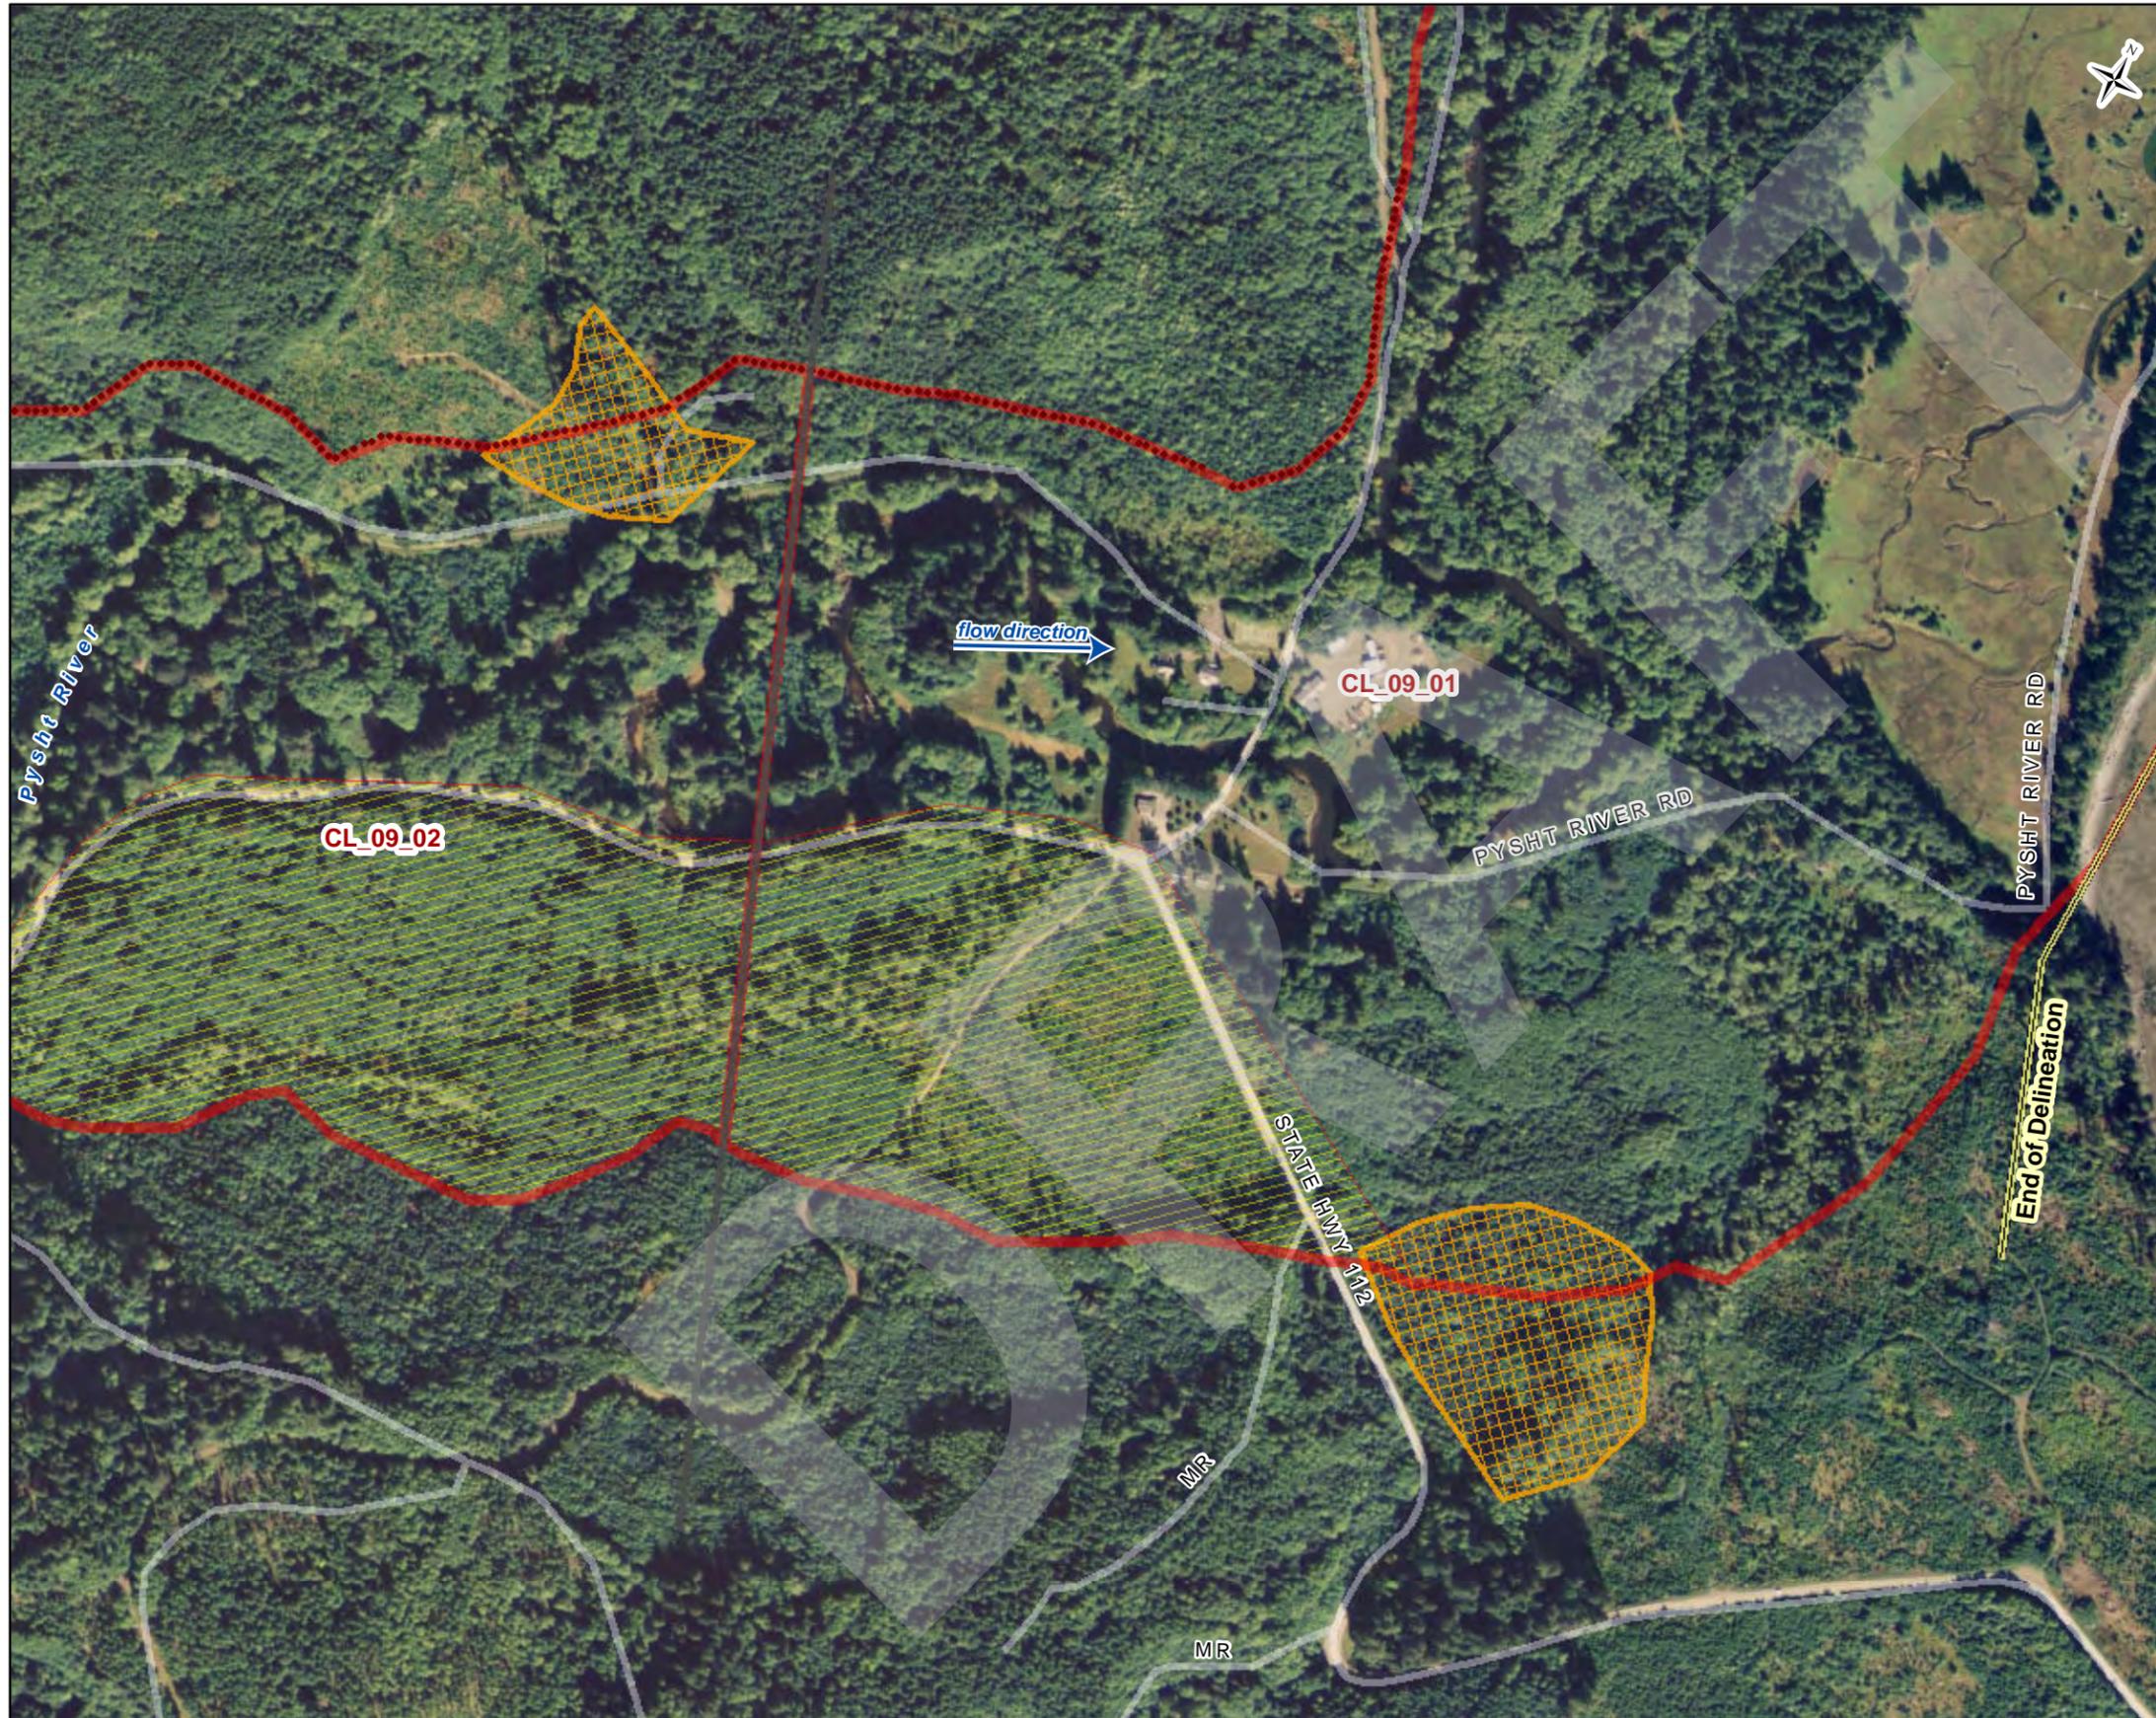
Map 36

2004 LIDAR topography (Puget Sound LIDAR Consortium).
 10 m USGS Hillshade
 2006 and 2009 aeriels from ESRI World Imagery
 WA State Dept of Nat. Resources 1:100,000 Geology
 River miles calculated from NHD stream alignment (USGS)
 Roads from TIGER (US Census Bureau)
 Coordinate System: State Plane Washington North

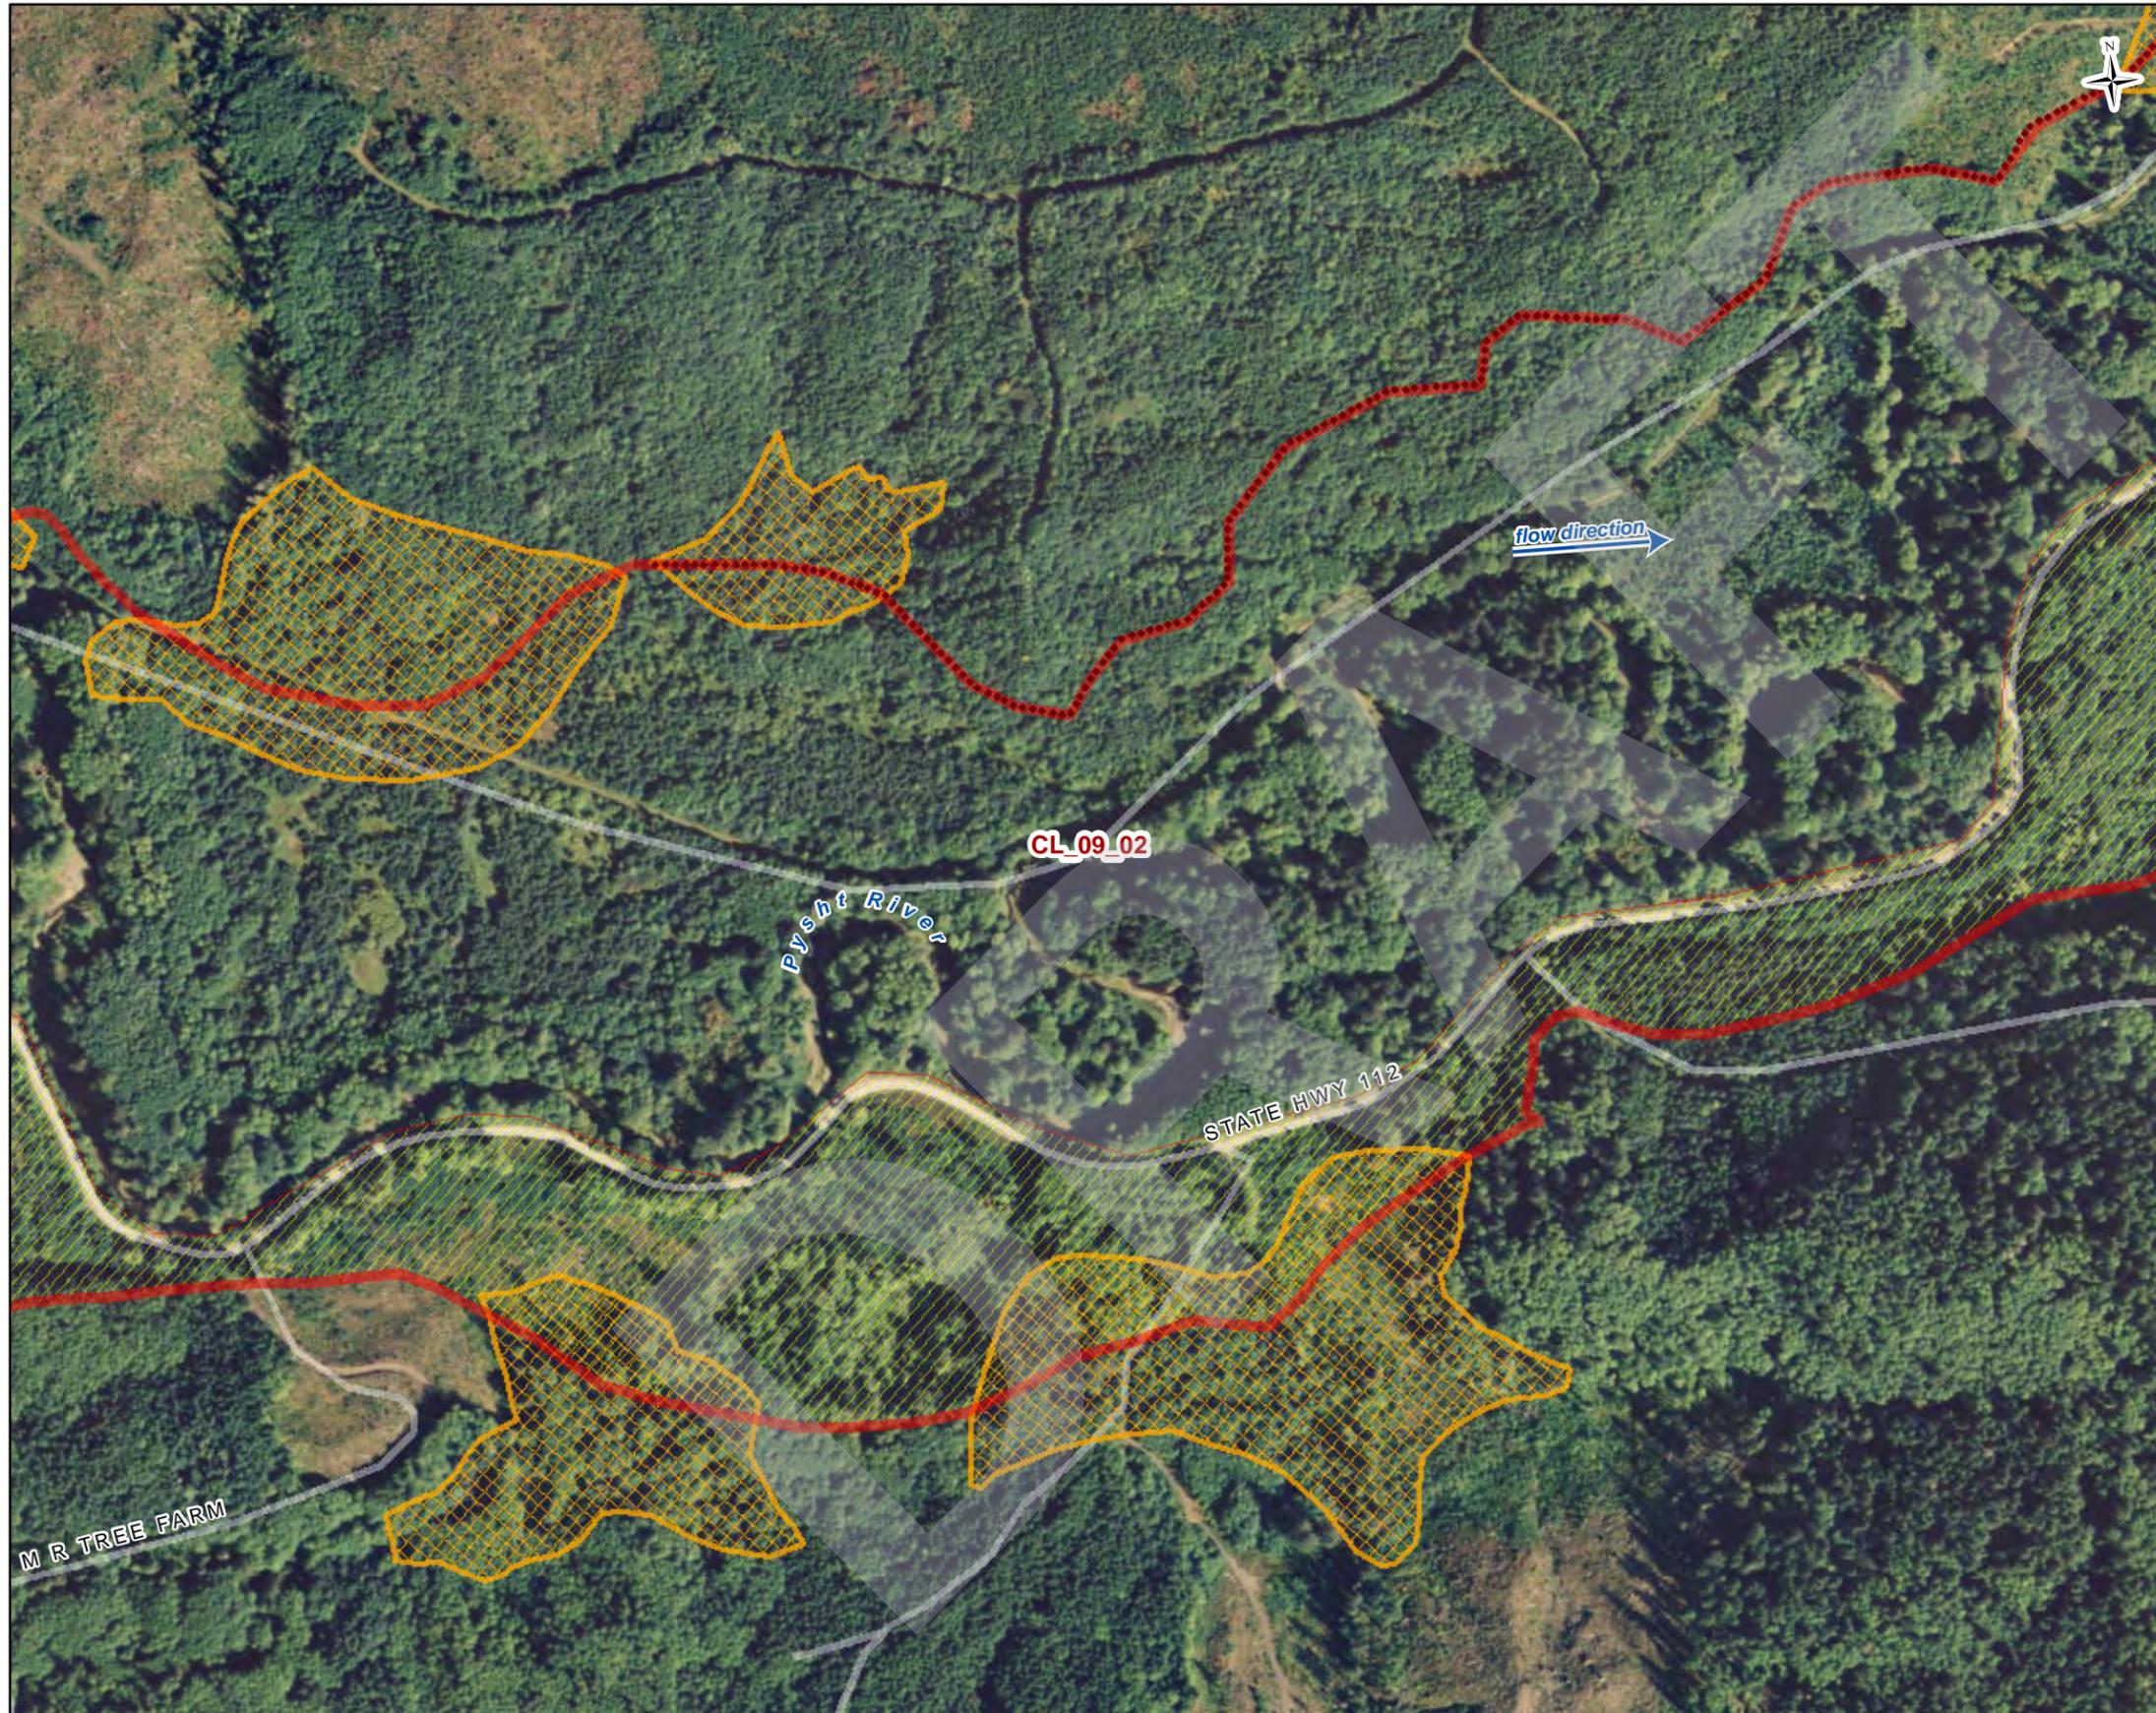
Map 37

2004 LIDAR topography (Puget Sound LIDAR Consortium).
 10 m USGS Hillshade
 2006 and 2009 aerials from ESRI World Imagery
 WA State Dept of Nat. Resources 1:100,000 Geology
 River miles calculated from NHD stream alignment (USGS)
 Roads from TIGER (US Census Bureau)
 Coordinate System: State Plane Washington North

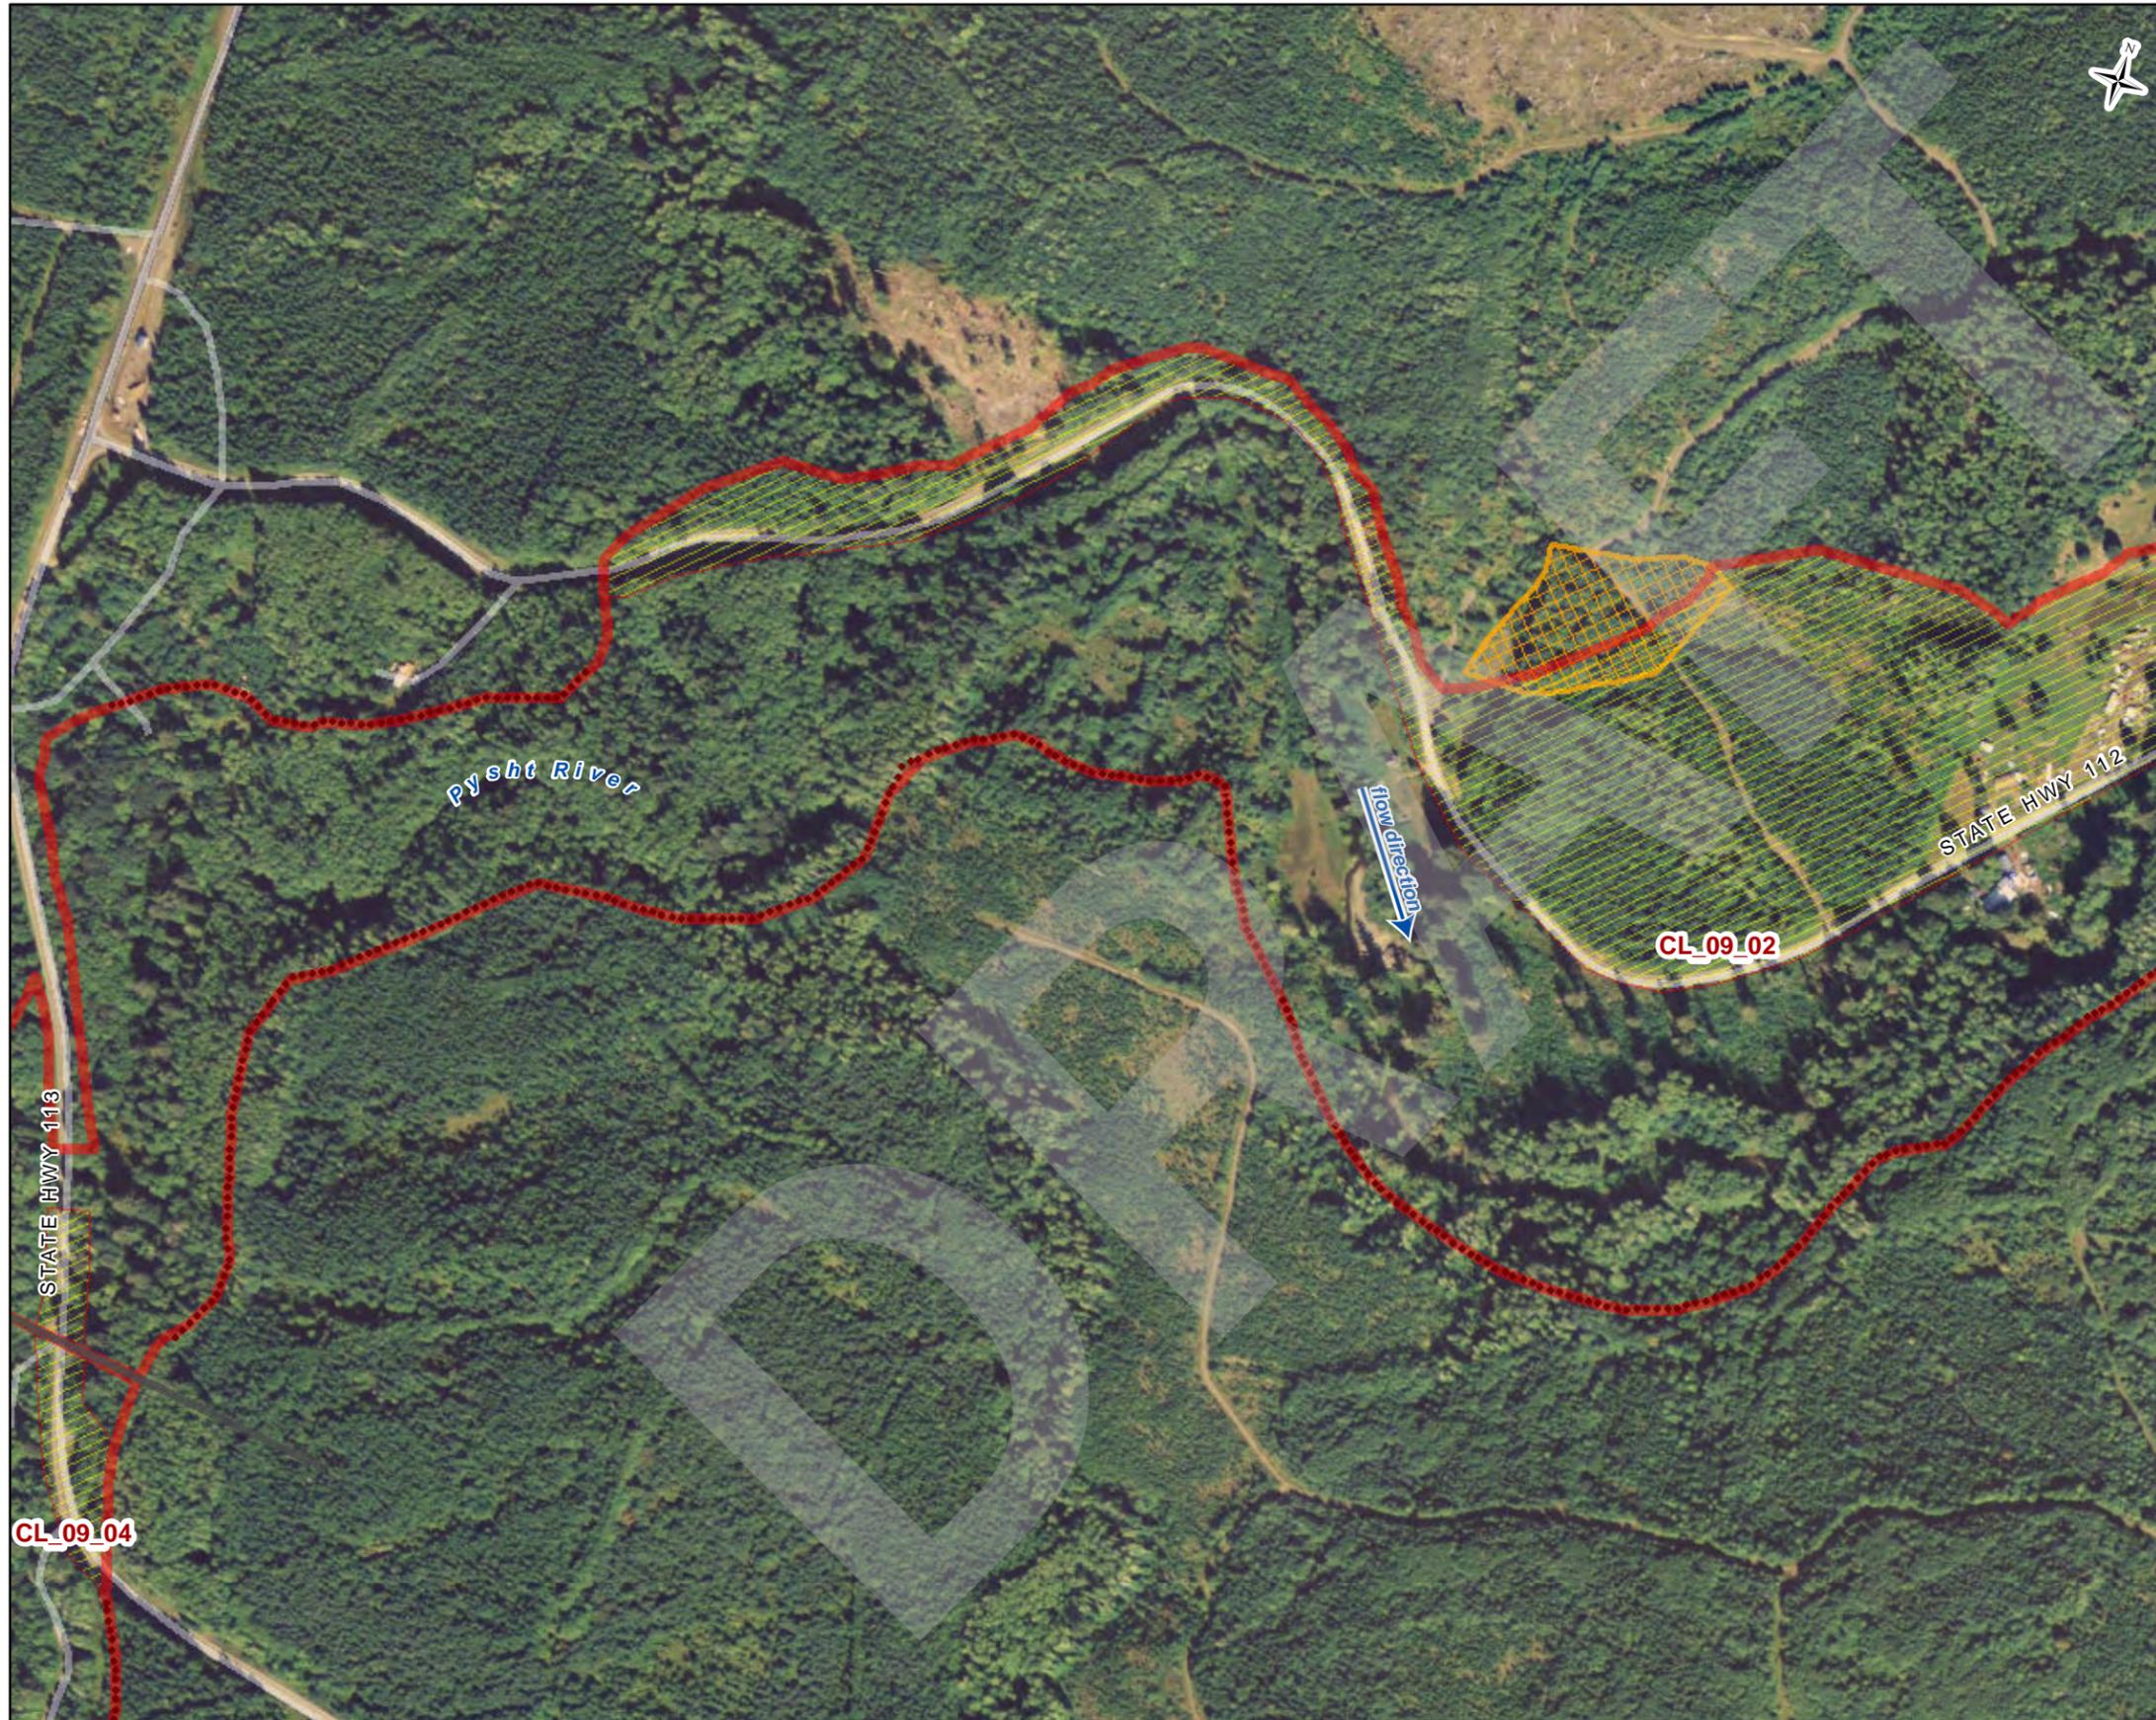
Pysht River **Map 40**

2004 LIDAR topography (Puget Sound LIDAR Consortium).
 10 m USGS Hillshade
 2006 and 2009 aeriols from ESRI World Imagery
 WA State Dept of Nat. Resources 1:100,000 Geology
 River miles calculated from NHD stream alignment (USGS)
 Roads from TIGER (US Census Bureau)
 Coordinate System: State Plane Washington North
