SHORELINE INVENTORY AND CHARACTERIZATION REPORT

**for Portions of Clallam County Draining to the Strait of Juan de
Fuca**

Clallam County Shoreline Master Program Update

March 2012

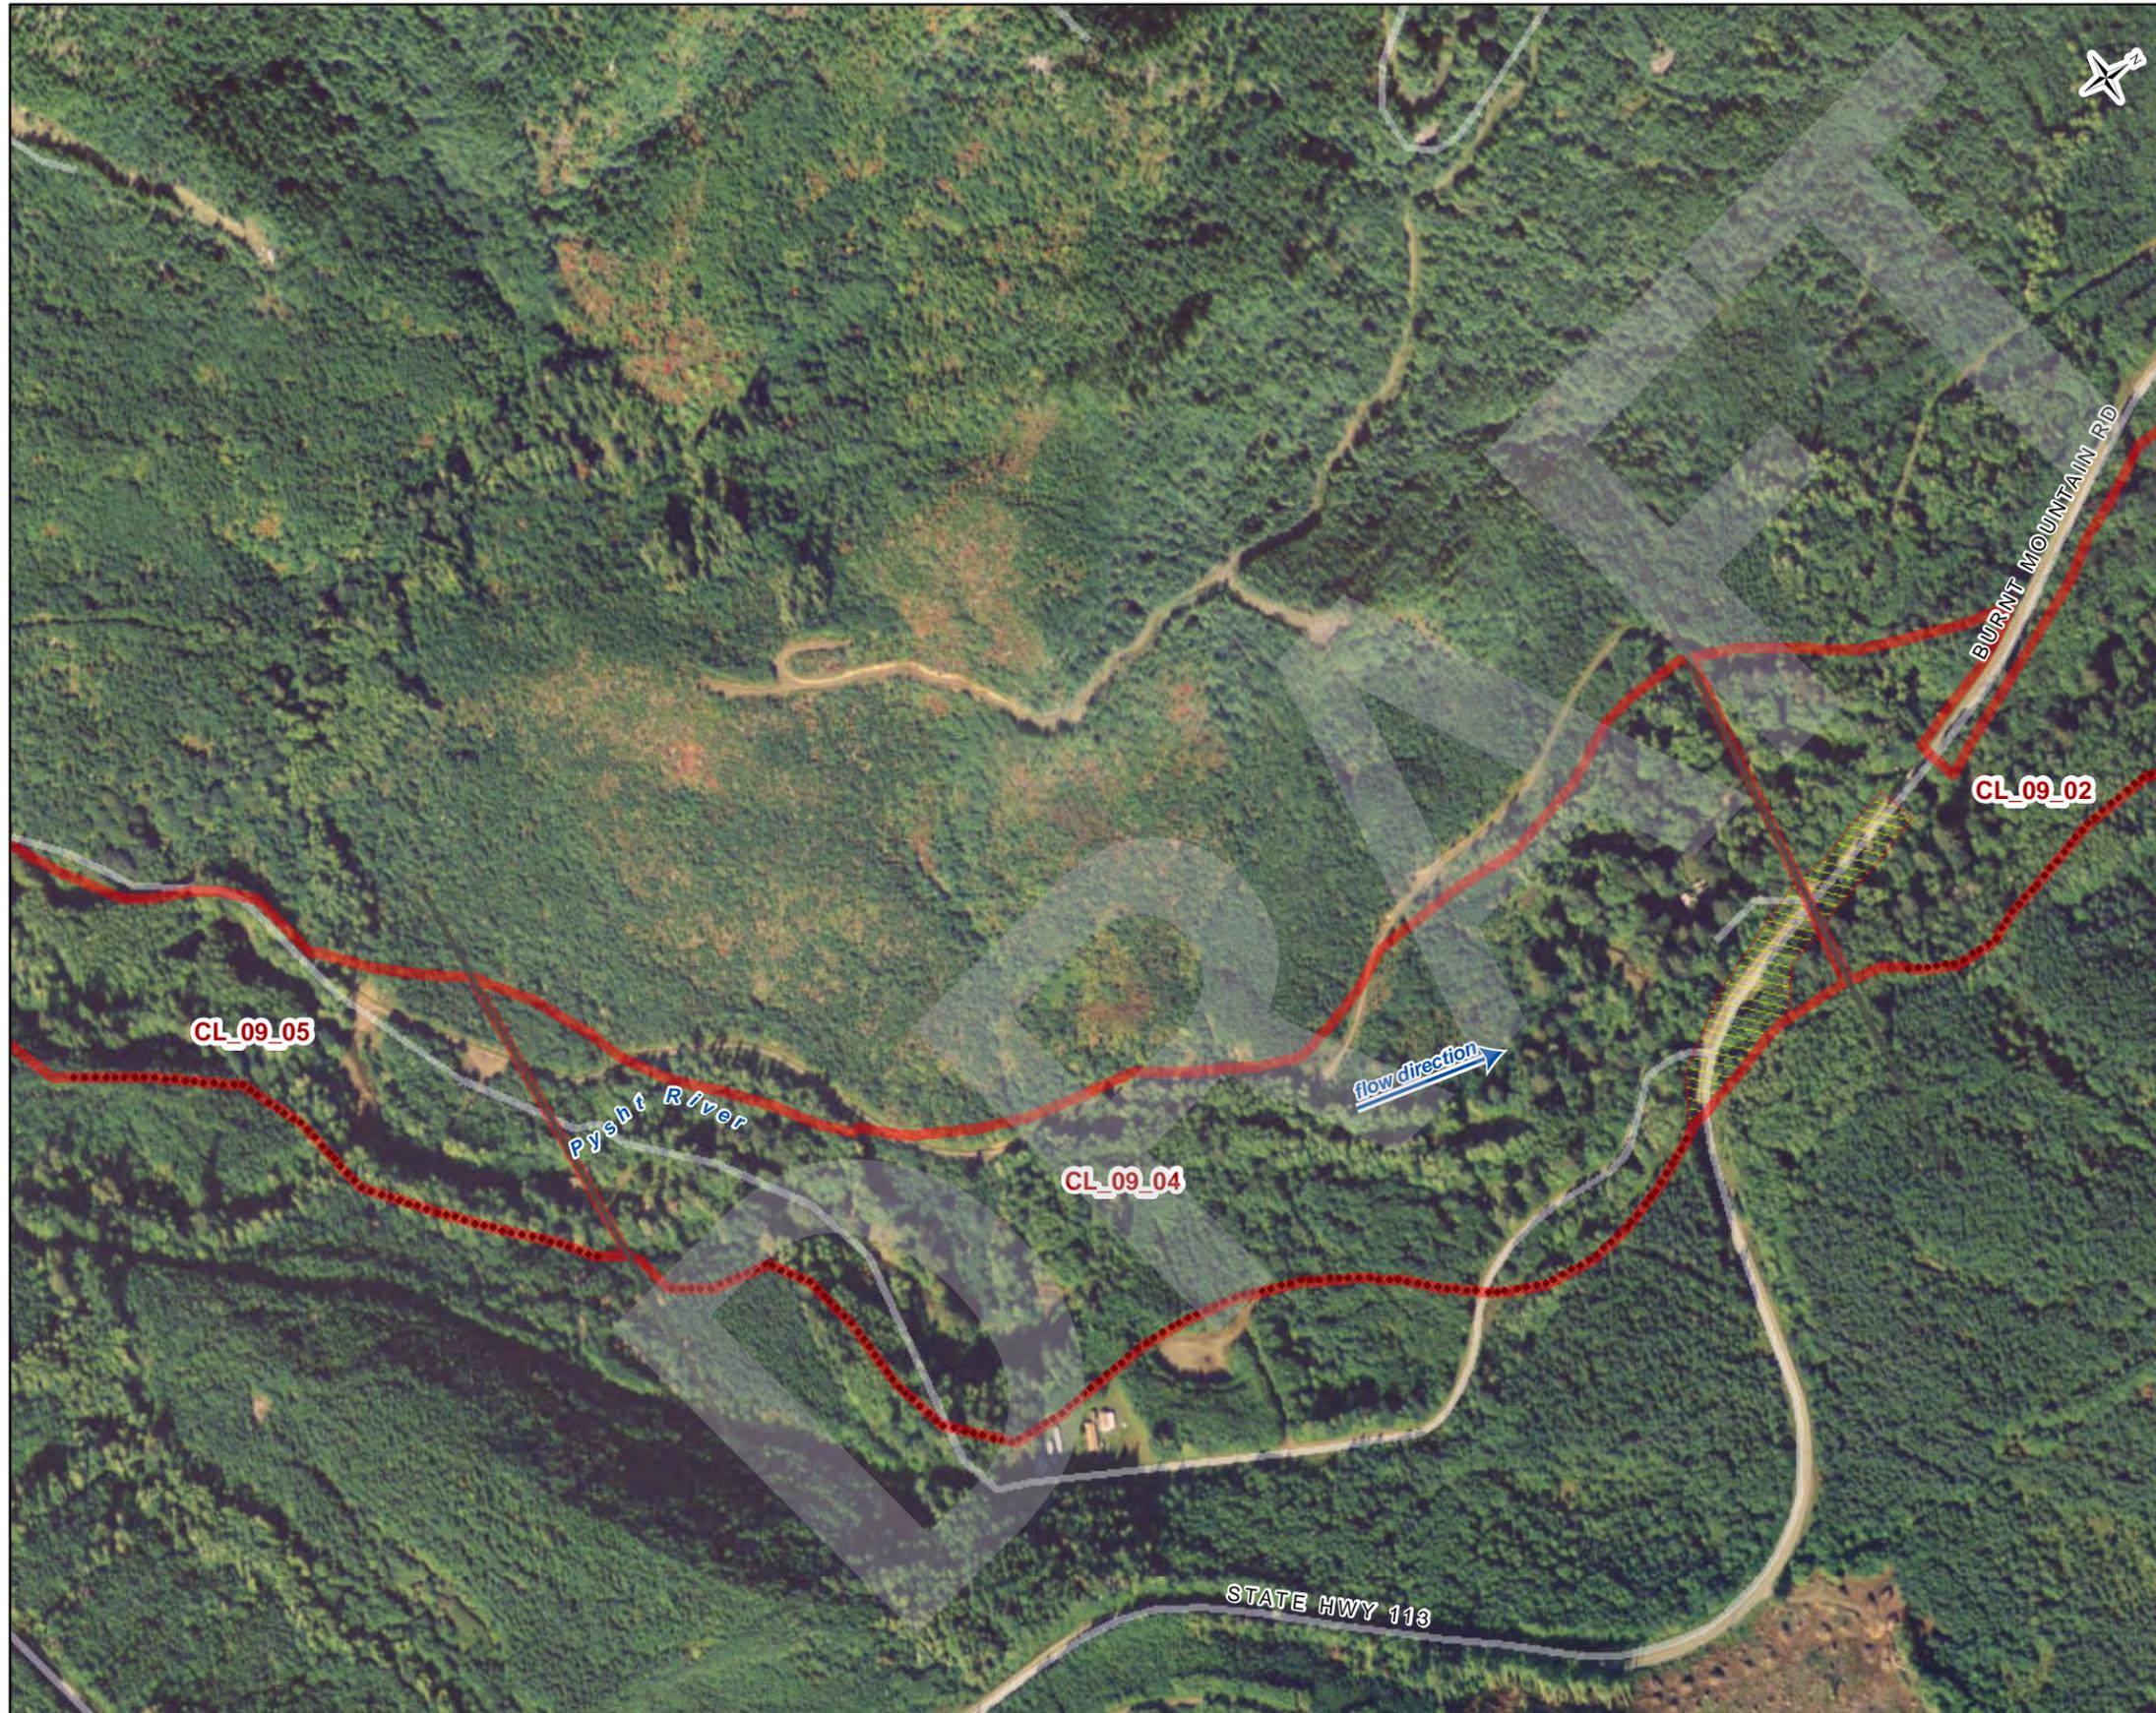
Map 41

2004 LIDAR topography (Puget Sound LIDAR Consortium).
 10 m USGS Hillshade
 2006 and 2009 aerials from ESRI World Imagery
 WA State Dept of Nat. Resources 1:100,000 Geology
 River miles calculated from NHD stream alignment (USGS)
 Roads from TIGER (US Census Bureau)
 Coordinate System: State Plane Washington North

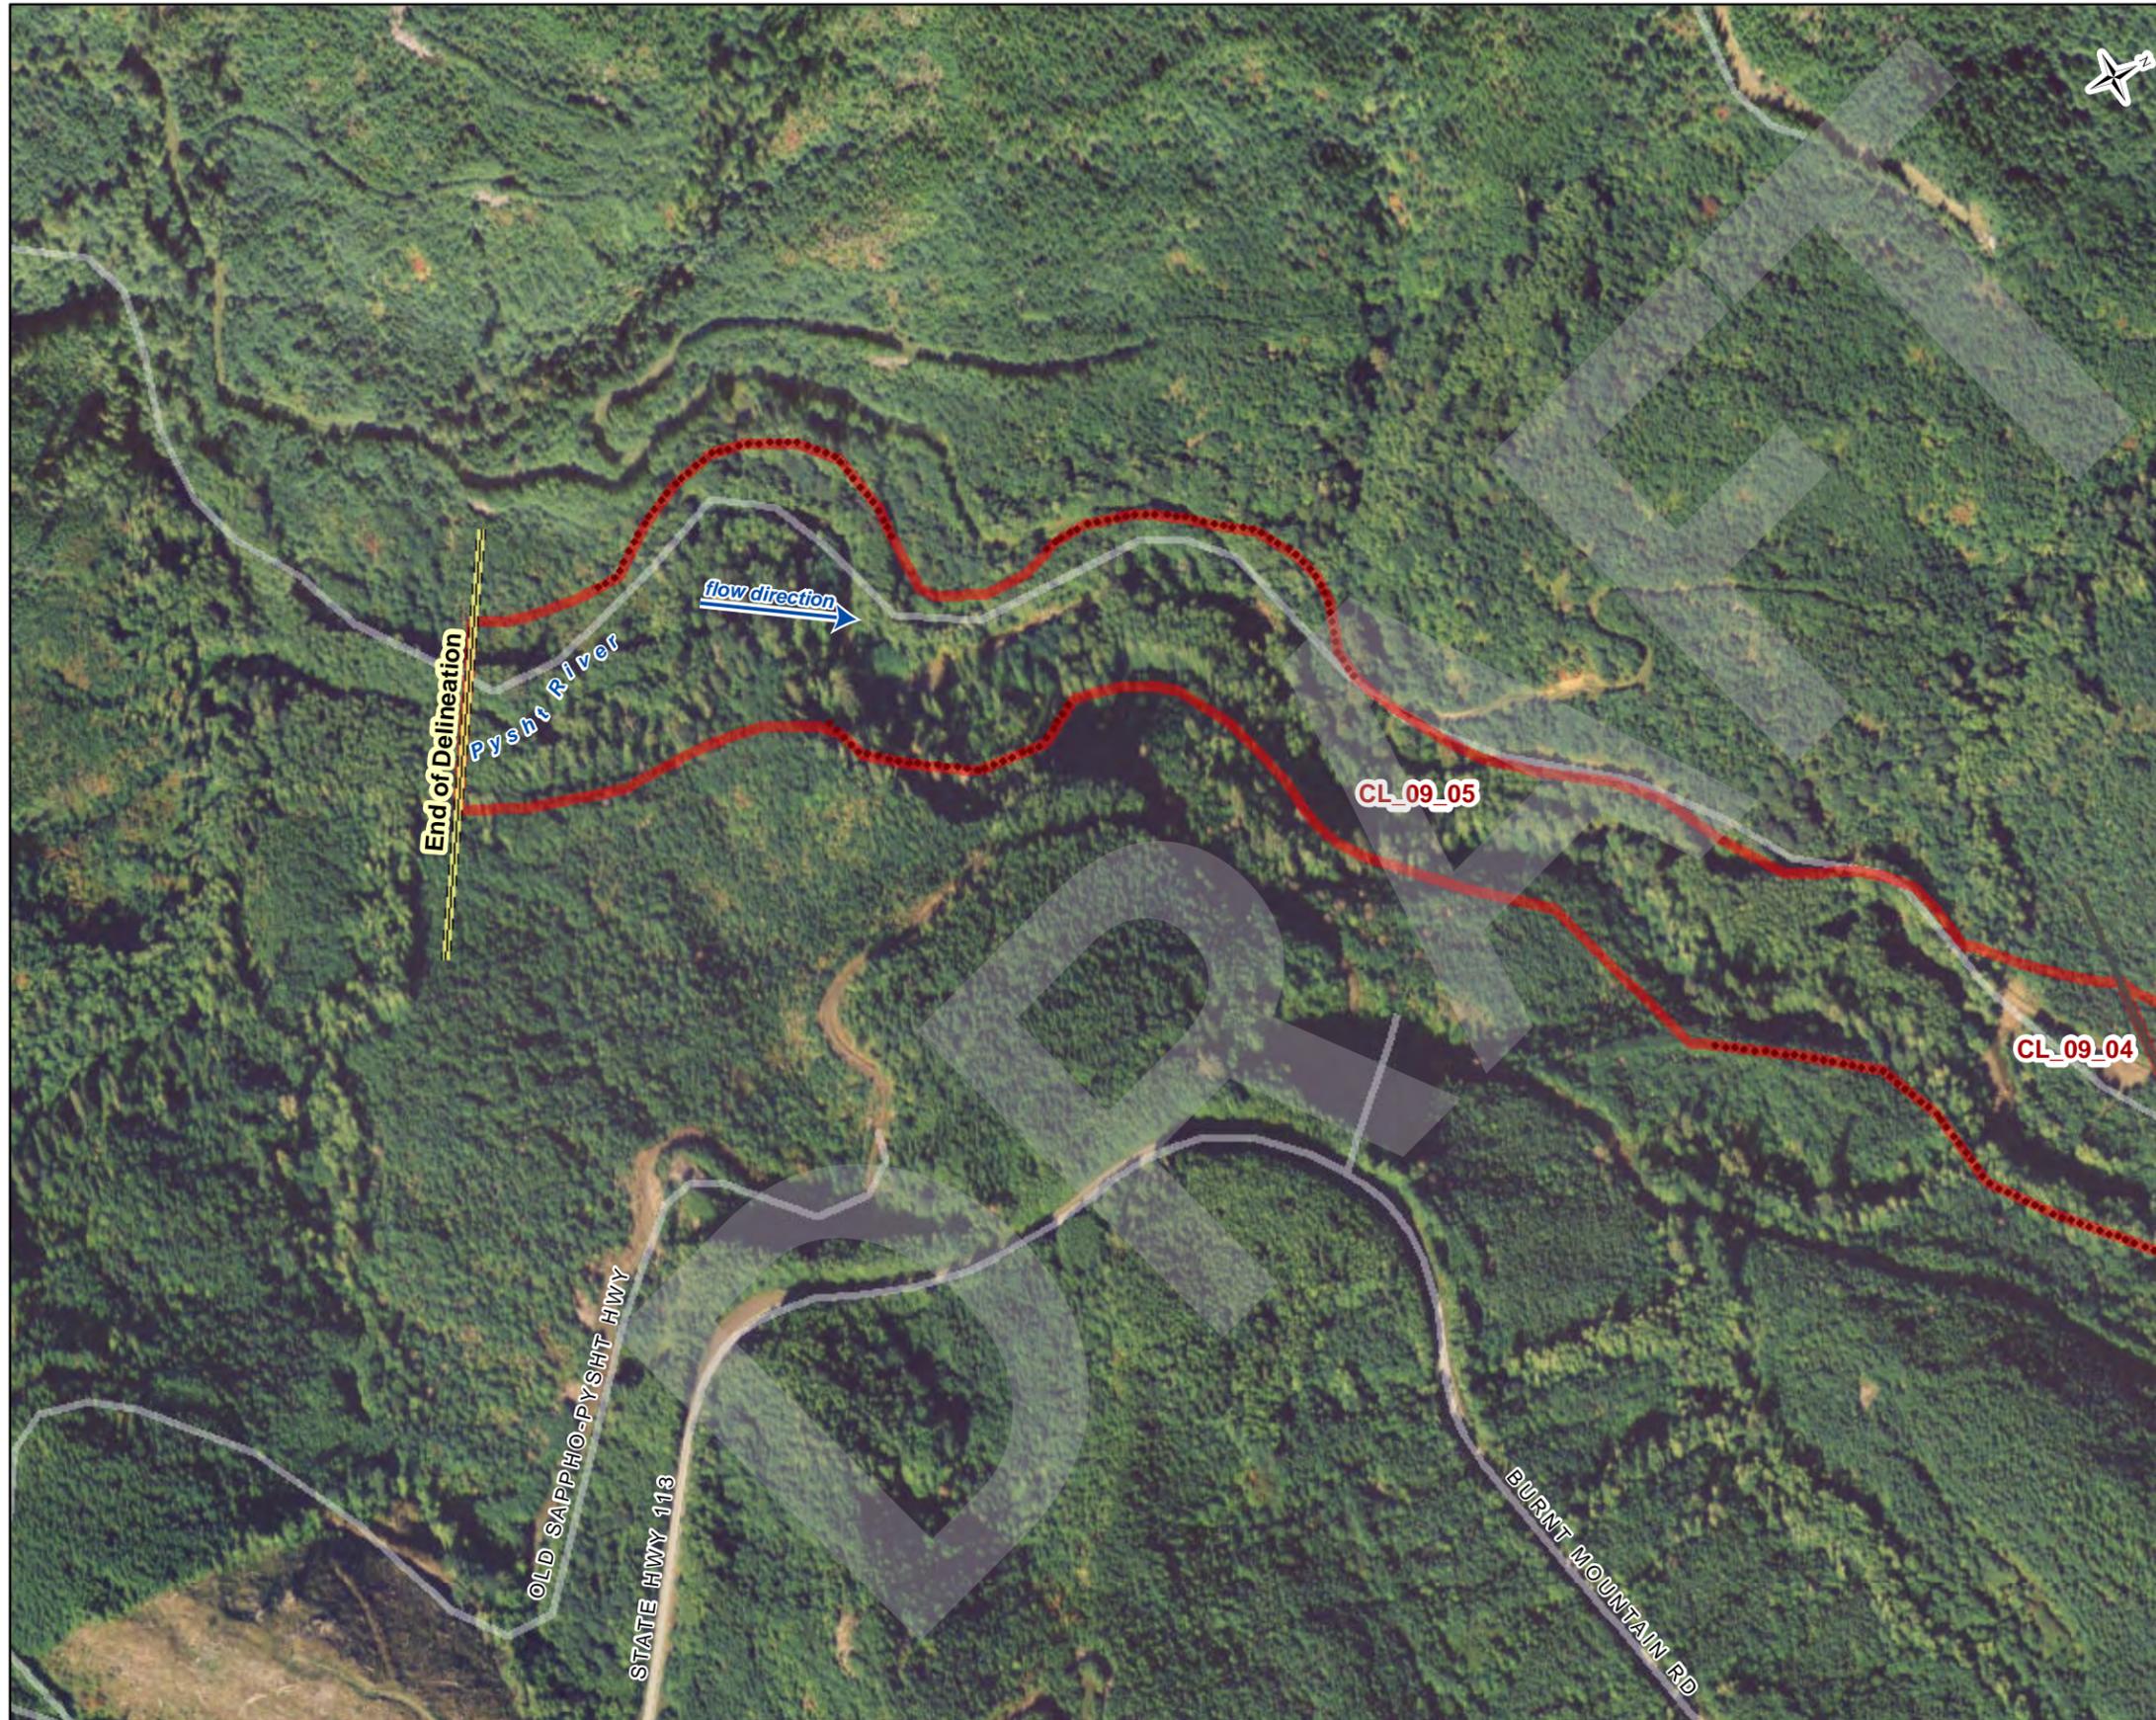
Pysht River **Map 42**

2004 LIDAR topography (Puget Sound LIDAR Consortium).
 10 m USGS Hillshade
 2006 and 2009 aeriels from ESRI World Imagery
 WA State Dept of Nat. Resources 1:100,000 Geology
 River miles calculated from NHD stream alignment (USGS)
 Roads from TIGER (US Census Bureau)
 Coordinate System: State Plane Washington North

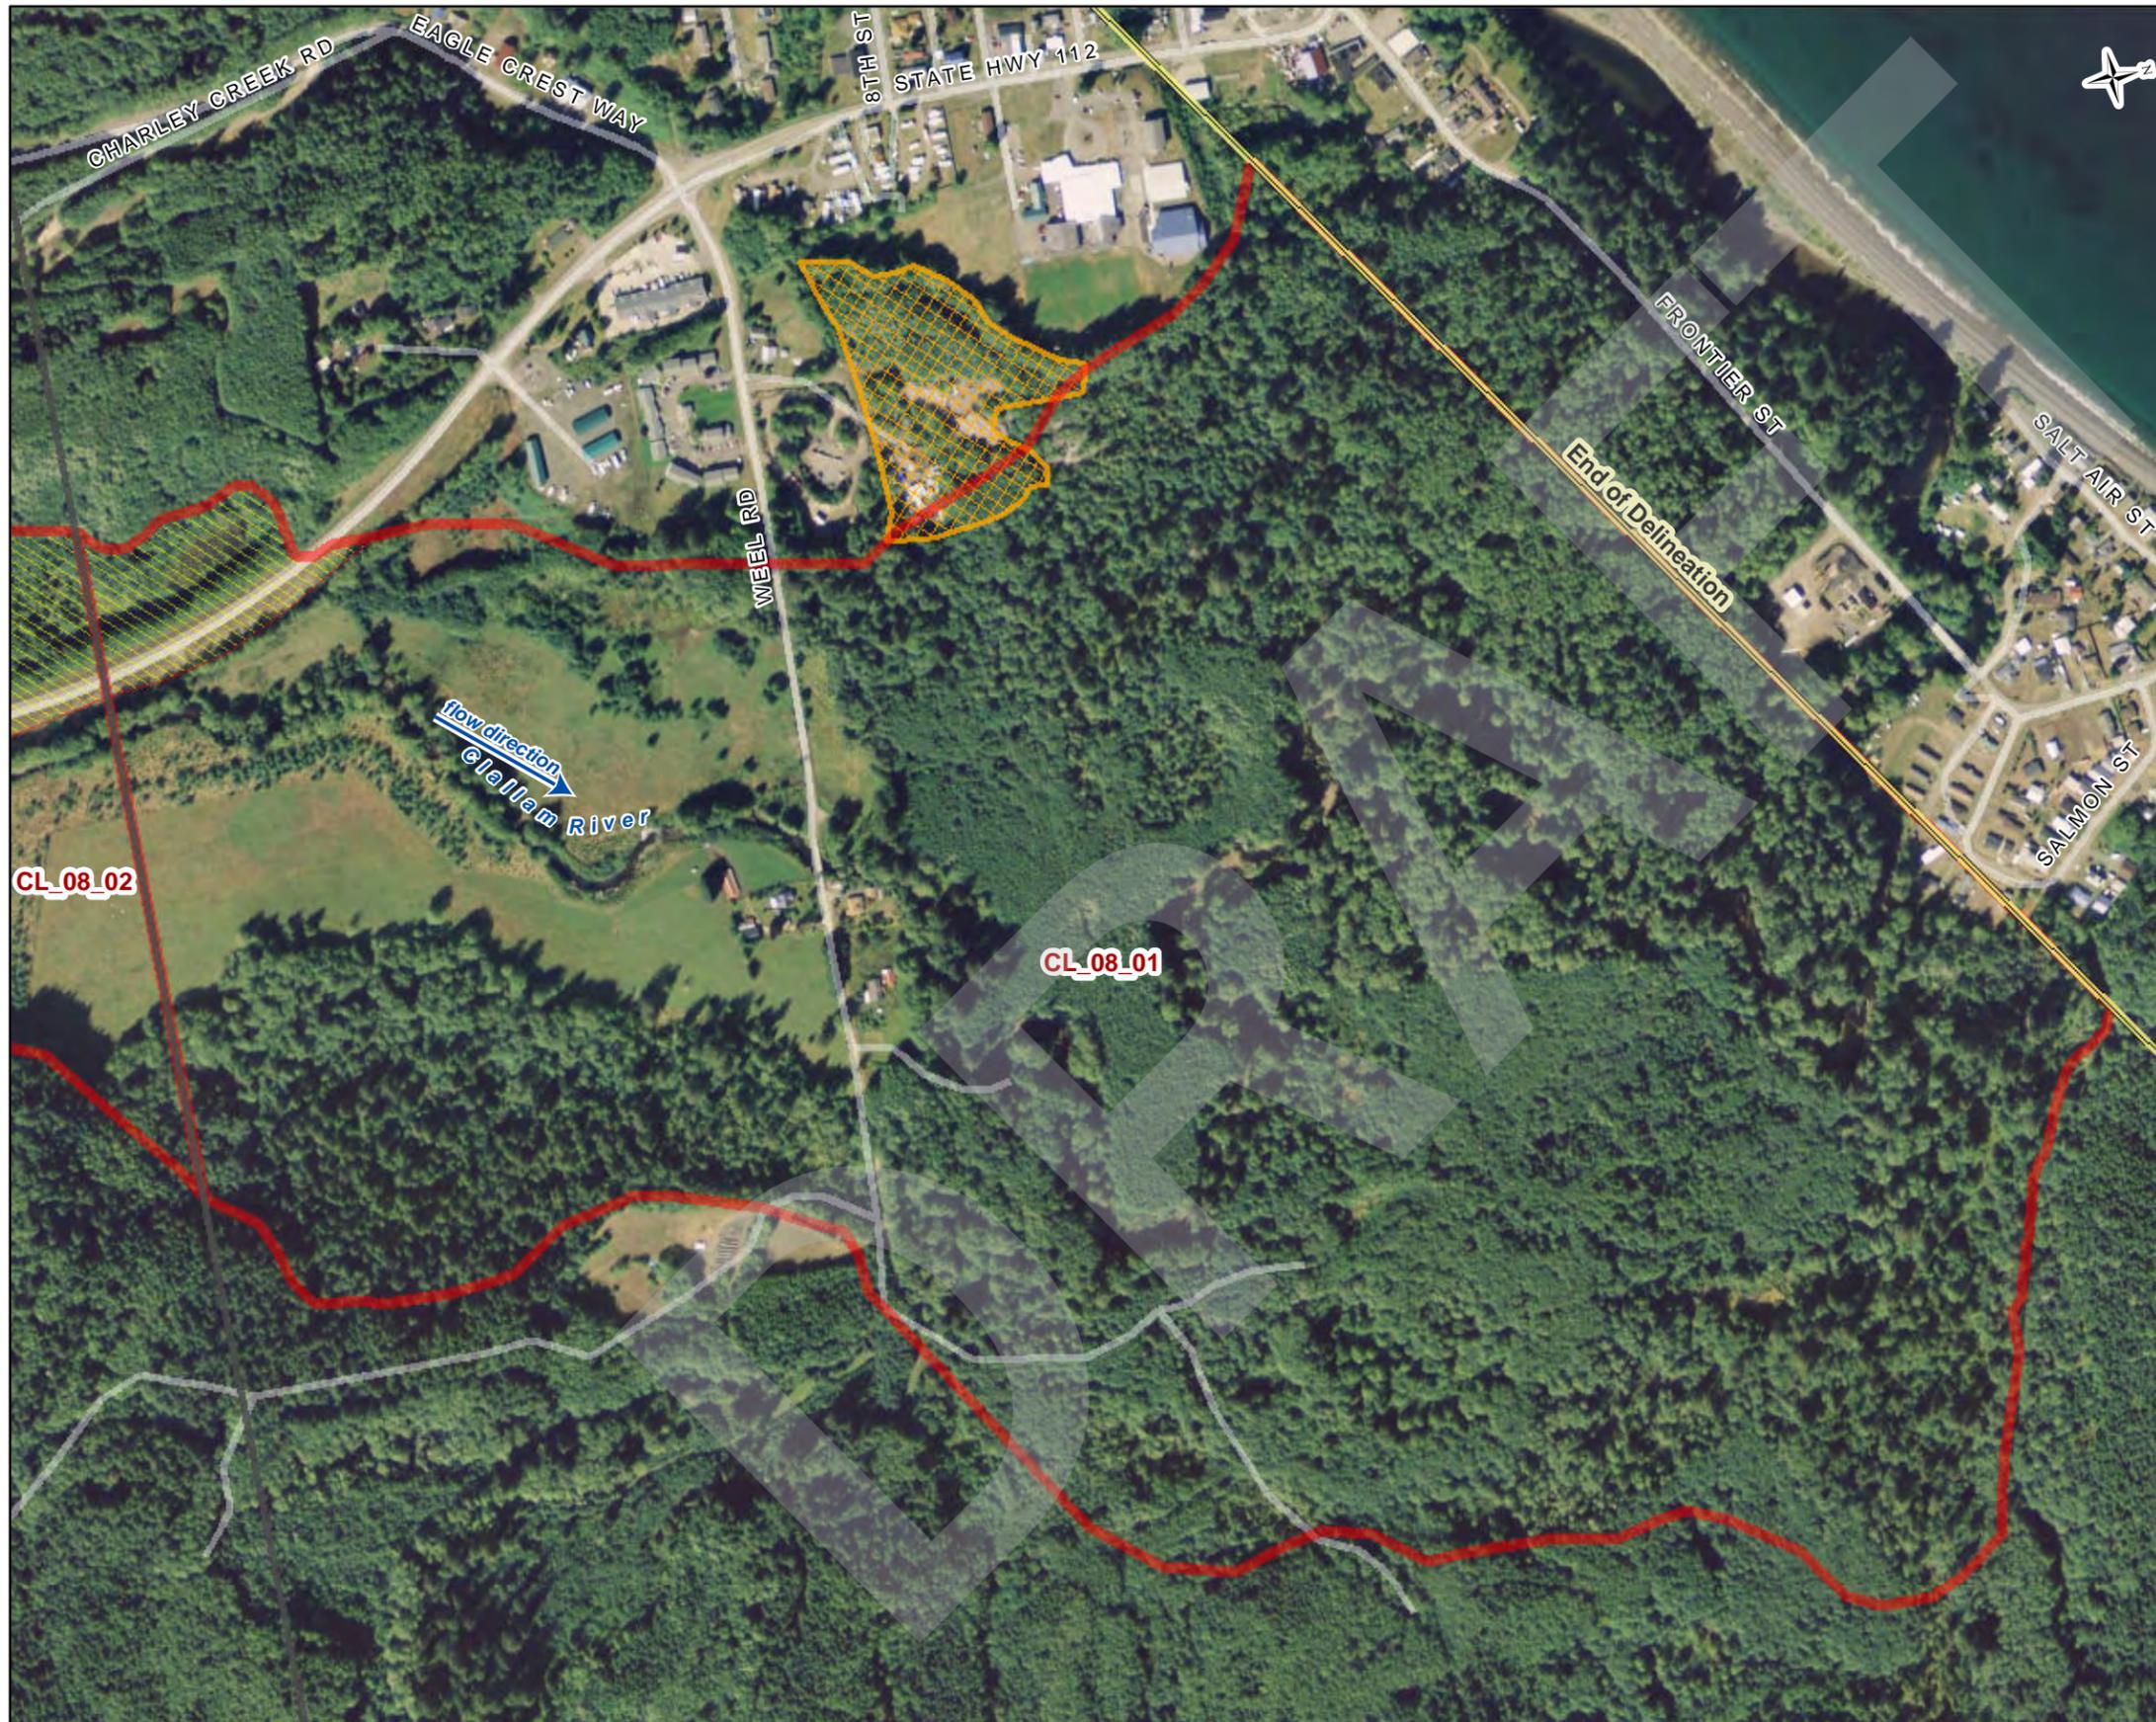
Map 43

2004 LIDAR topography (Puget Sound LIDAR Consortium).
 10 m USGS Hillshade
 2006 and 2009 aeriols from ESRI World Imagery
 WA State Dept of Nat. Resources 1:100,000 Geology
 River miles calculated from NHD stream alignment (USGS)
 Roads from TIGER (US Census Bureau)
 Coordinate System: State Plane Washington North

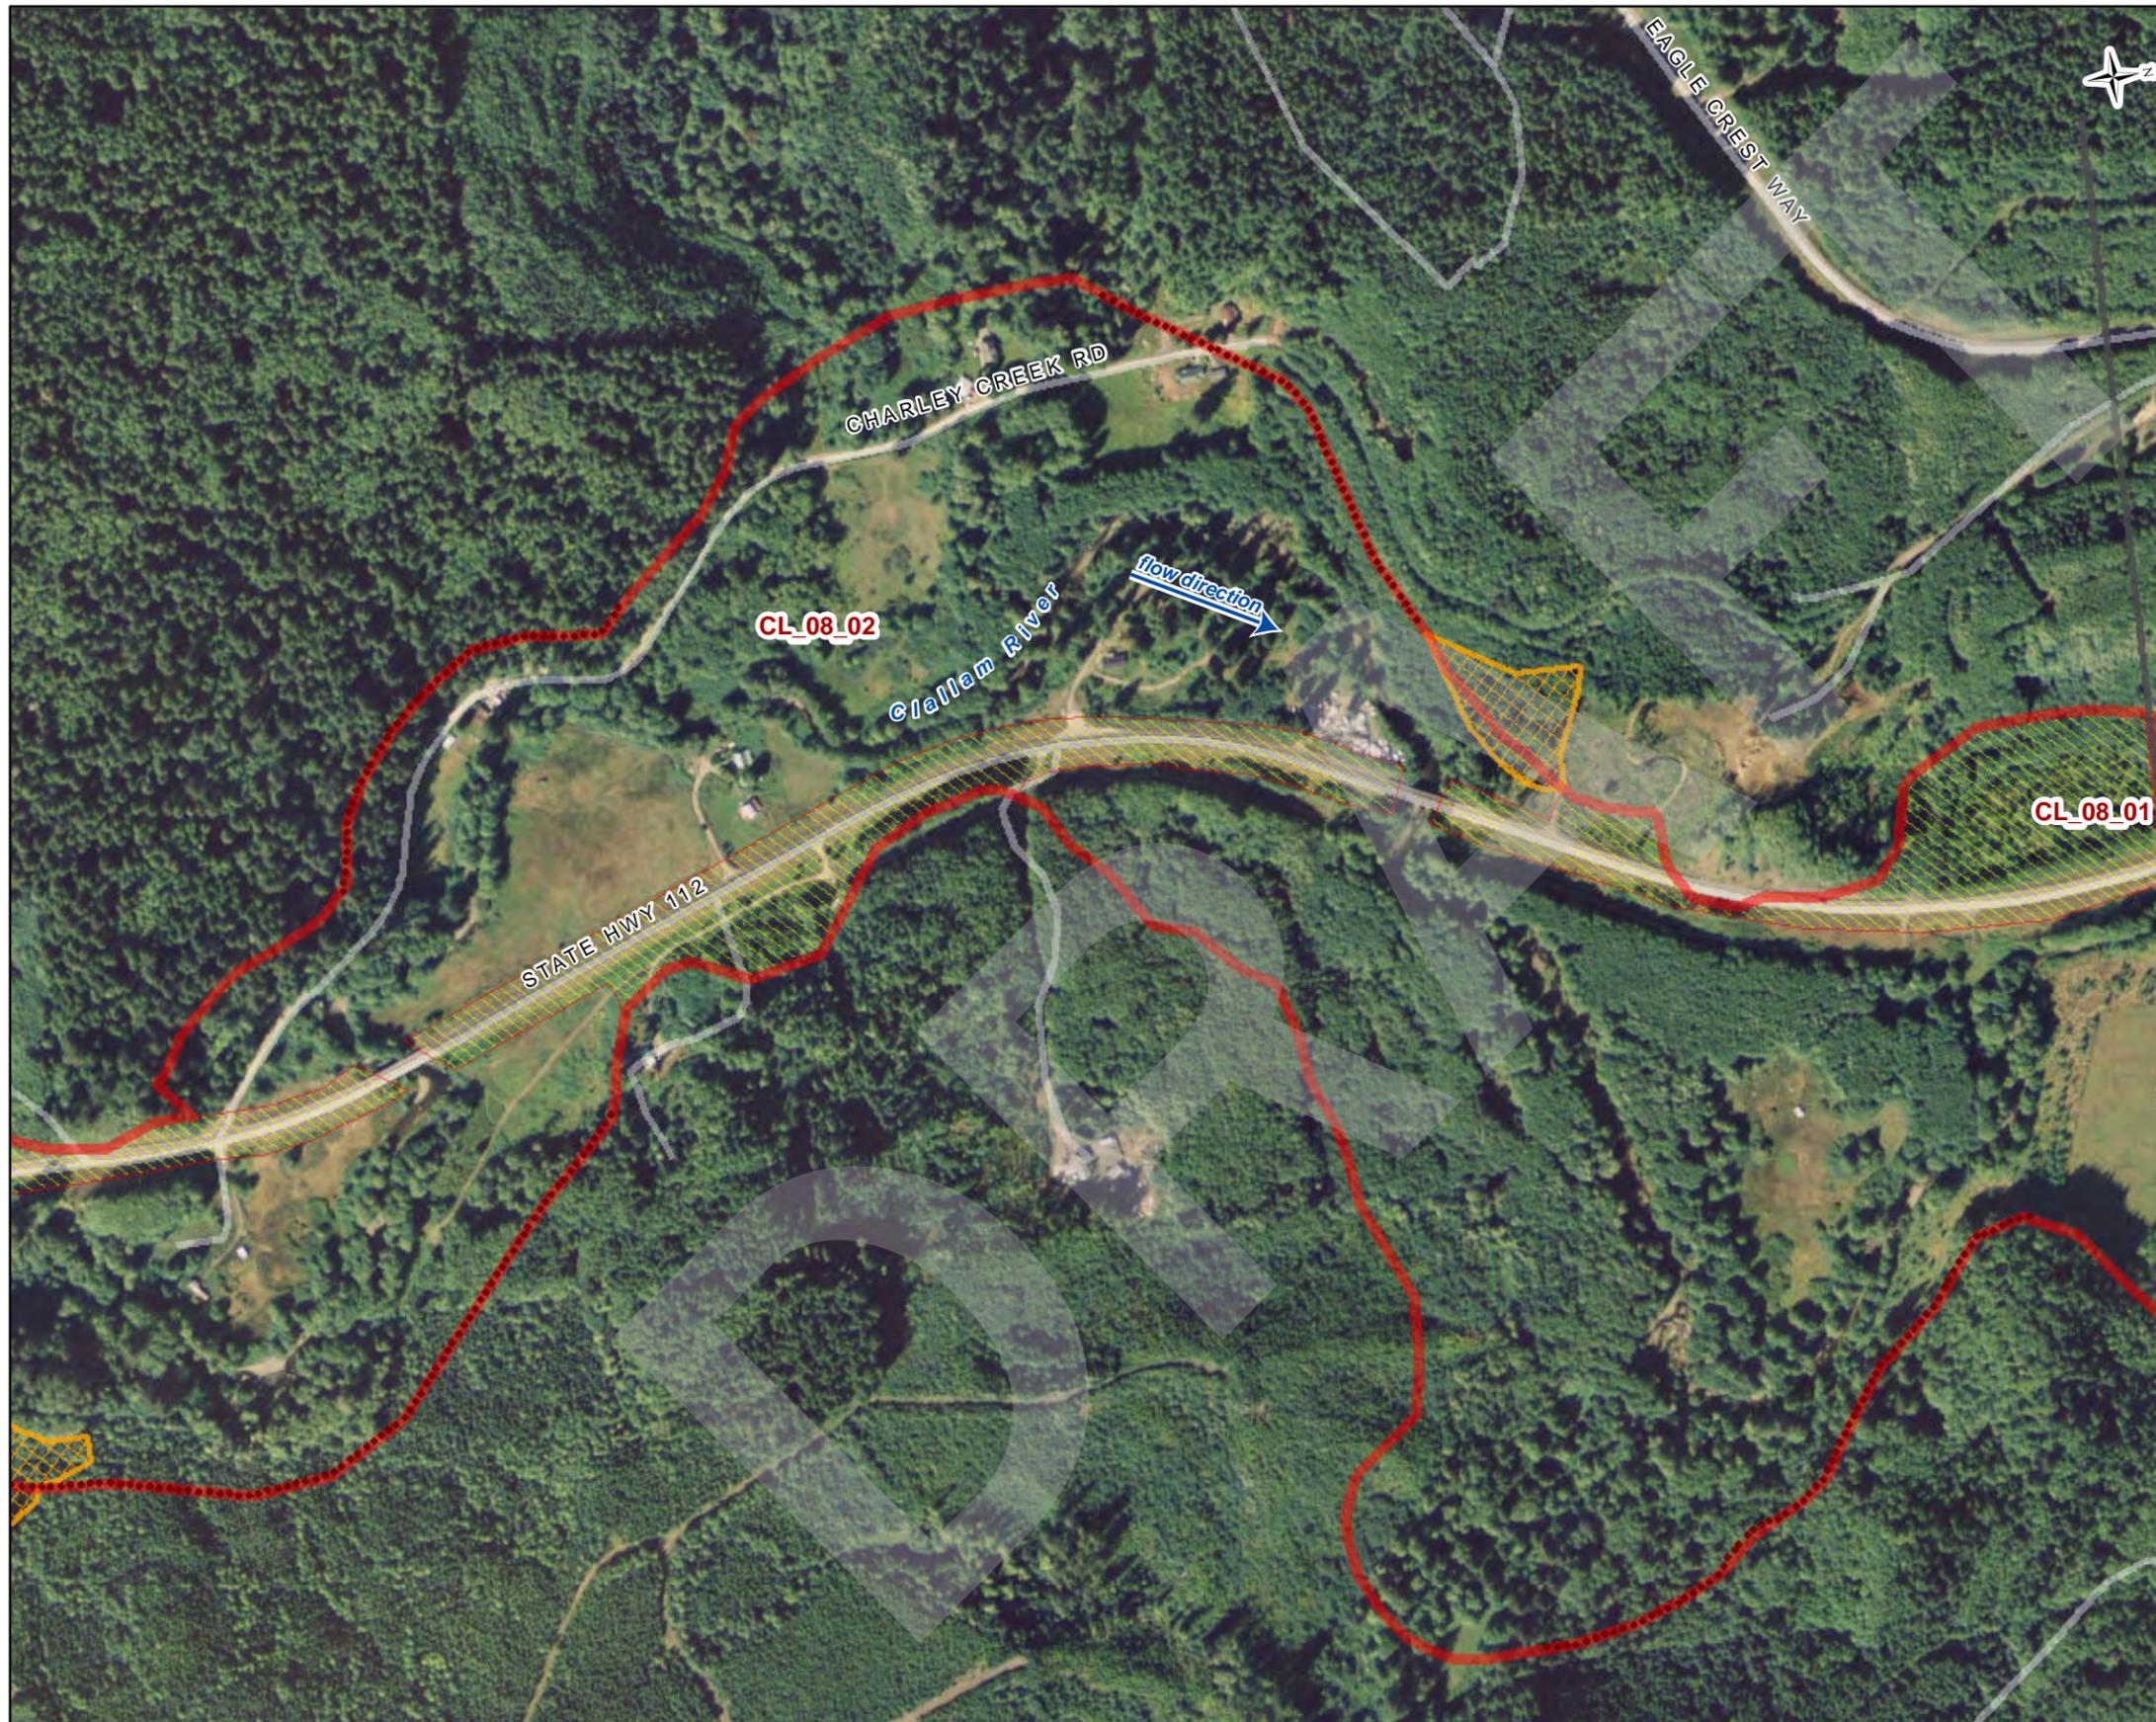
Clallam River **Map 32**

2004 LIDAR topography (Puget Sound LIDAR Consortium).
 10 m USGS Hillshade
 2006 and 2009 aeriels from ESRI World Imagery
 WA State Dept of Nat. Resources 1:100,000 Geology
 River miles calculated from NHD stream alignment (USGS)
 Roads from TIGER (US Census Bureau)
 Coordinate System: State Plane Washington North

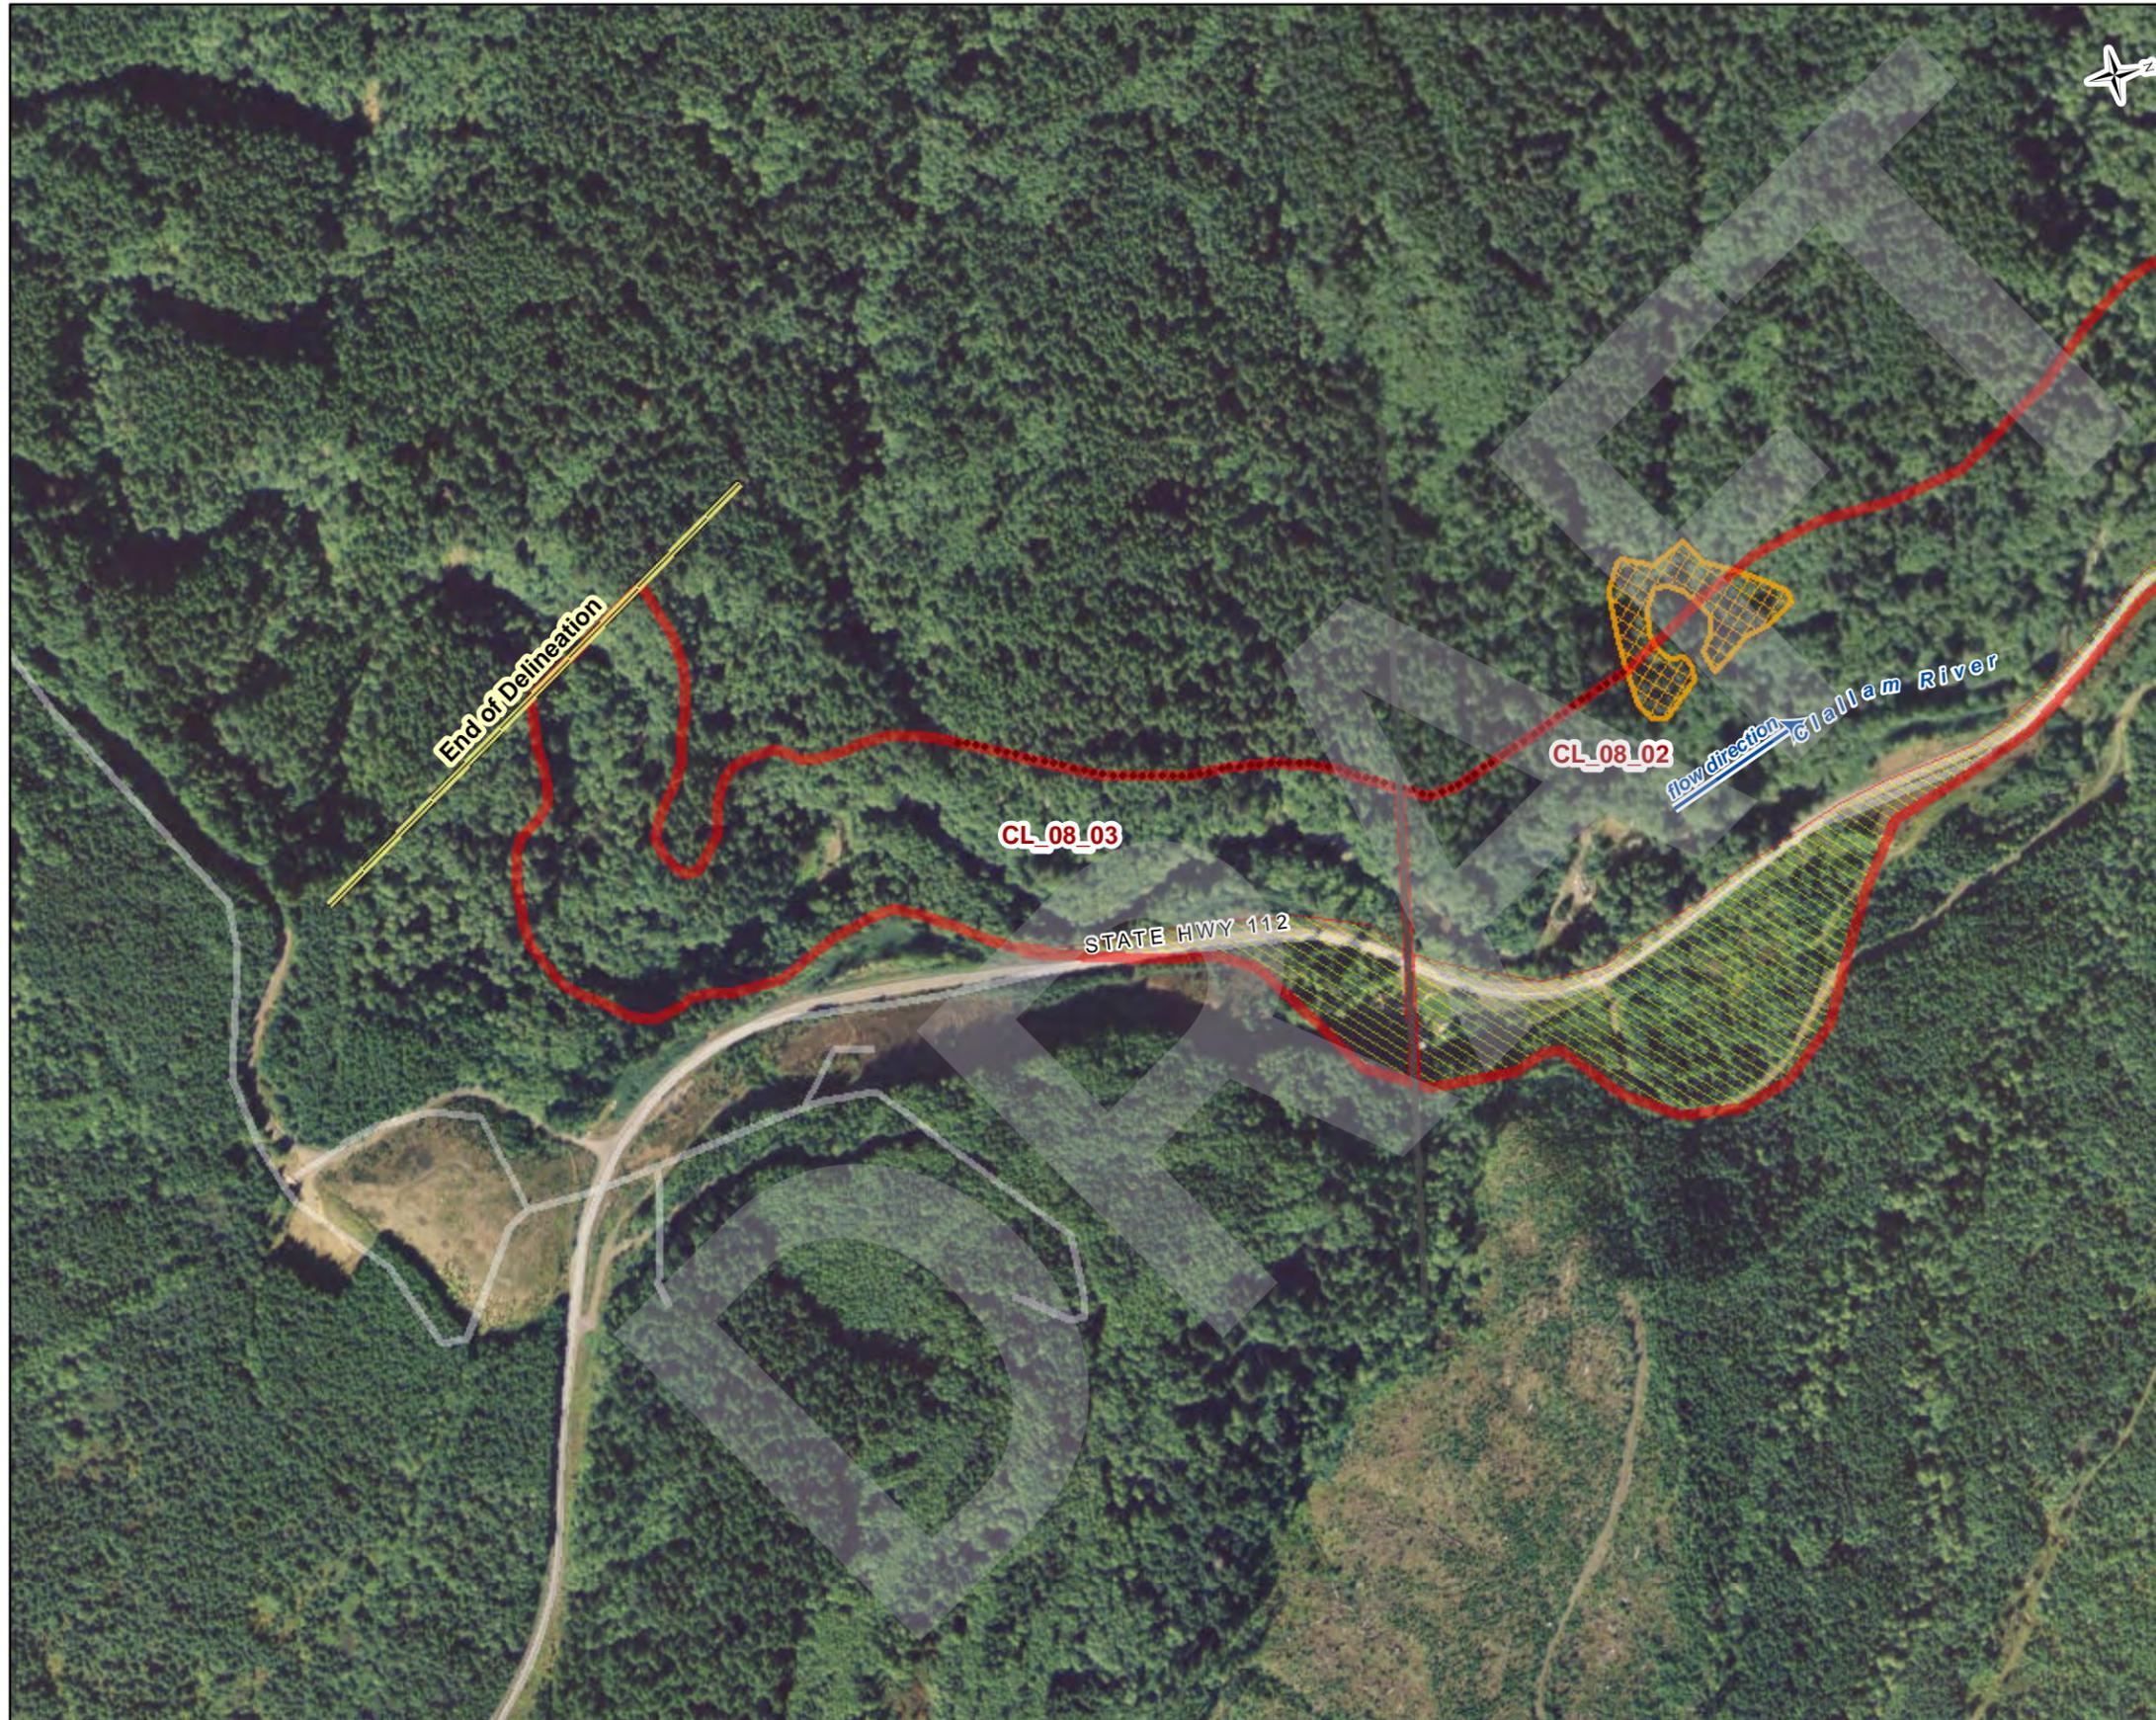
Map 34

2004 LIDAR topography (Puget Sound LIDAR Consortium).
 10 m USGS Hillshade
 2006 and 2009 aeriels from ESRI World Imagery
 WA State Dept of Nat. Resources 1:100,000 Geology
 River miles calculated from NHD stream alignment (USGS)
 Roads from TIGER (US Census Bureau)
 Coordinate System: State Plane Washington North

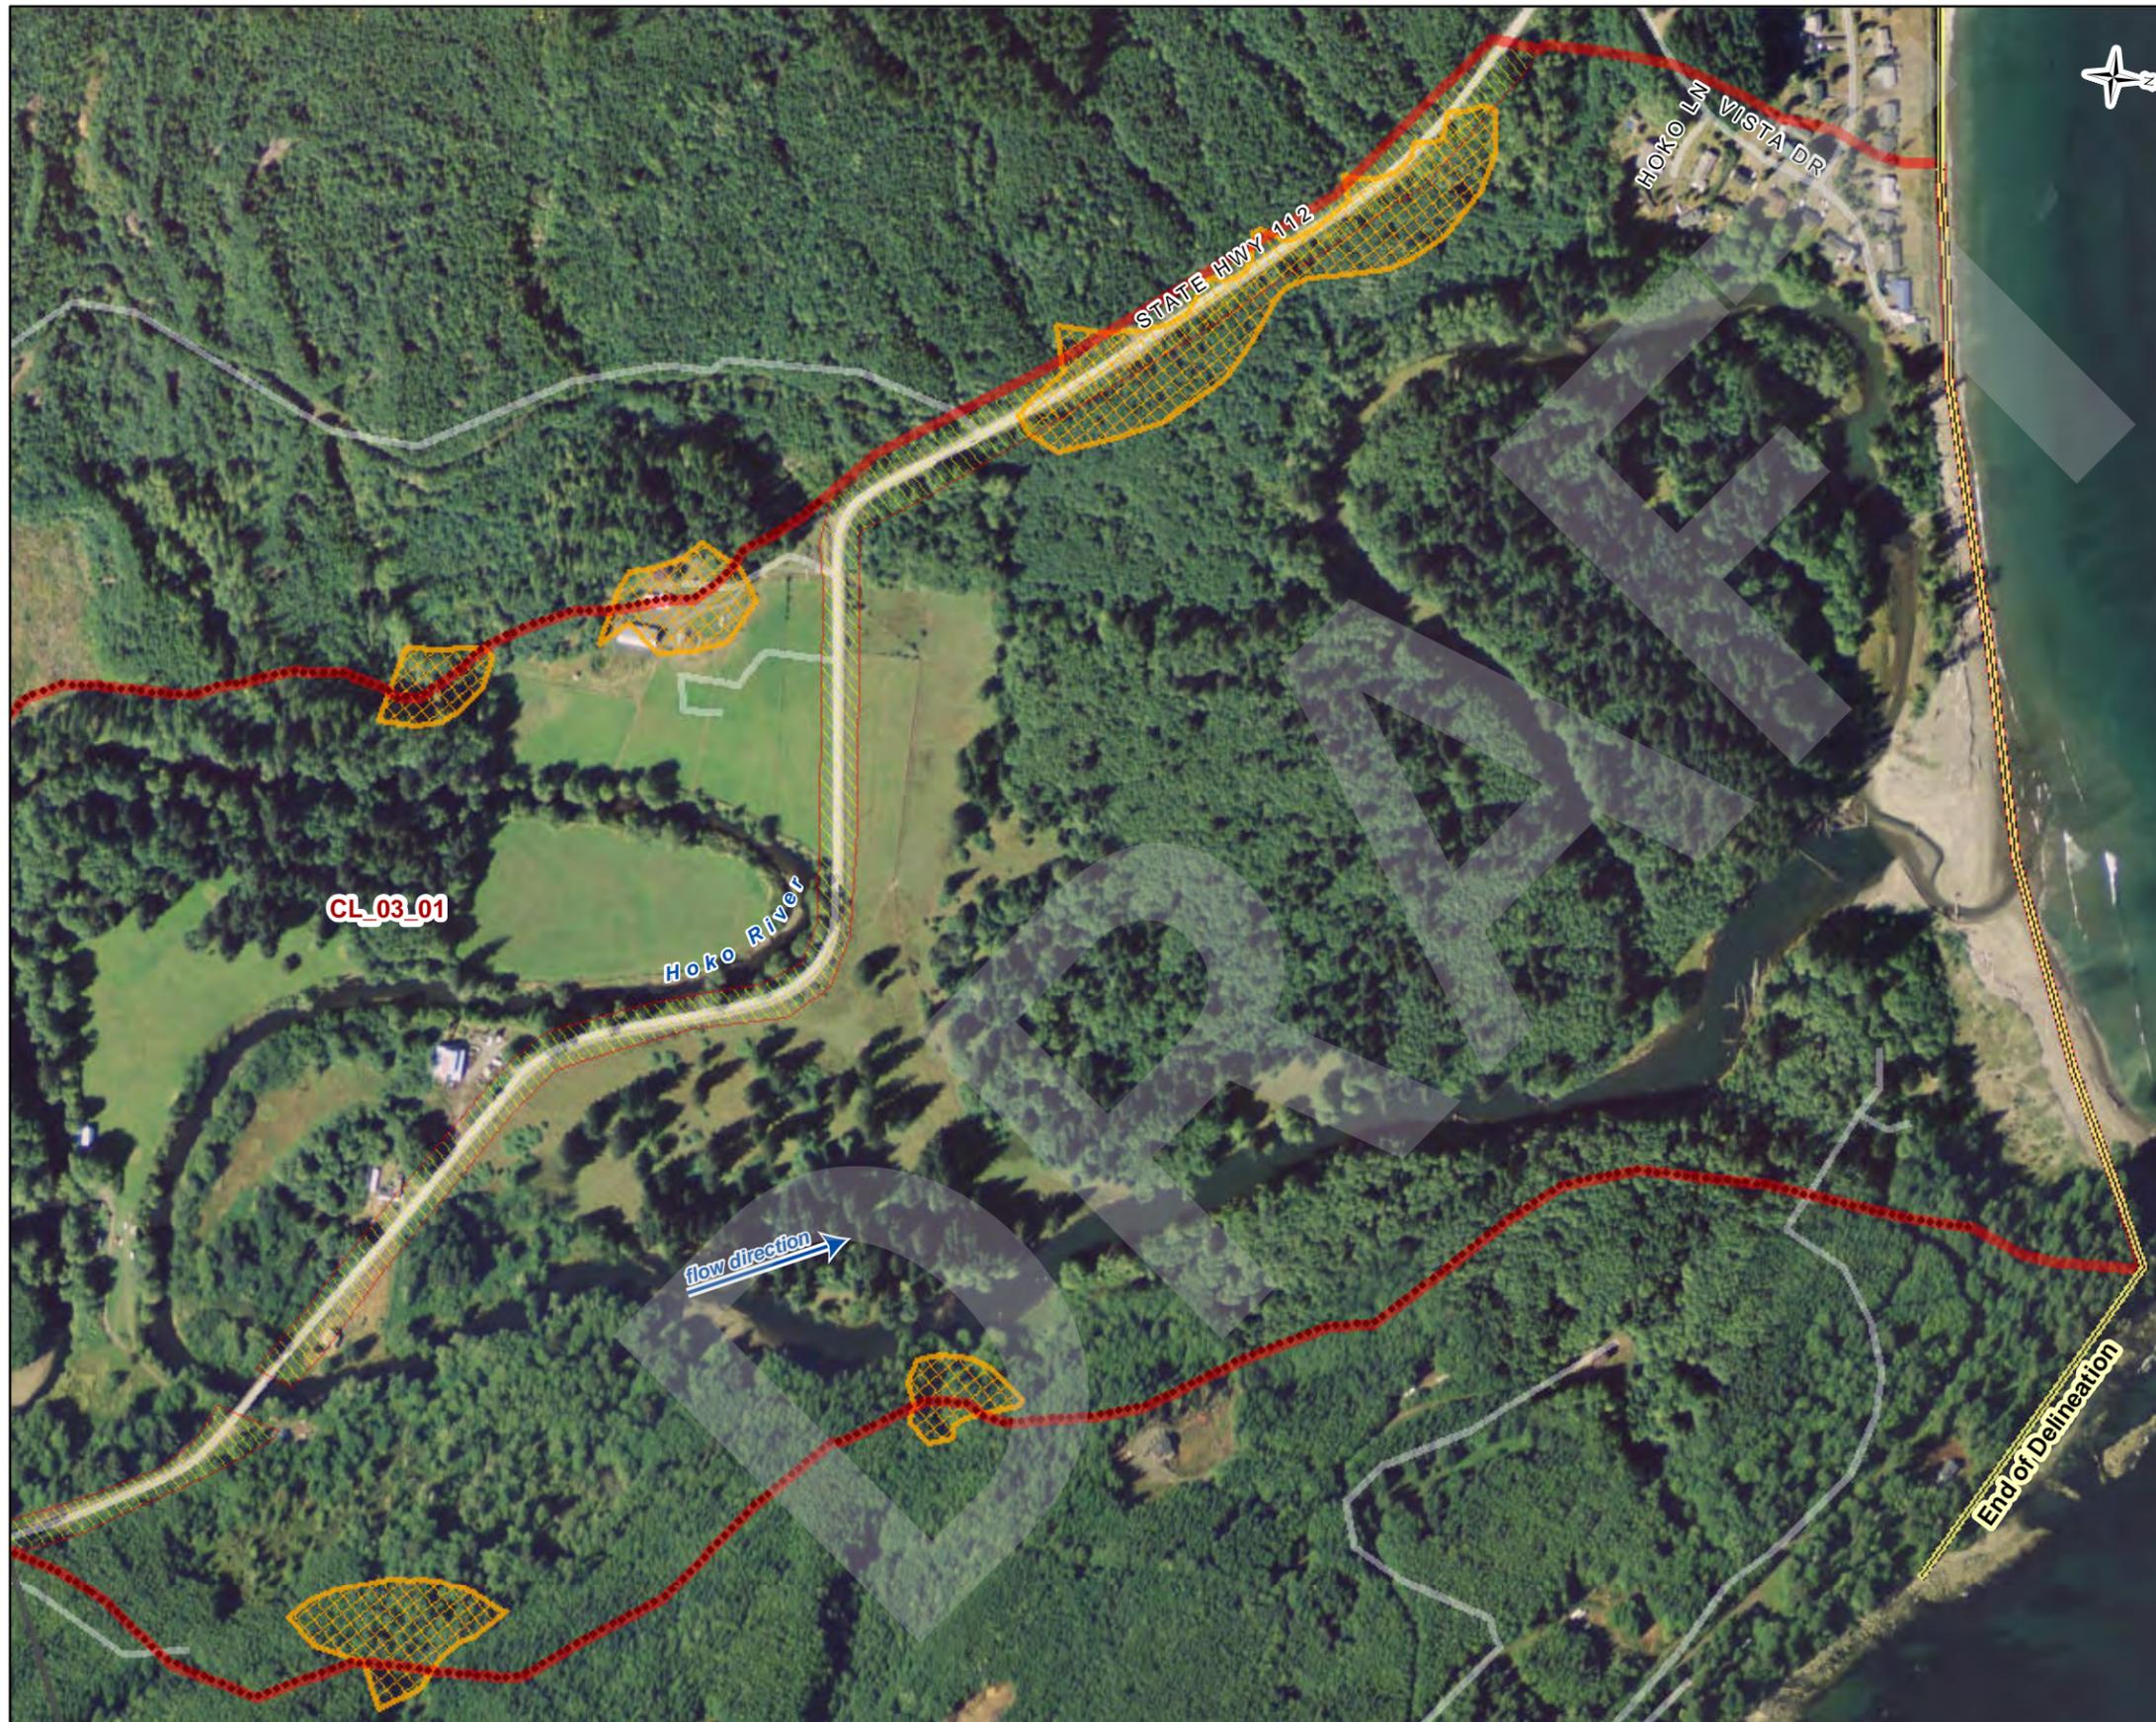
Map 35

2004 LIDAR topography (Puget Sound LIDAR Consortium).
 10 m USGS Hillshade
 2006 and 2009 aeriels from ESRI World Imagery
 WA State Dept of Nat. Resources 1:100,000 Geology
 River miles calculated from NHD stream alignment (USGS)
 Roads from TIGER (US Census Bureau)
 Coordinate System: State Plane Washington North
