SHORELINE INVENTORY AND CHARACTERIZATION REPORT

**for Portions of Clallam County Draining to the Strait of Juan de
Fuca**

Clallam County Shoreline Master Program Update

March 2012

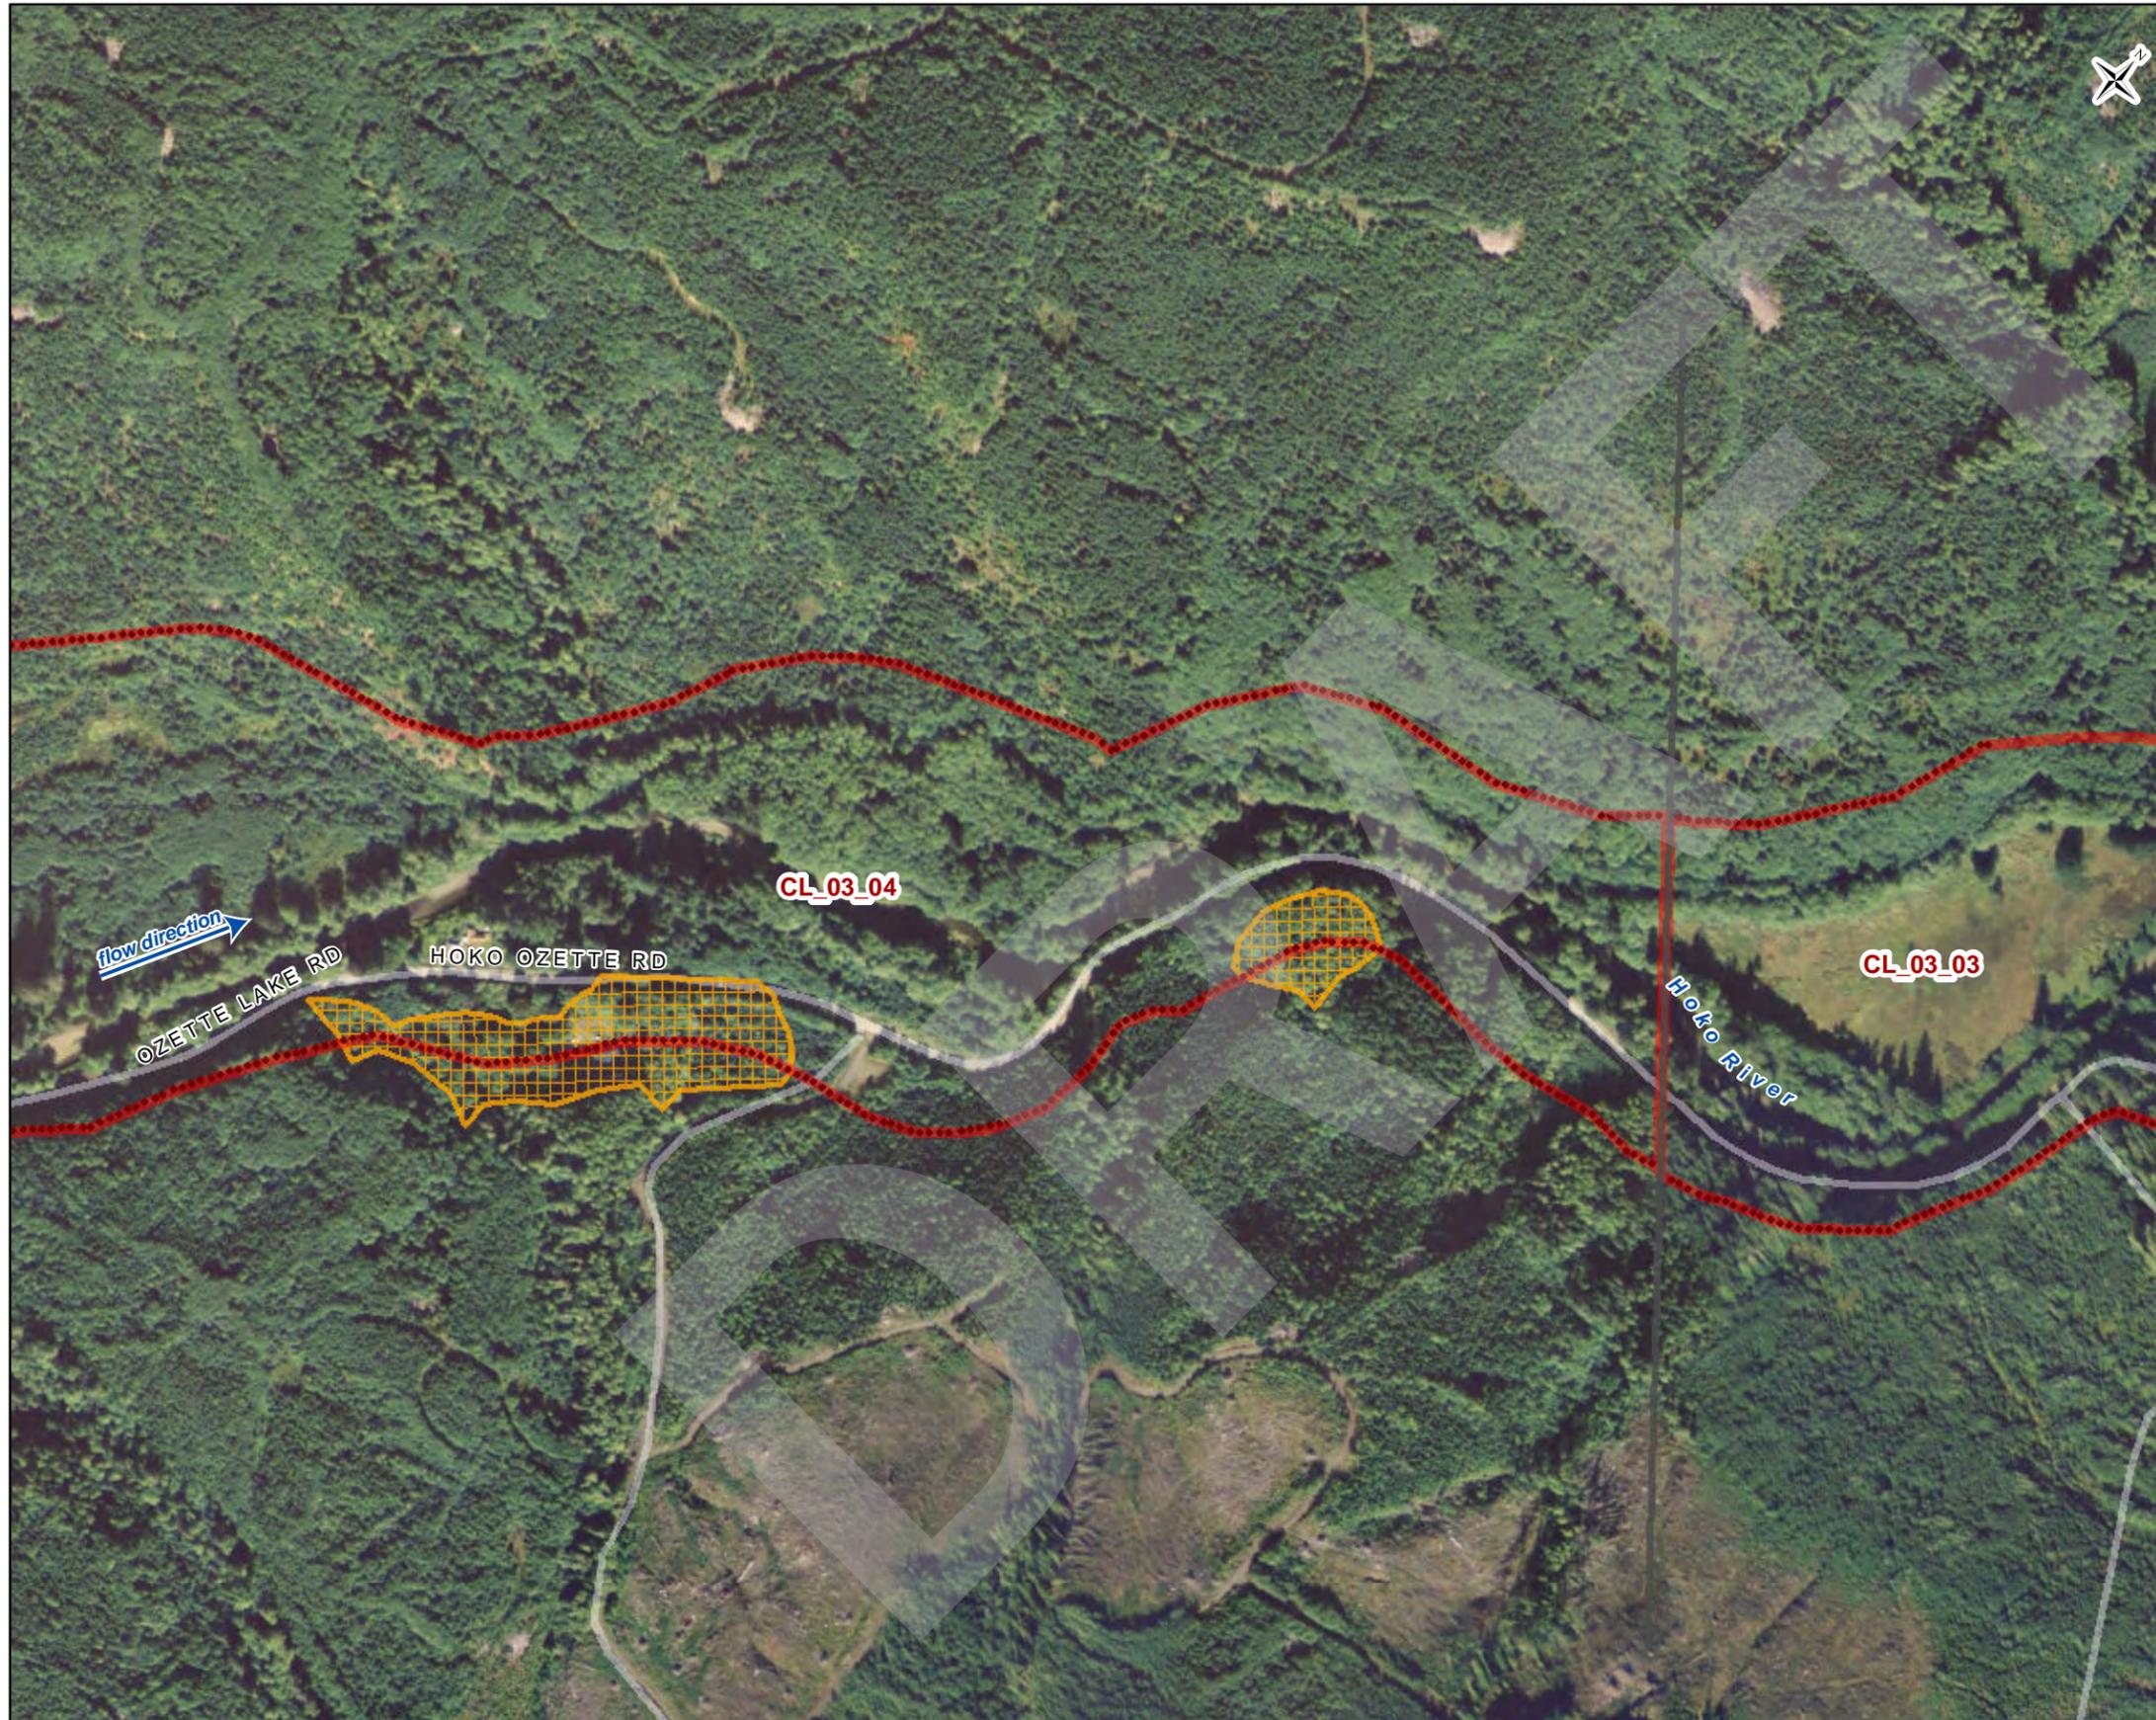
Map 16

2004 LIDAR topography (Puget Sound LIDAR Consortium).
 10 m USGS Hillshade
 2006 and 2009 aeriels from ESRI World Imagery
 WA State Dept of Nat. Resources 1:100,000 Geology
 River miles calculated from NHD stream alignment (USGS)
 Roads from TIGER (US Census Bureau)
 Coordinate System: State Plane Washington North

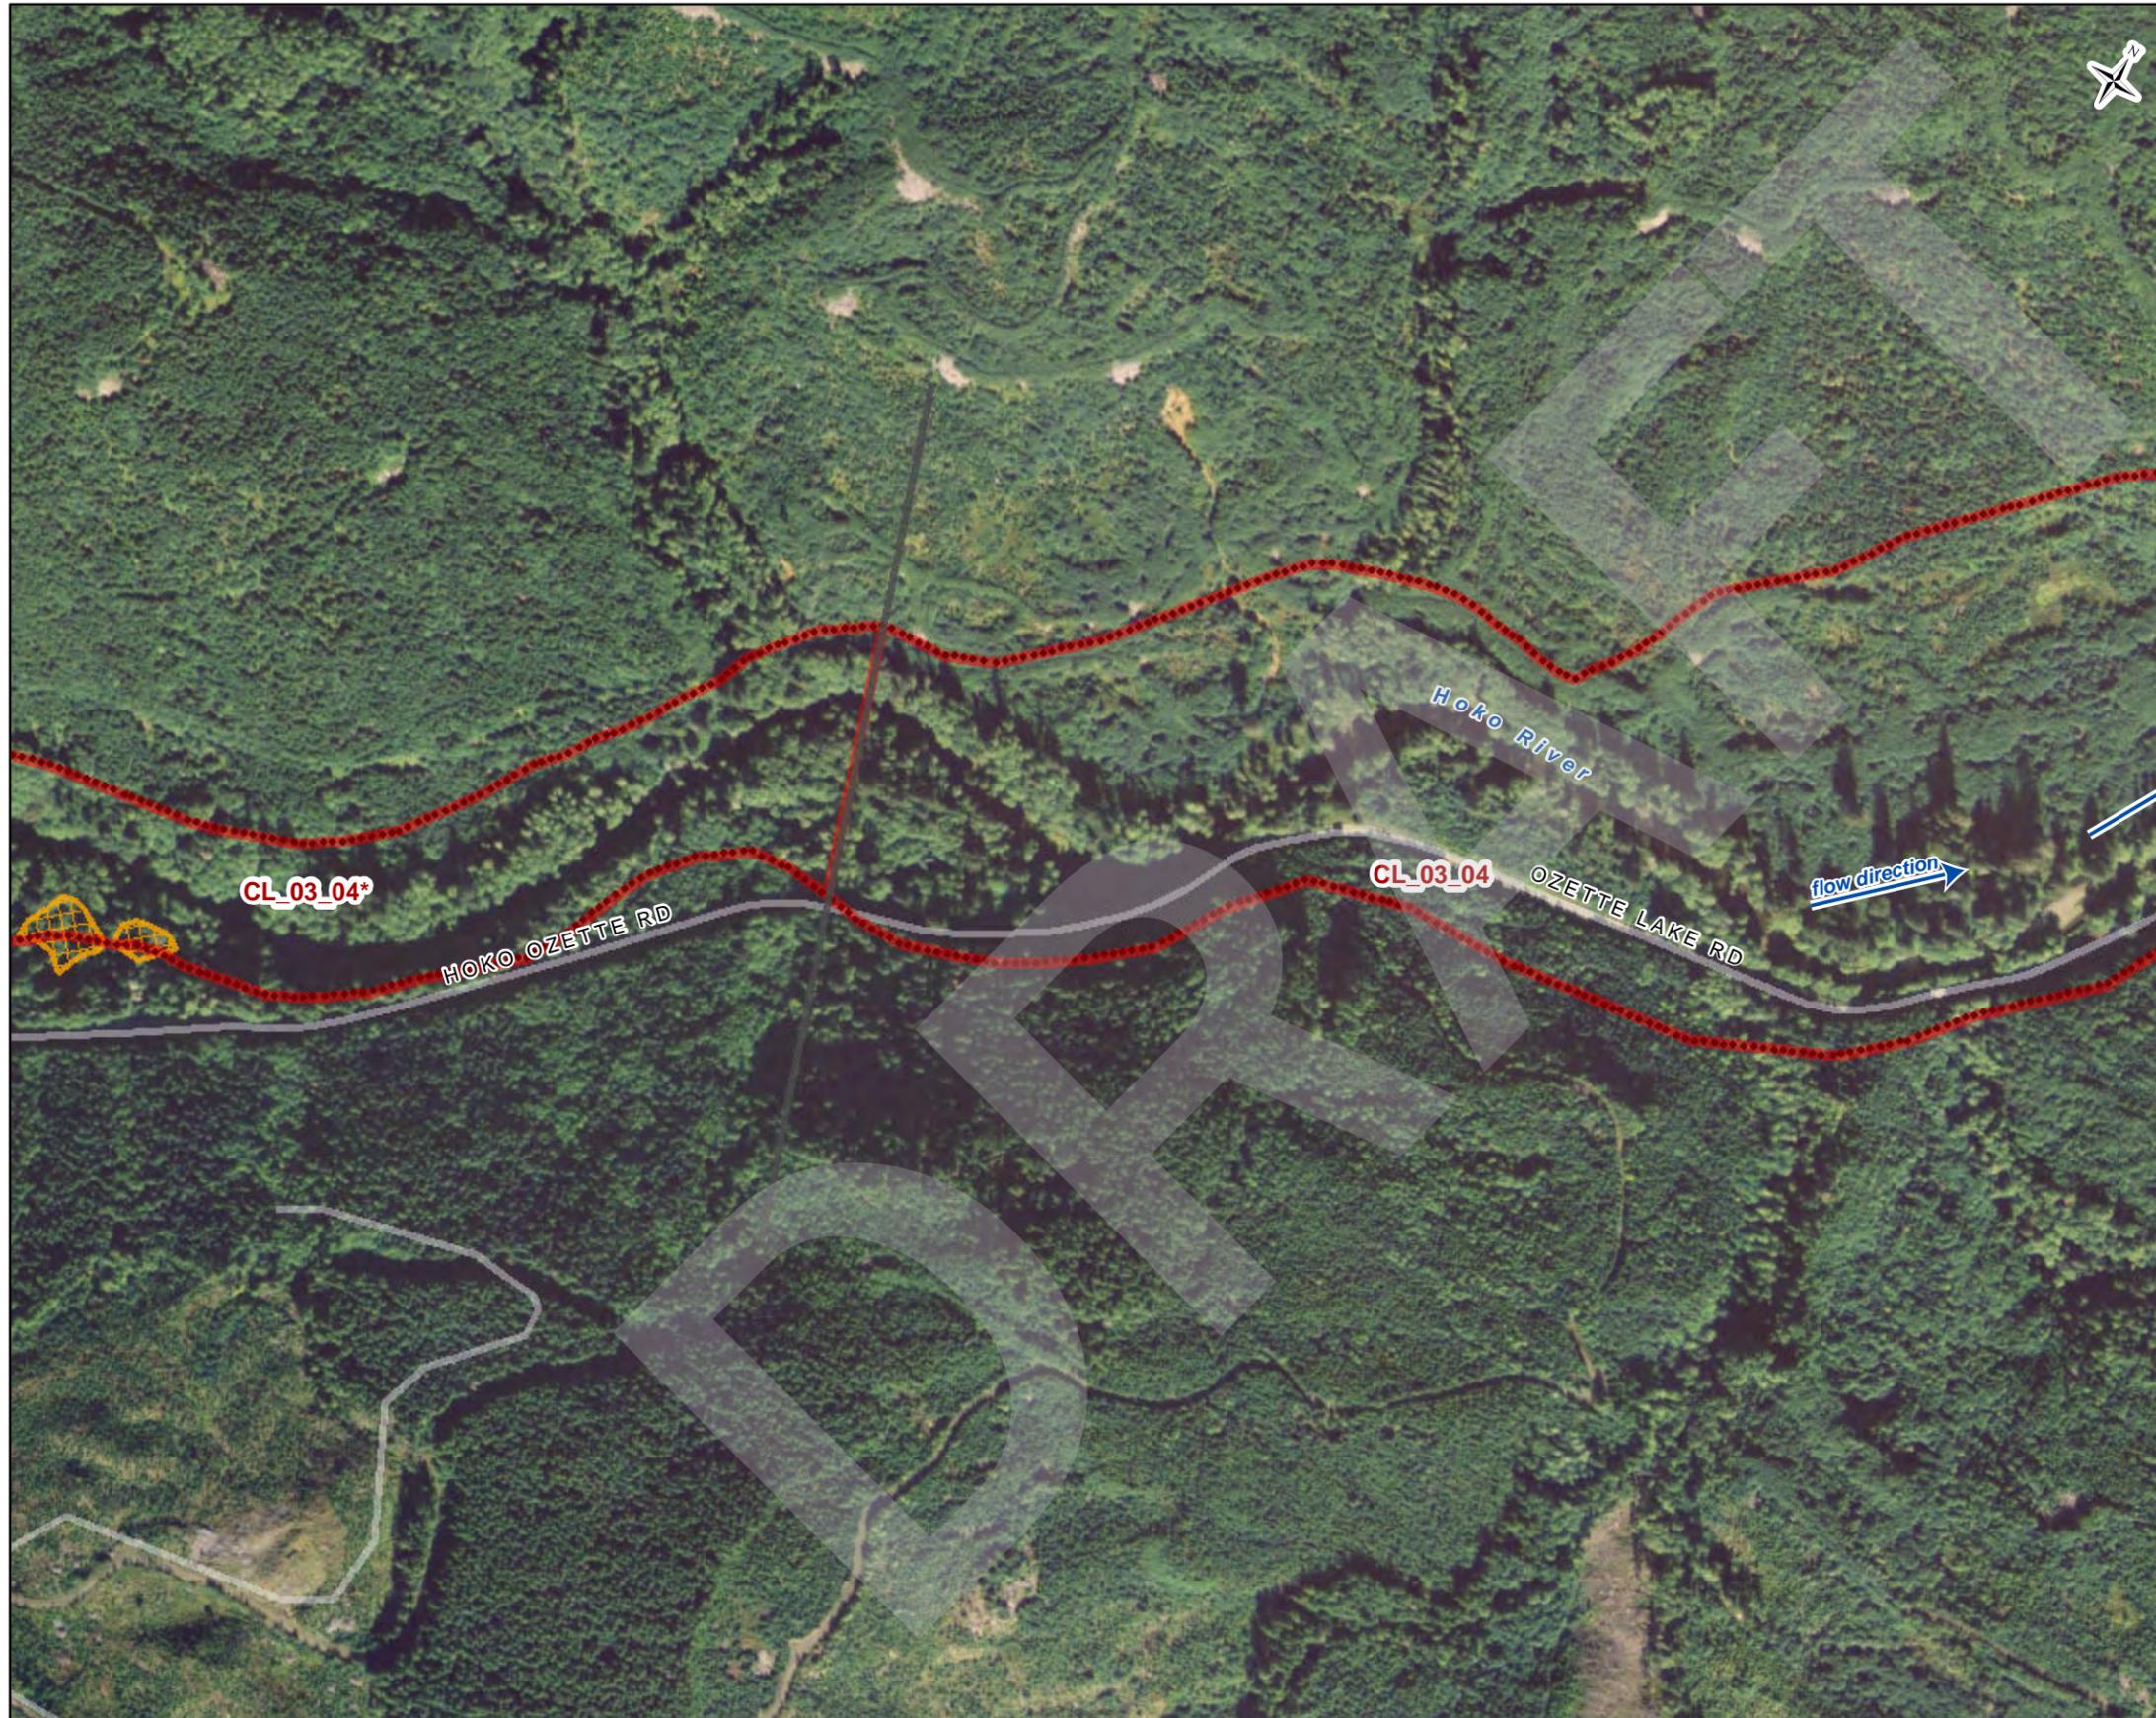
Map 17

2004 LIDAR topography (Puget Sound LIDAR Consortium).
 10 m USGS Hillshade
 2006 and 2009 aerials from ESRI World Imagery
 WA State Dept of Nat. Resources 1:100,000 Geology
 River miles calculated from NHD stream alignment (USGS)
 Roads from TIGER (US Census Bureau)
 Coordinate System: State Plane Washington North

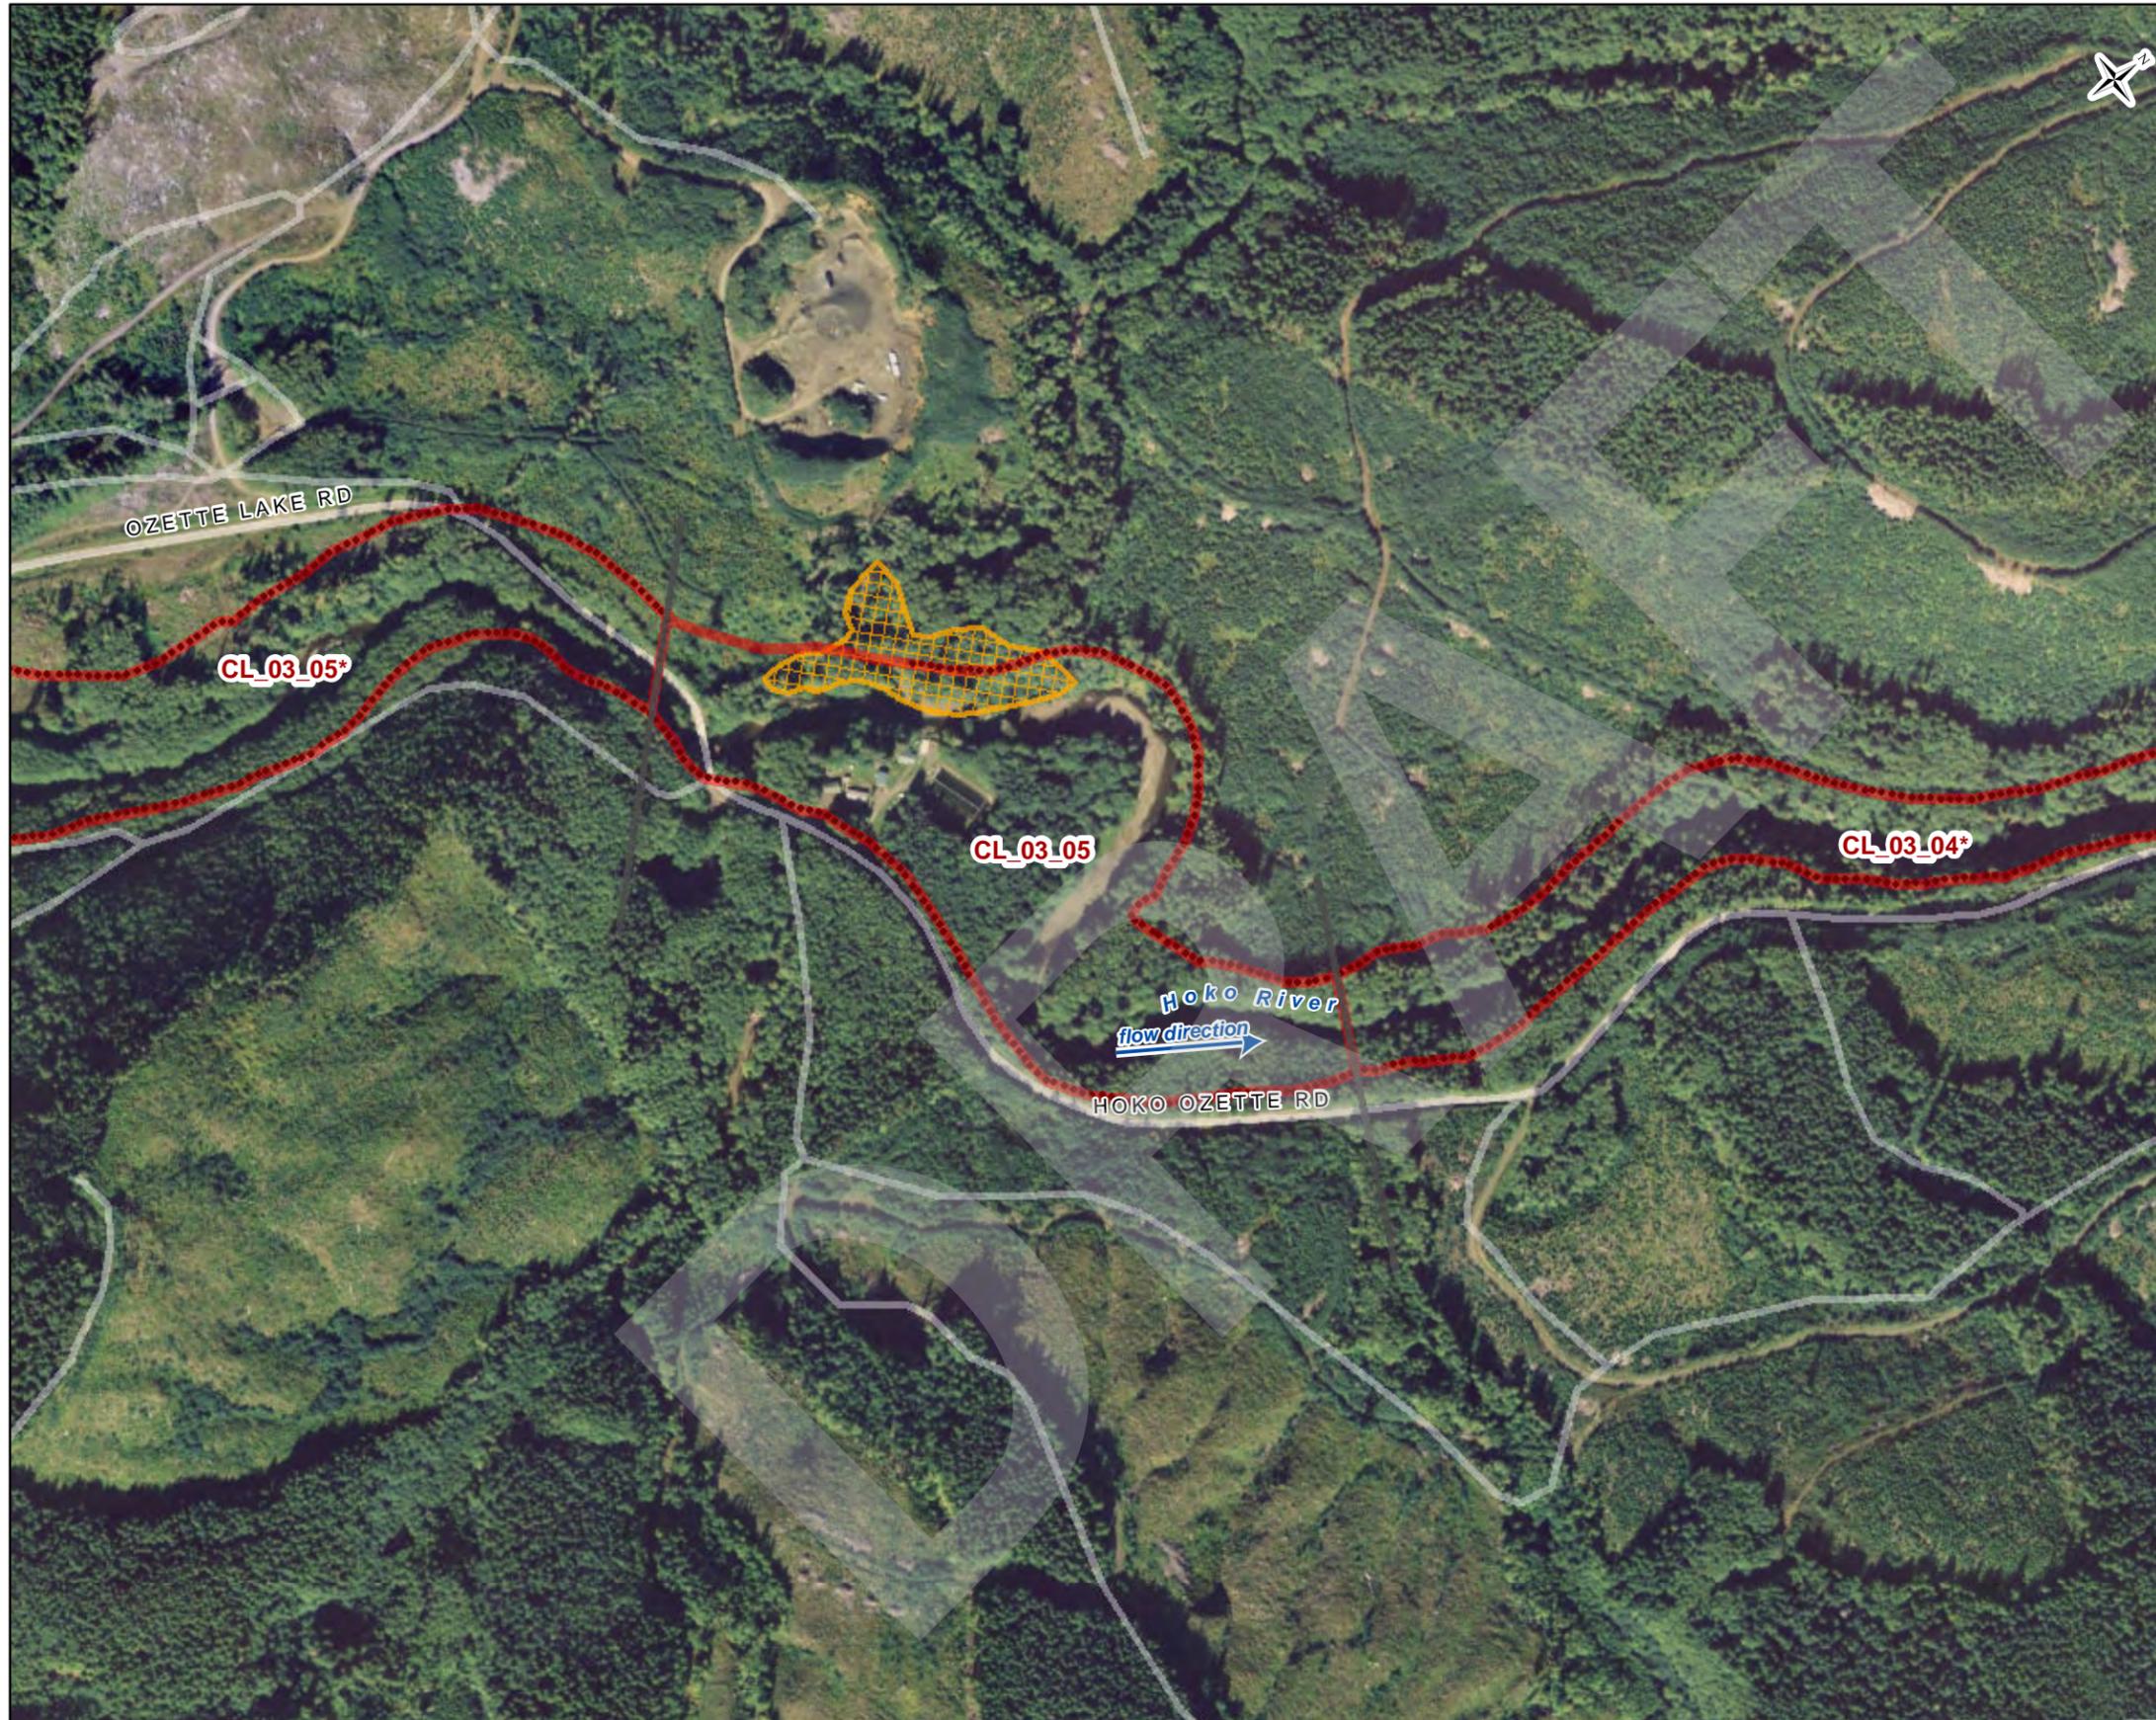
Hoko River **Map 20**

2004 LIDAR topography (Puget Sound LIDAR Consortium).
 10 m USGS Hillshade
 2006 and 2009 aerials from ESRI World Imagery
 WA State Dept of Nat. Resources 1:100,000 Geology
 River miles calculated from NHD stream alignment (USGS)
 Roads from TIGER (US Census Bureau)
 Coordinate System: State Plane Washington North

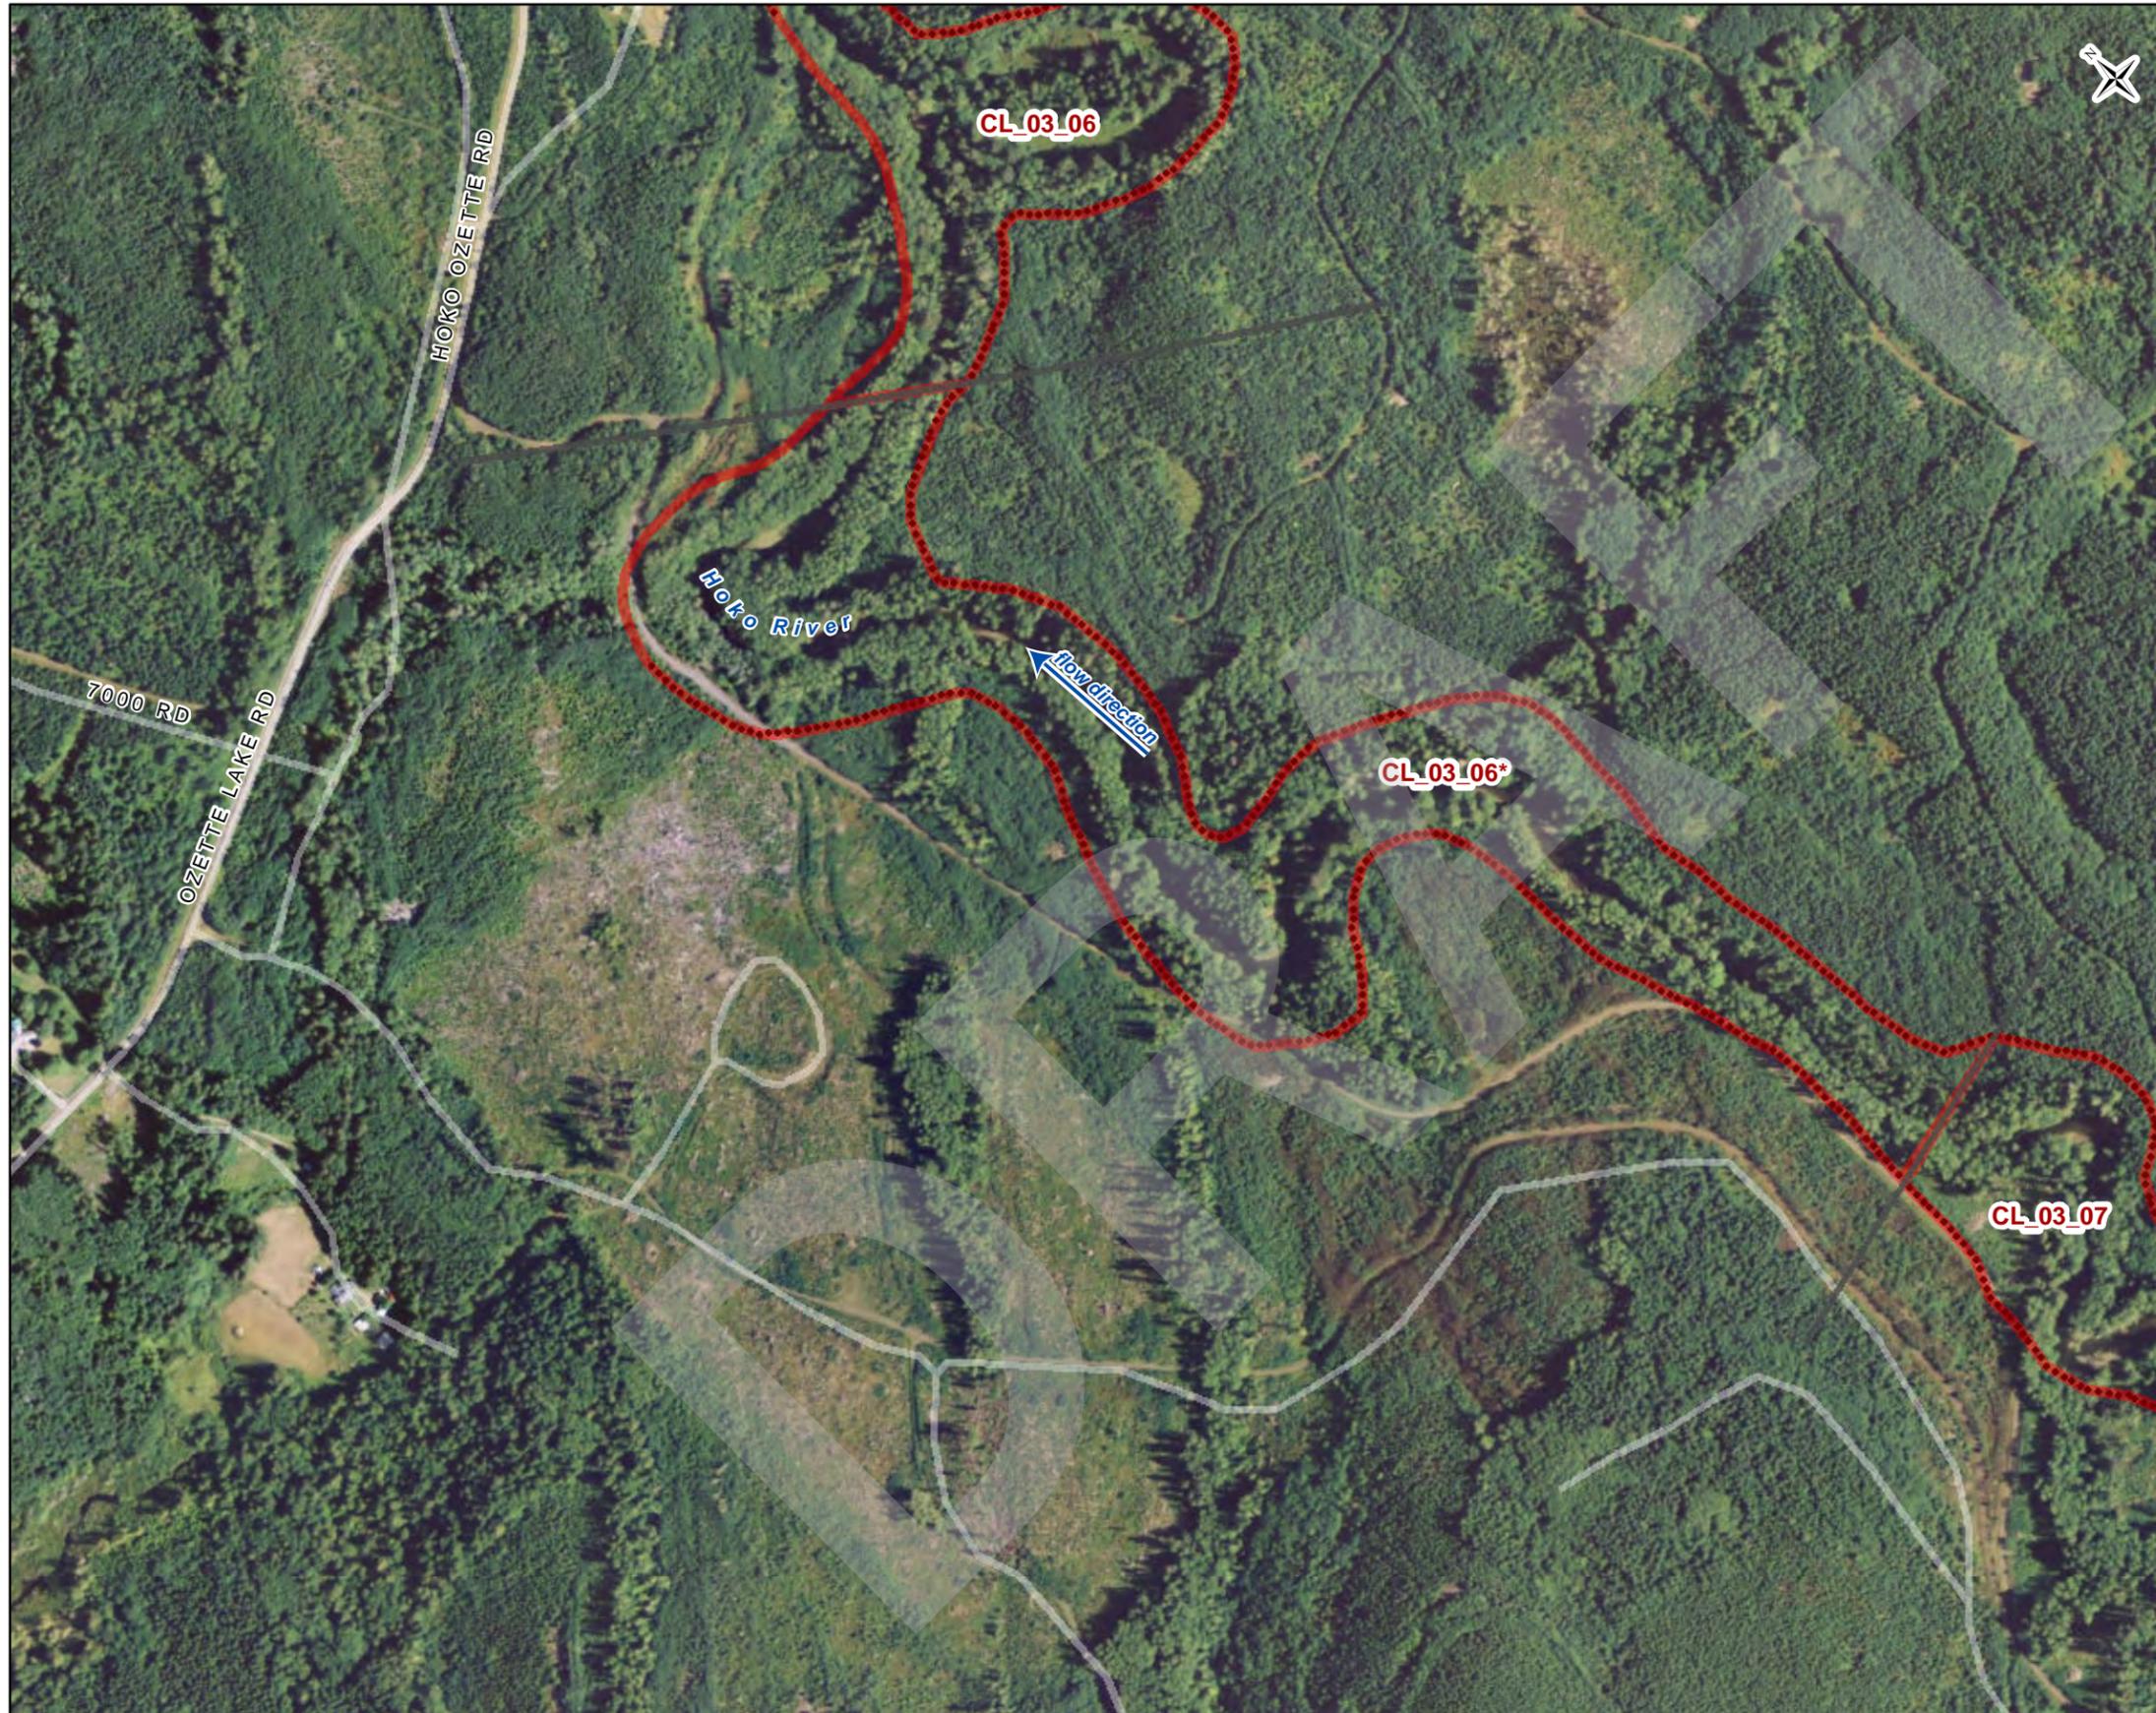
Hoko River **Map 22**

2004 LIDAR topography (Puget Sound LIDAR Consortium).
 10 m USGS Hillshade
 2006 and 2009 aeriols from ESRI World Imagery
 WA State Dept of Nat. Resources 1:100,000 Geology
 River miles calculated from NHD stream alignment (USGS)
 Roads from TIGER (US Census Bureau)
 Coordinate System: State Plane Washington North

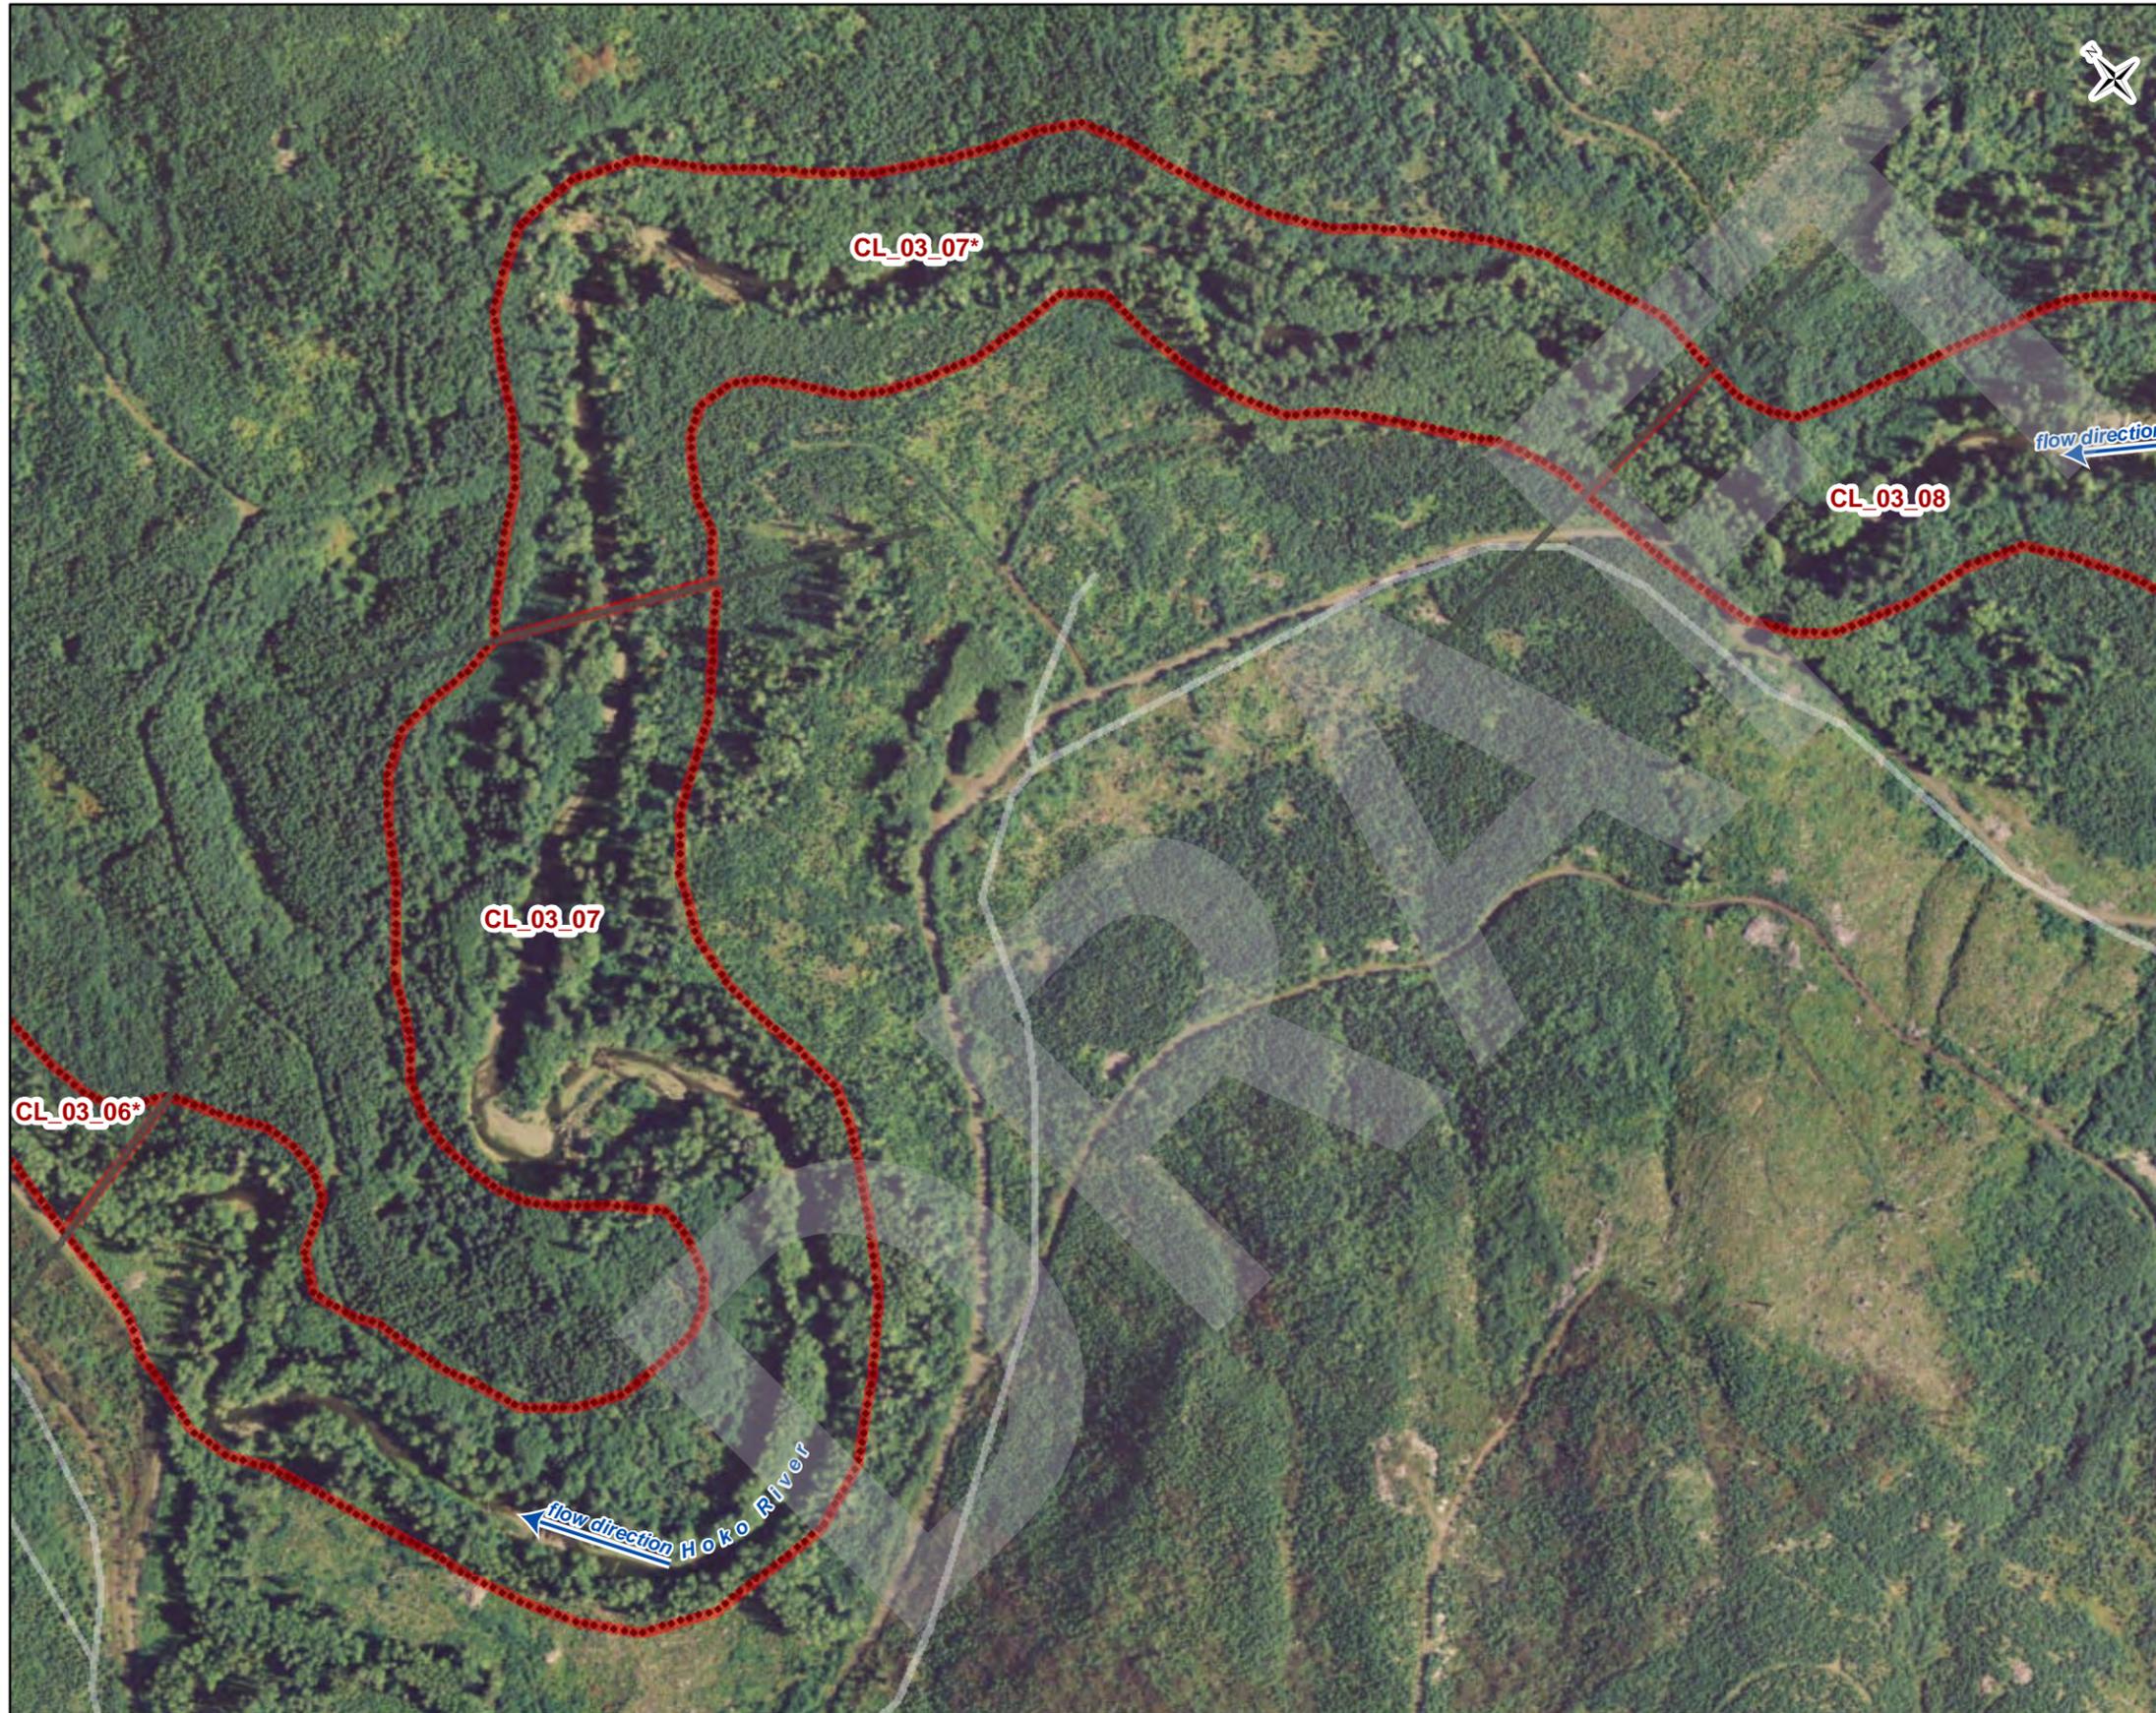
Hoko River **Map 23**

2004 LIDAR topography (Puget Sound LIDAR Consortium).
 10 m USGS Hillshade
 2006 and 2009 aerials from ESRI World Imagery
 WA State Dept of Nat. Resources 1:100,000 Geology
 River miles calculated from NHD stream alignment (USGS)
 Roads from TIGER (US Census Bureau)
 Coordinate System: State Plane Washington North

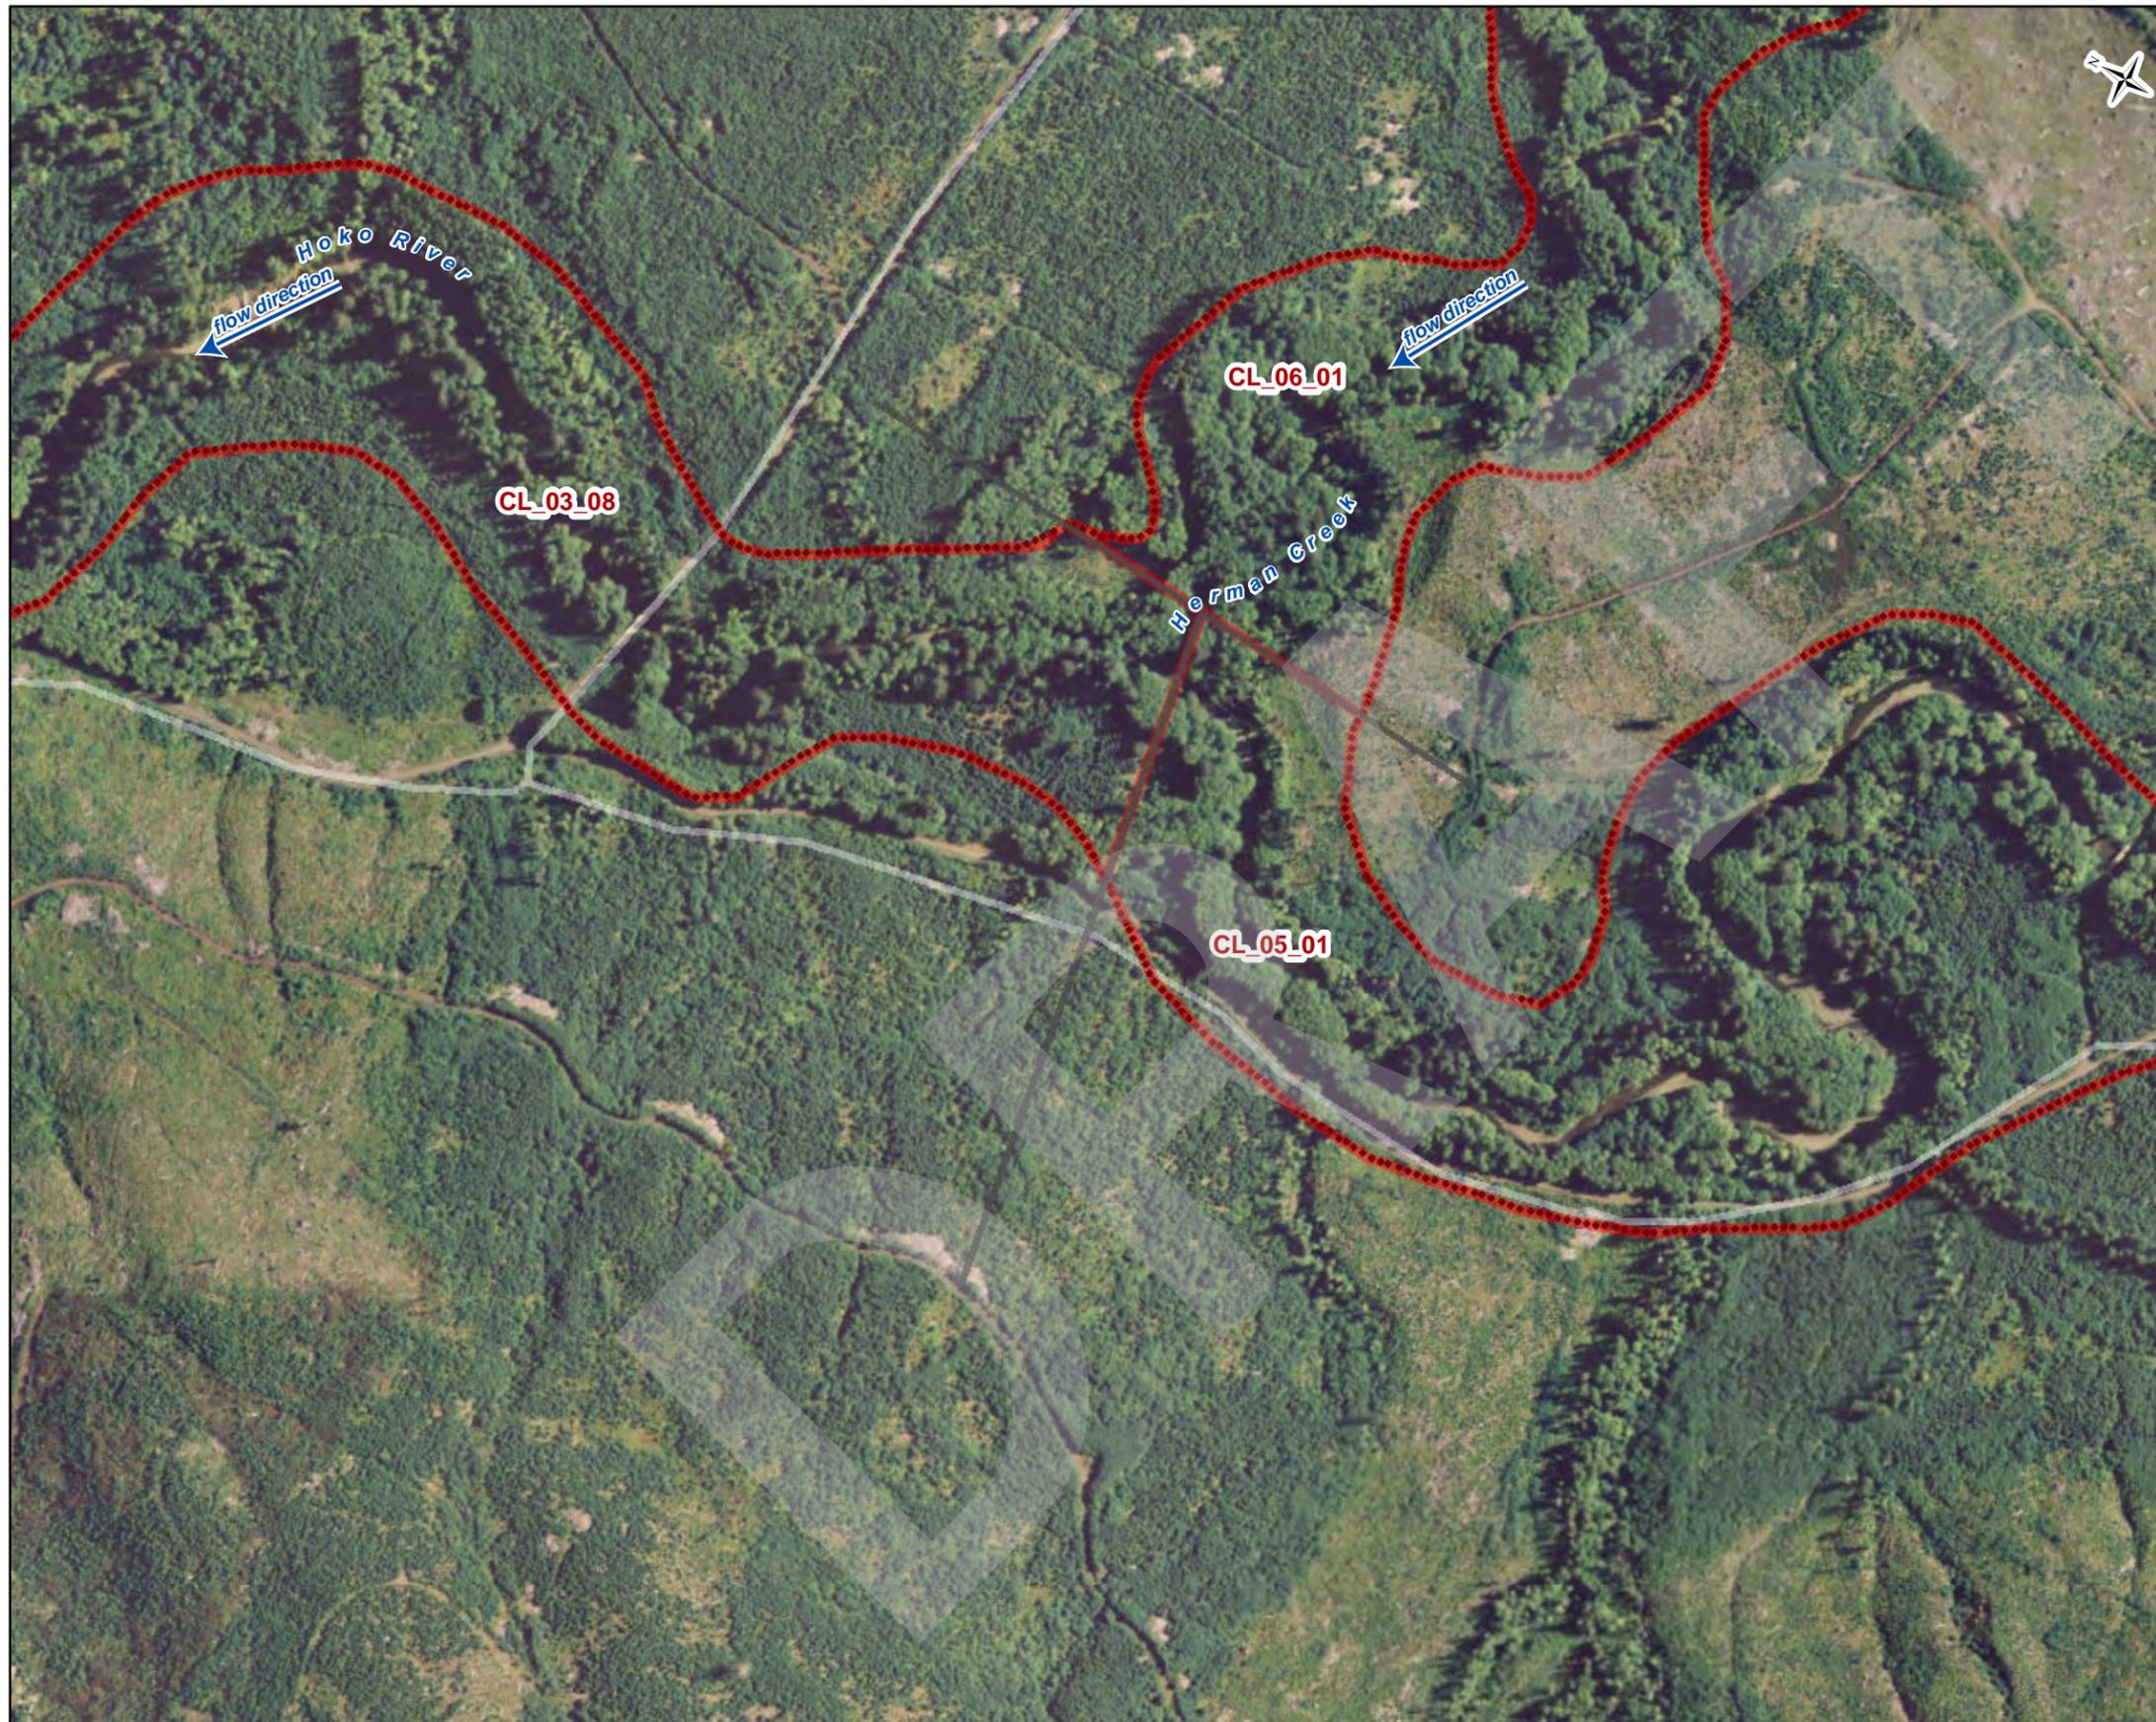
Map 24

2004 LIDAR topography (Puget Sound LIDAR Consortium).
 10 m USGS Hillshade
 2006 and 2009 aerials from ESRI World Imagery
 WA State Dept of Nat. Resources 1:100,000 Geology
 River miles calculated from NHD stream alignment (USGS)
 Roads from TIGER (US Census Bureau)
 Coordinate System: State Plane Washington North
