SHORELINE INVENTORY AND CHARACTERIZATION REPORT

**for Portions of Clallam County Draining to the Strait of Juan de
Fuca**

Clallam County Shoreline Master Program Update

March 2012

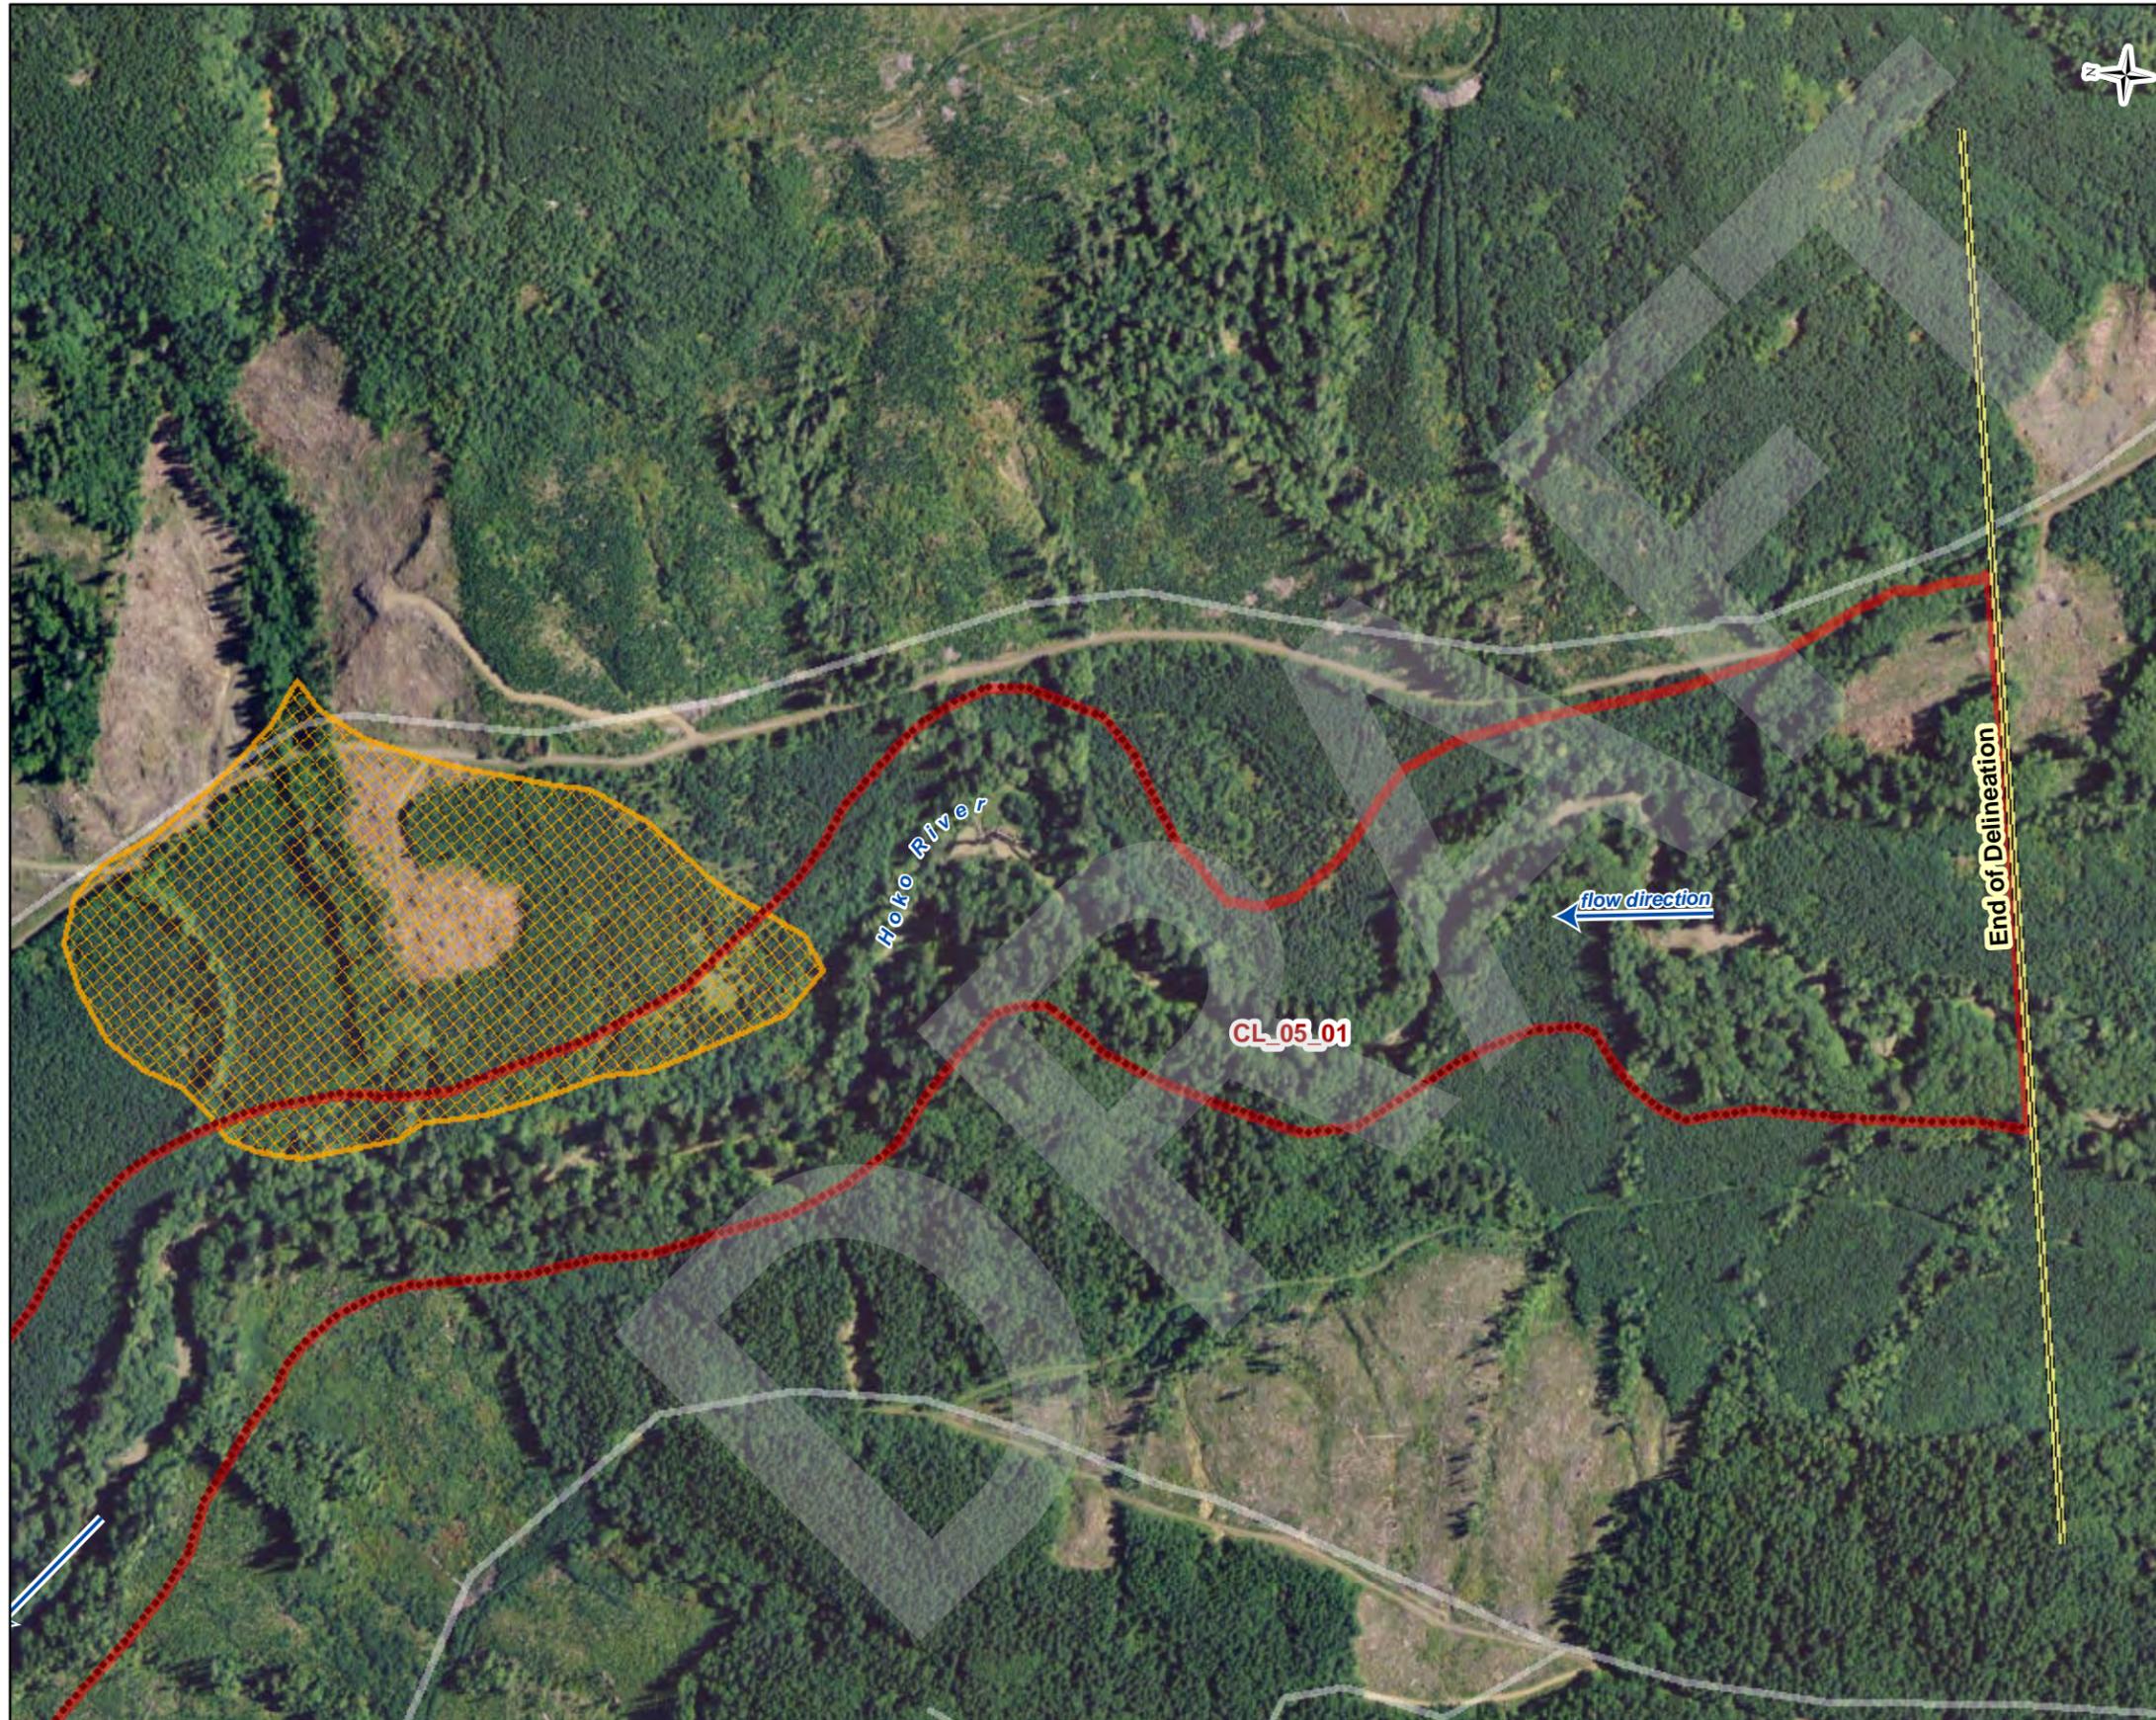
Hoko River **Map 27**

2004 LIDAR topography (Puget Sound LIDAR Consortium).
 10 m USGS Hillshade
 2006 and 2009 aeriels from ESRI World Imagery
 WA State Dept of Nat. Resources 1:100,000 Geology
 River miles calculated from NHD stream alignment (USGS)
 Roads from TIGER (US Census Bureau)
 Coordinate System: State Plane Washington North

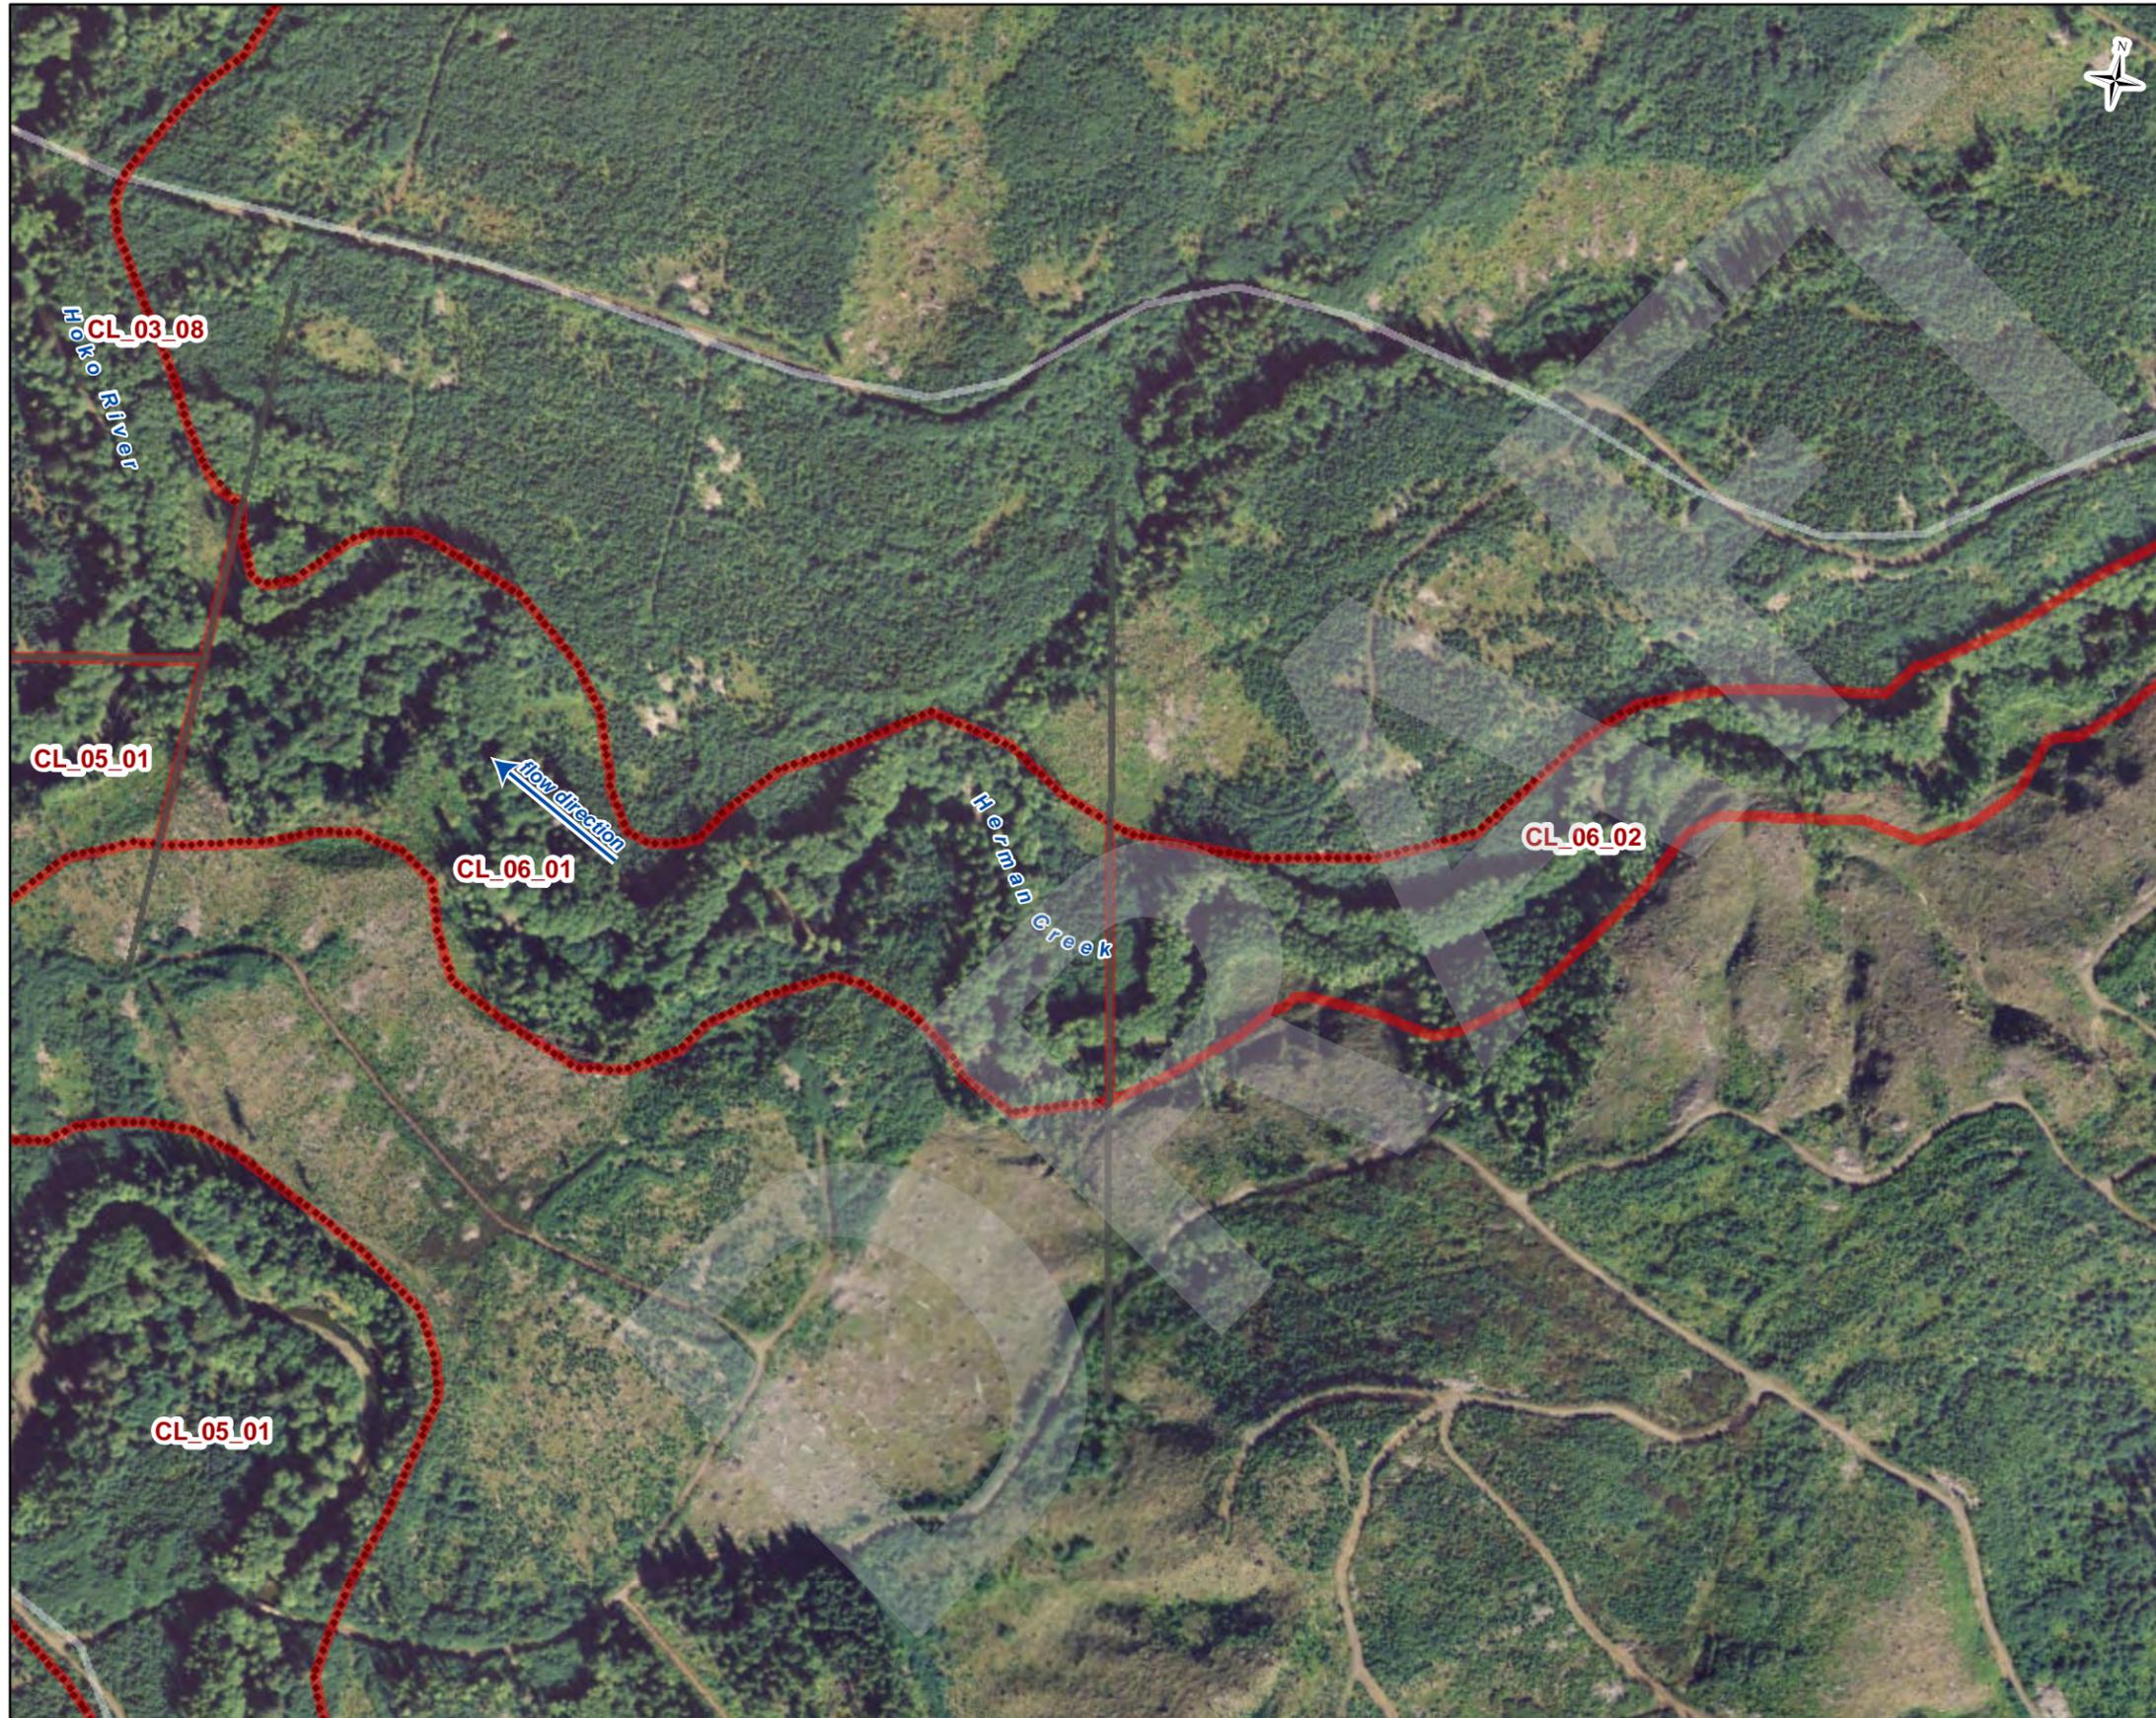
Map 28

2004 LIDAR topography (Puget Sound LIDAR Consortium).
 10 m USGS Hillshade
 2006 and 2009 aerials from ESRI World Imagery
 WA State Dept of Nat. Resources 1:100,000 Geology
 River miles calculated from NHD stream alignment (USGS)
 Roads from TIGER (US Census Bureau)
 Coordinate System: State Plane Washington North

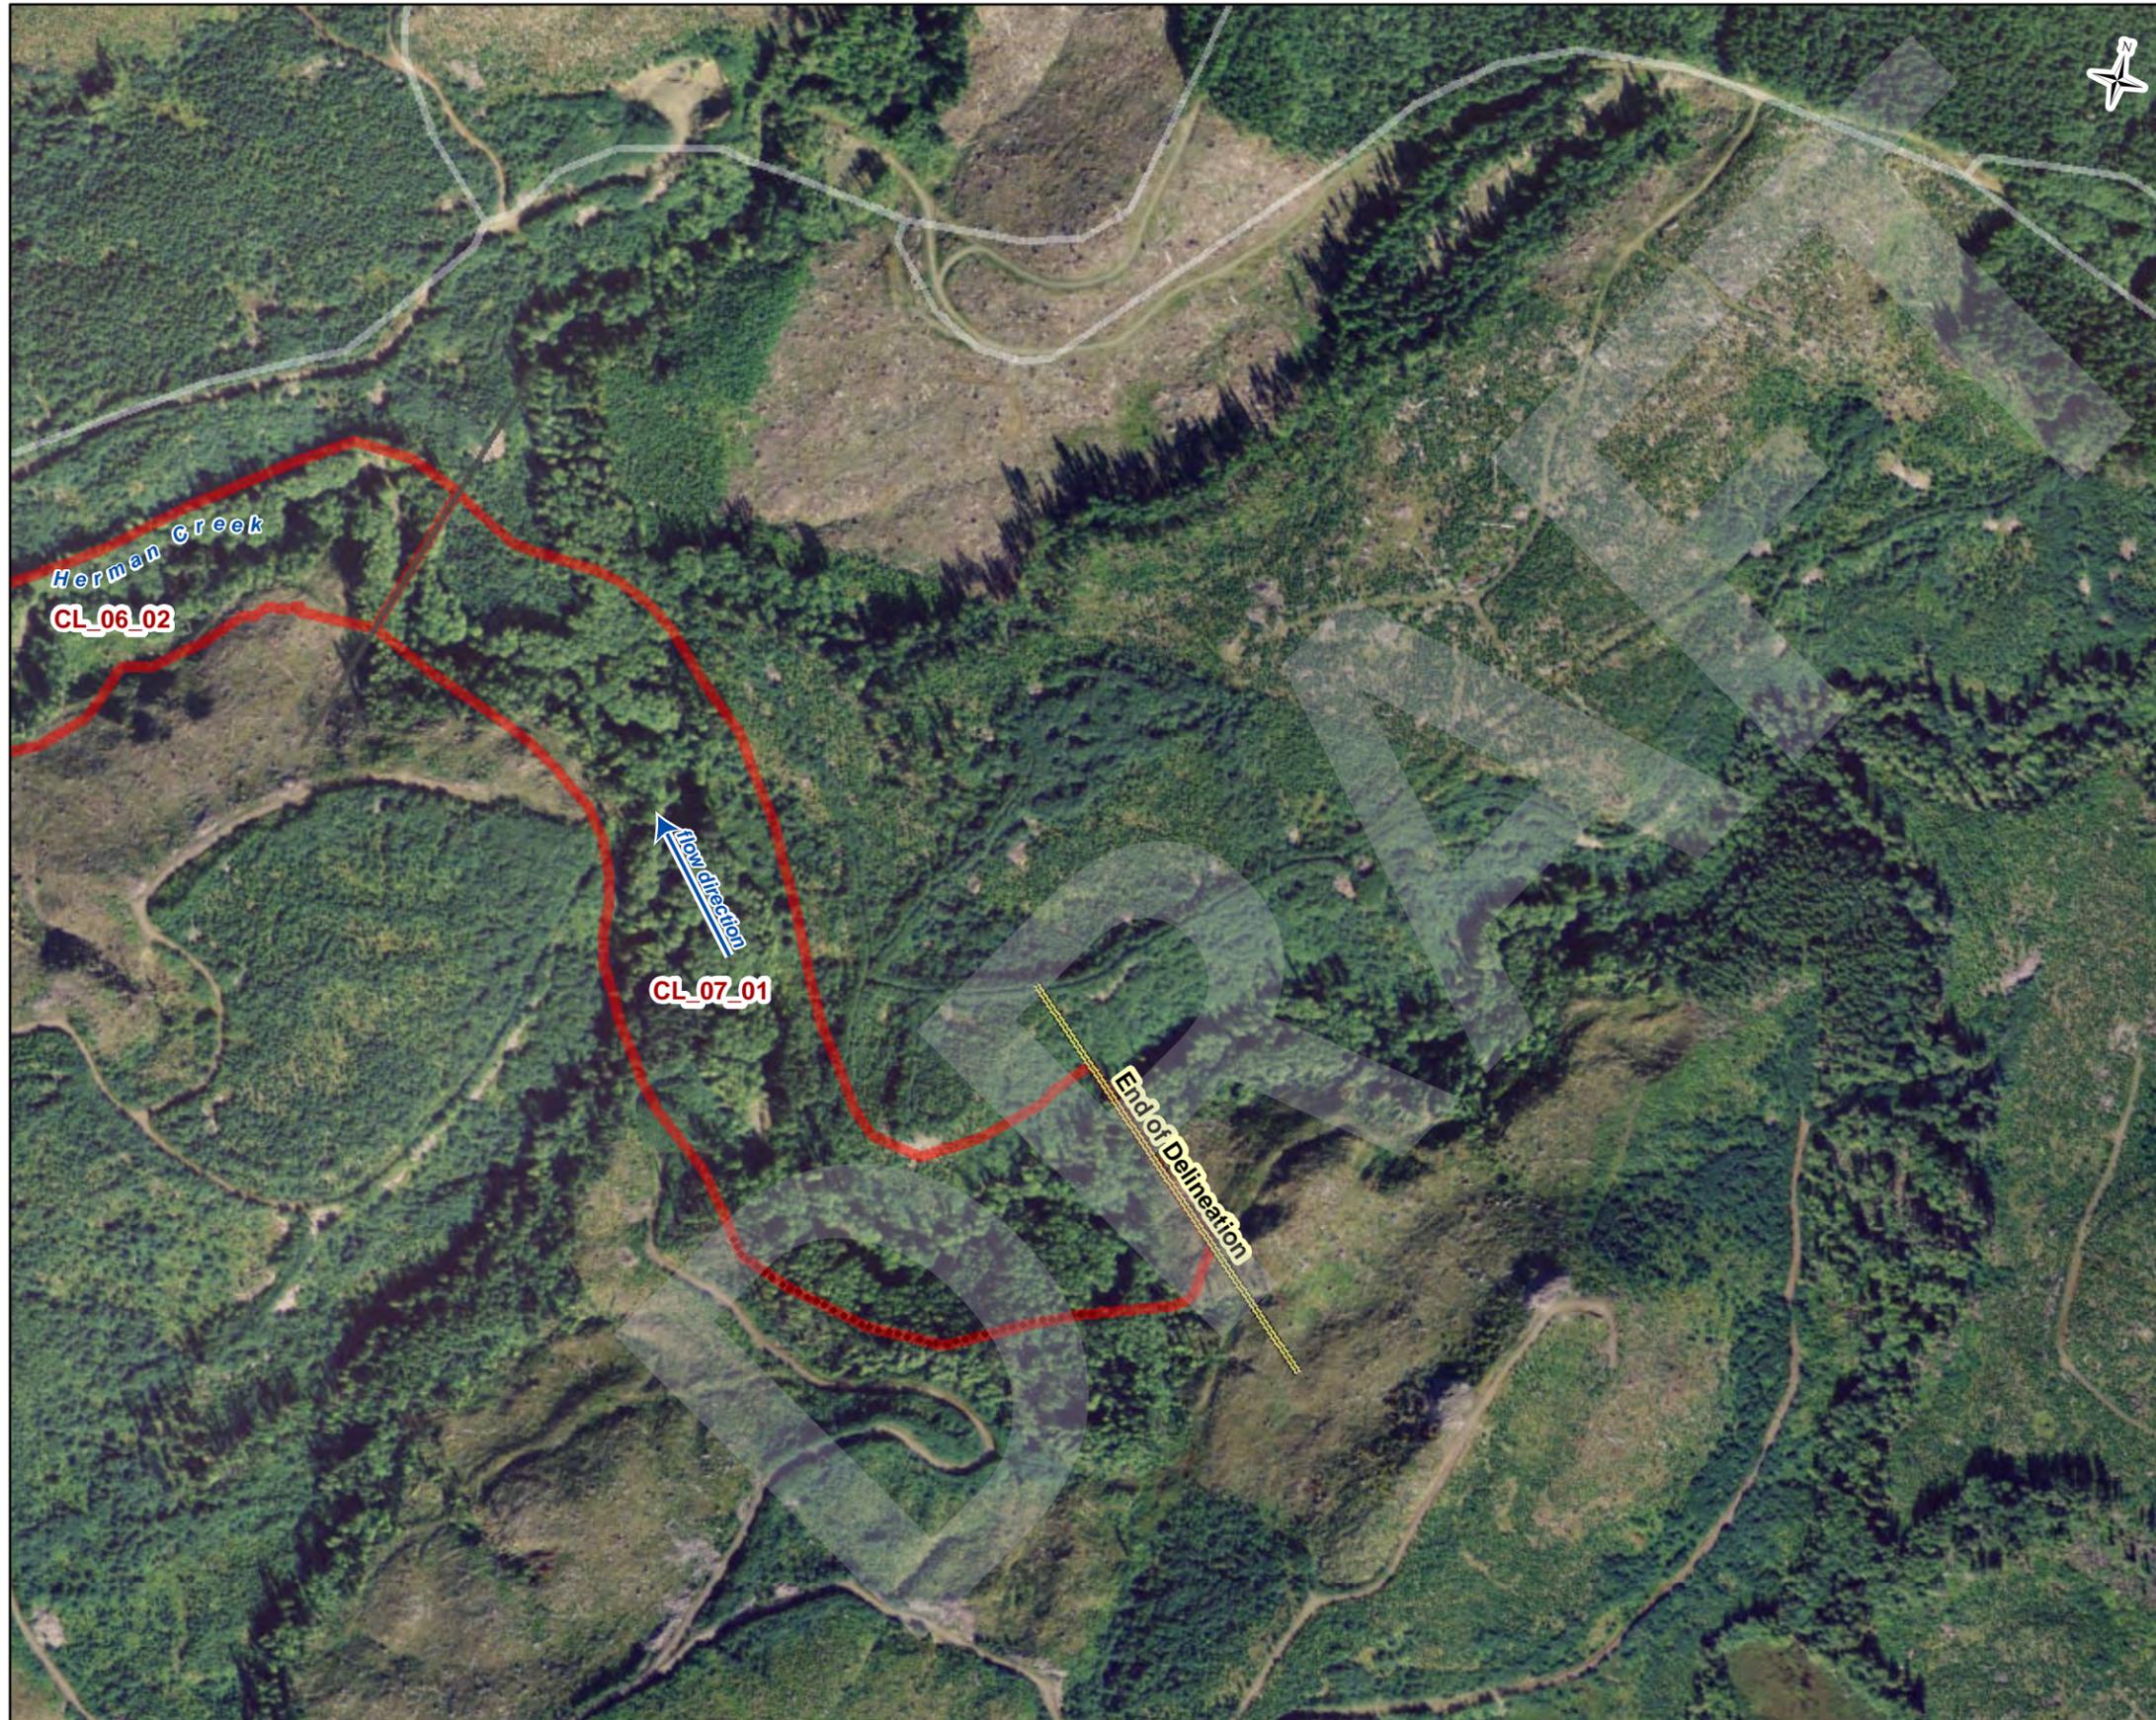
Map 29

2004 LIDAR topography (Puget Sound LIDAR Consortium).
 10 m USGS Hillshade
 2006 and 2009 aerials from ESRI World Imagery
 WA State Dept of Nat. Resources 1:100,000 Geology
 River miles calculated from NHD stream alignment (USGS)
 Roads from TIGER (US Census Bureau)
 Coordinate System: State Plane Washington North
