# Technical Memorandum

**To:** Ann Soule, Clallam County  
**From:** Tad Cline & Russ Prior, Pacific Groundwater Group  
**Re:** Installation of monitoring wells and staff gages in the lower Dungeness watershed  
**Date:** 9/30/2008

The purpose this memorandum is to document of the work completed to install monitoring wells and staff gages (stations) in the lower Dungeness watershed as part of Clallam County's aquifer storage and recovery grant project. The stations were installed to enable groundwater and surface water elevation monitoring by Clallam County (the County) during aquifer testing and over the long term. Work was conducted according to contract 100511-08-PGG and Amendments 1 and 2 between the County and Pacific Groundwater Group (PGG). This memorandum comprises the final project deliverable.

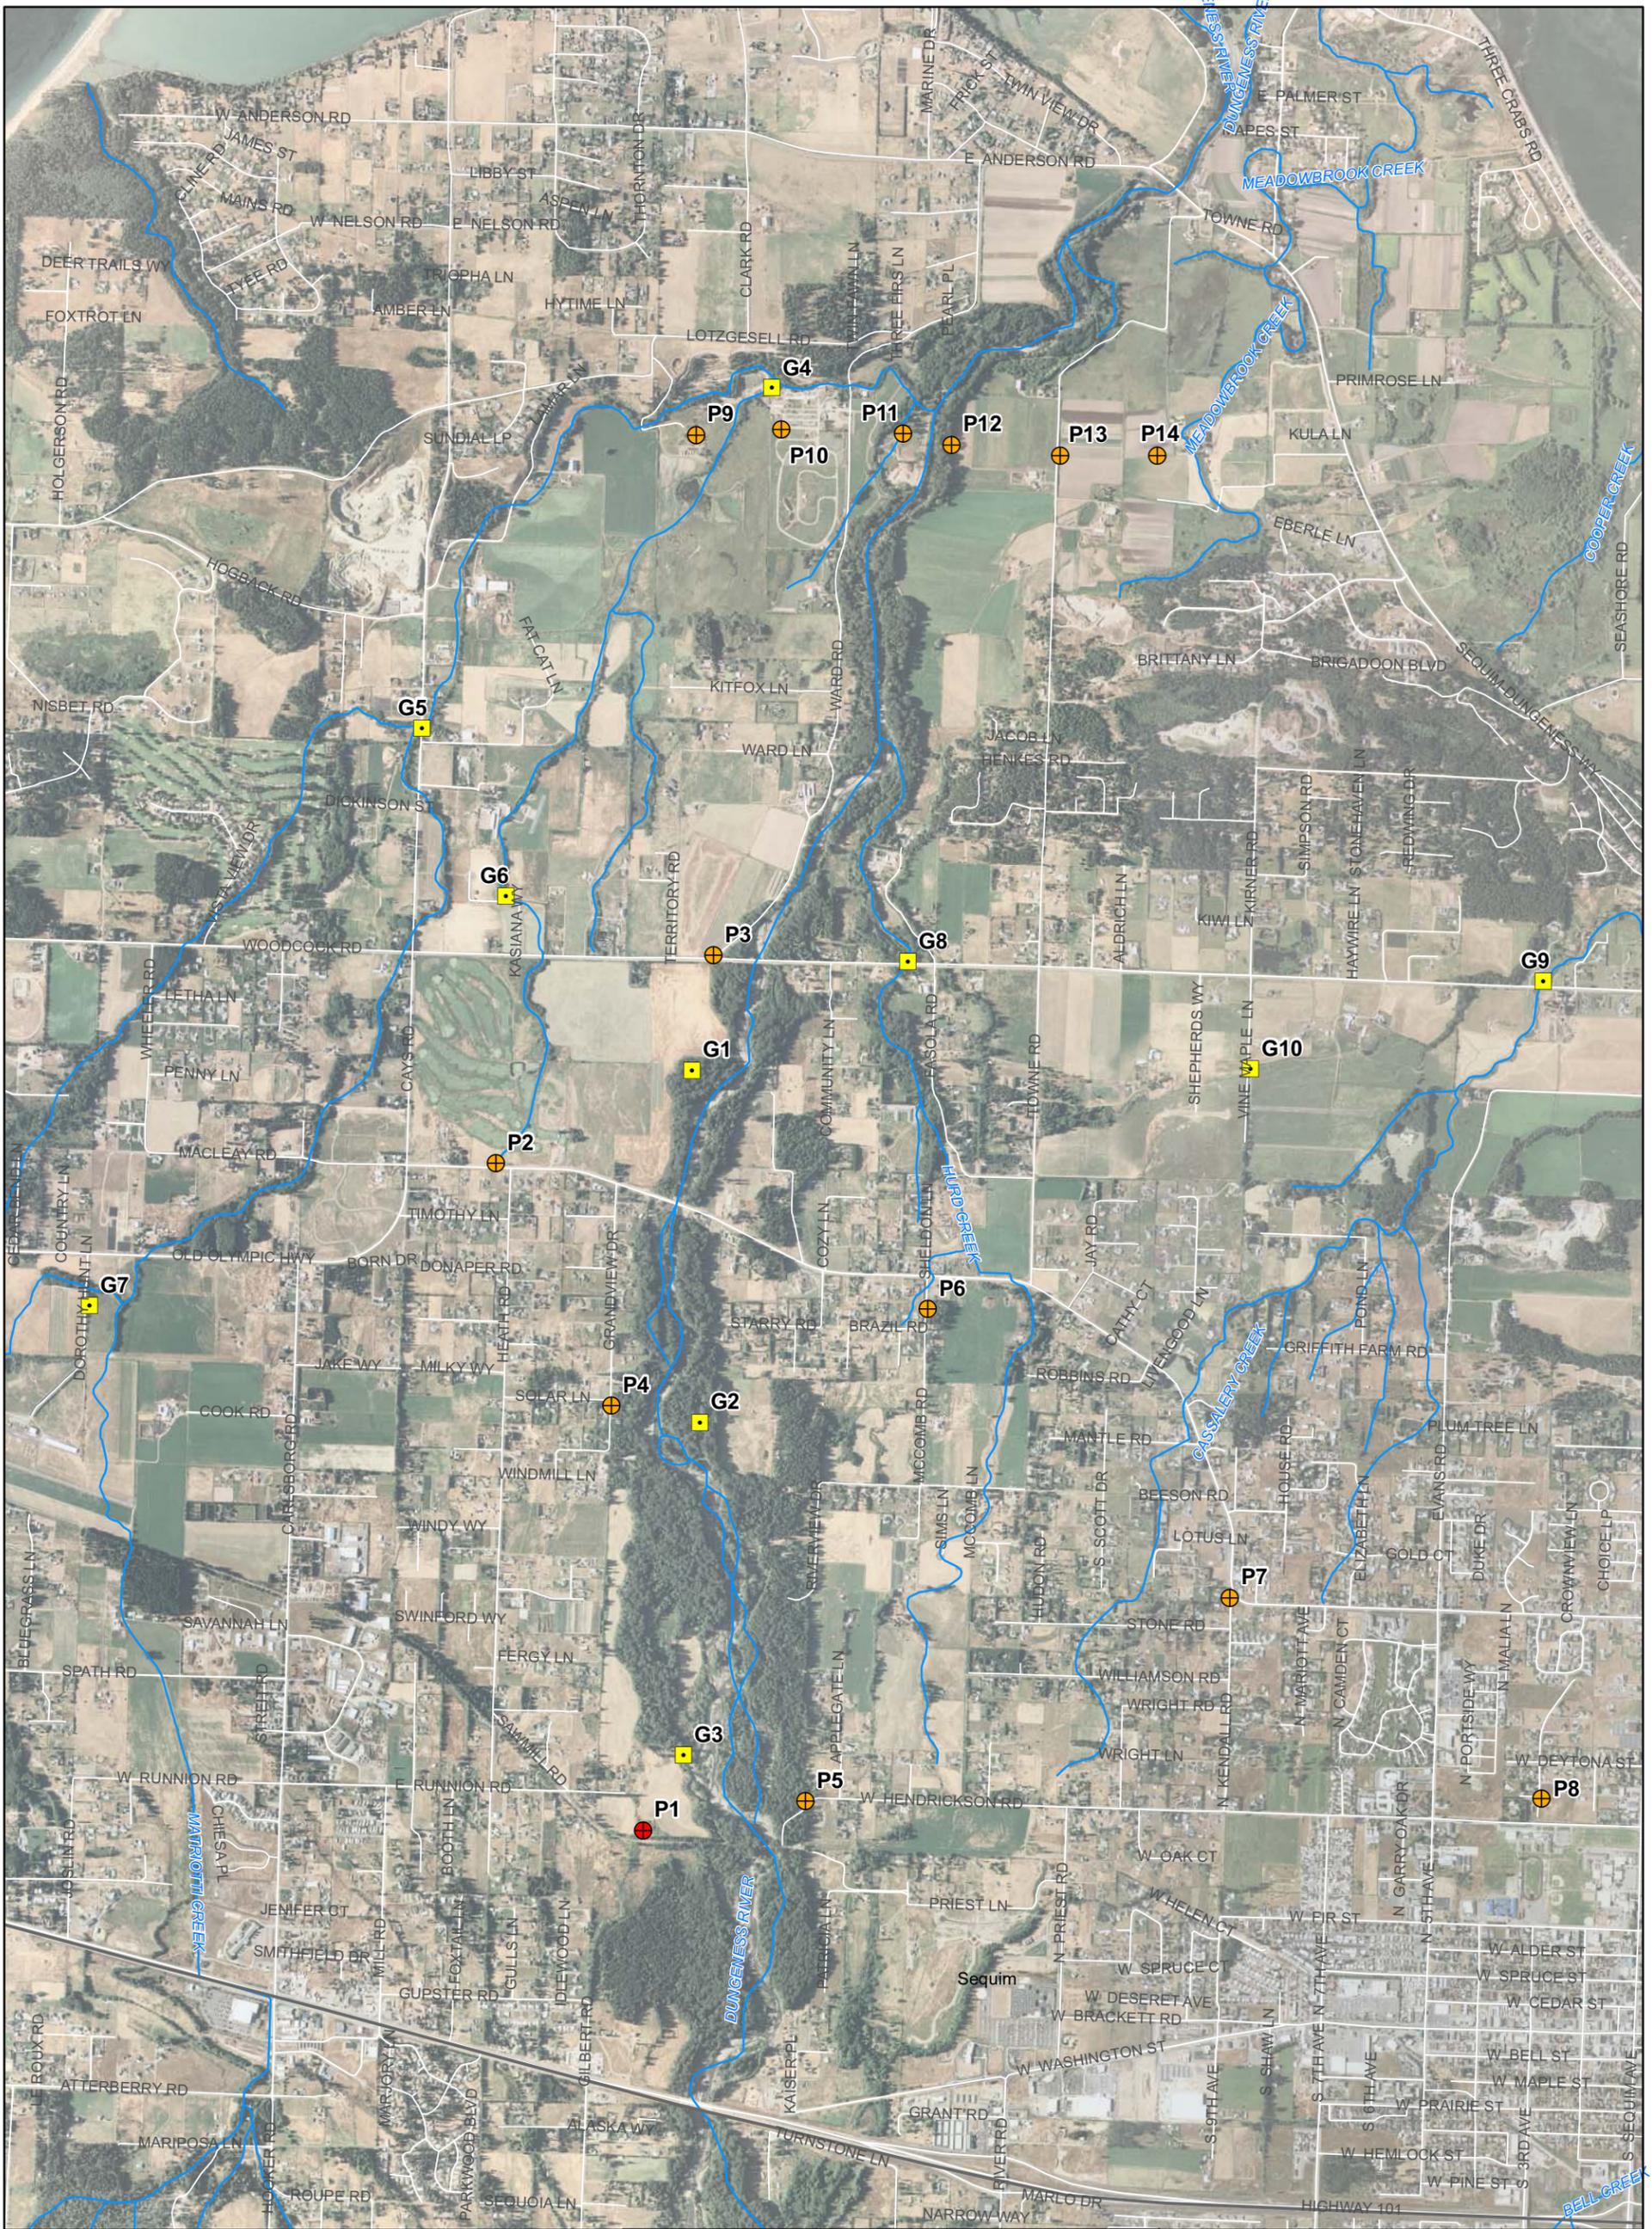
**Figure 1**  
Locations of Stream Gages & Monitoring Wells

Work began in April 2008 contacting property owners for site access. Field work was conducted in two phases. The first phase occurred between May 28 and June 4, 2008. The second phase began August 19 and was finished August 22, 2008. In all, 13 monitoring wells (labeled P2 through P14) were installed using a push rig operated by Environmental Services Network (ESN) from Olympia, Washington. PGG also installed ten stream gages (labeled G1 through G10) in side channels and tributaries to the Dungeness River downstream of the Railroad Bridge Park. Locations are shown in Figure 1. Station information is summarized in Table 1.

- Stream Gages
- Monitoring Well - Installed
- Monitoring Well - Refusal (Not Installed)

Subsurface conditions (likely cobbles) prevented installation of well P1 at the Railroad Bridge Park (west side of Dungeness). Thirteen attempts were made to install P1 during work Phases 1 and 2 along the public trail between the bench west of the bridge and the parking area and kiosk to the west. None of the attempts were successful.
